PERFORMANCE VERIFICATION STATEMENT
for the FSI NXIC-CTD-BIO-AUTO Salinity Sensor

TECHNOLOGY TYPE:	Coupled conductivity and temperature sensors with instrument based algorithms for estimation of salinity
APPLICATION:	In situ estimates of salinity for coastal moored and profiled deployments
PARAMETERS EVALUATED:	Response linearity, accuracy, precision and reliability
TYPE OF EVALUATION:	Laboratory and Field Performance Verification
DATE OF EVALUATION:	Testing conducted from May through October 2008
EVALUATION PERSONNEL:	S. Gilbert, K. Gundersen, T. Johengen, T. McKissack, M. McIntyre, A. Pinchuk, H. Purcell, C. Robertson, D. Schar, G.J. Smith, M. Tamburri and D. Wells.

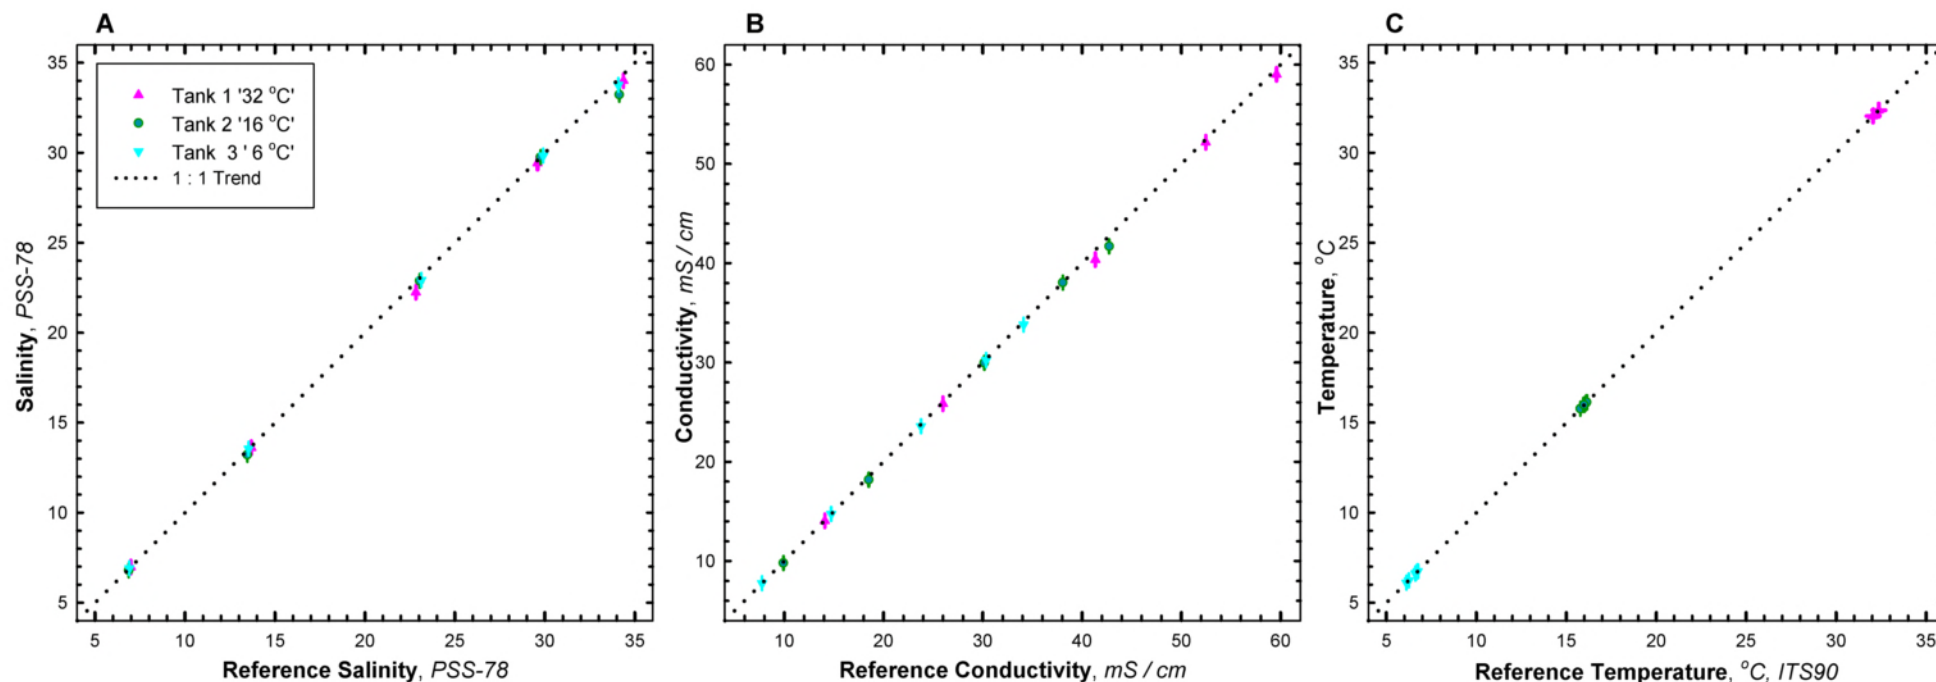
Analyzed across all five salinity levels and all three temperatures, the NXIC exhibited a strong linear response to the test solutions with R^2 = 0.9996, standard error = 0.2225, and slope = 0.9869 (Fig. 3). Most of variability was observed in the conductivity measurements which had a linear response of R^2 = 0.9997, standard error = 0.2737, and slope = 0.987. The temperature response regression was R^2 > 0.9999, standard error = 0.0036 and slope = 1.000. The variance in 30 repeated measurements taken at one minute intervals for each of the laboratory trials is shown in Figure 4. The plots are not a measure of engineering precision as environmental conditions within the test baths did change during the sampling process. The variation in instrument derived measurements is plotted relative to the average standard deviation and 3-times the standard deviation upper specification limit of reference salinity, conductivity, and temperature measurements taken over corresponding time intervals for all lab tests. An alternative version of this figure showing a direct comparison of instrument versus reference sample variance for each individual trial is given in Appendix 1. Instrument offsets in salinity, conductivity and temperature were computed for each test run as the difference in the mean instrument measure from the mean reference measure for that test bath condition (Fig. 5). There was a slight increase in the amount of offset for salinity and conductivity measurements as the salinity of the test solutions increased. The mean offset in measured salinity for the 15 laboratory test conditions was -0.2180 $\pm$0.2543 psu. When examined independently for conductivity and temperature, the mean offsets were -0.2882 $\pm$ 0.3303 mS/cm and -0.0073 $\pm$ 0.0034 ^{o}C, respectively.

Figure 3. Evaluation of the response linearity for the FSI conductivity and temperature sensor package during controlled laboratory exposures to a combination of natural seawater dilutions and temperatures. Consecutive test exposures ranged between 35 to 6 on the practical salinity scale (PSS-78; 60 to 6 mS/cm conductivity) and 33 to 6 °C. [*A*]Correspondence of instrument derived salinity to Portasal reference measurements; [*B*] Correspondence of instrument in situ conductivity measurement to conductivity estimate derived from the Portasal salinity and reference temperature measurement by inversion of the seawater equations of state (IAPSO PSS-78); [*C*] Correspondence of instrument temperature measurement to bath reference temperature recorded by a calibrated RBR 1060 logging thermometer. Data points are represented as mean ± standard deviation of and 10 reference water samples. Dotted lines represent 1:1 ideal correlation of measures.

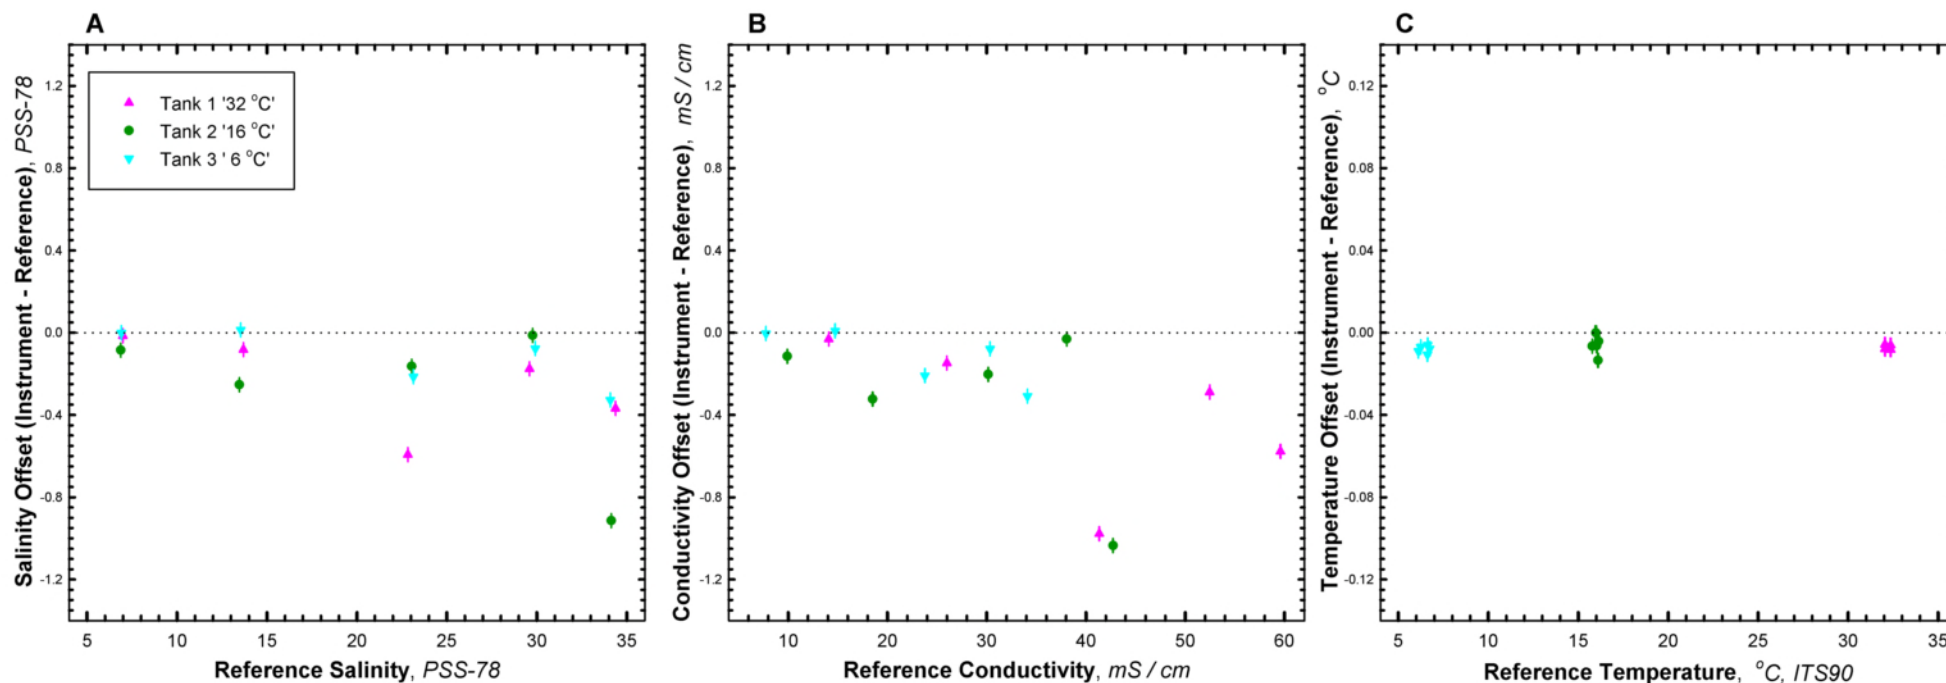
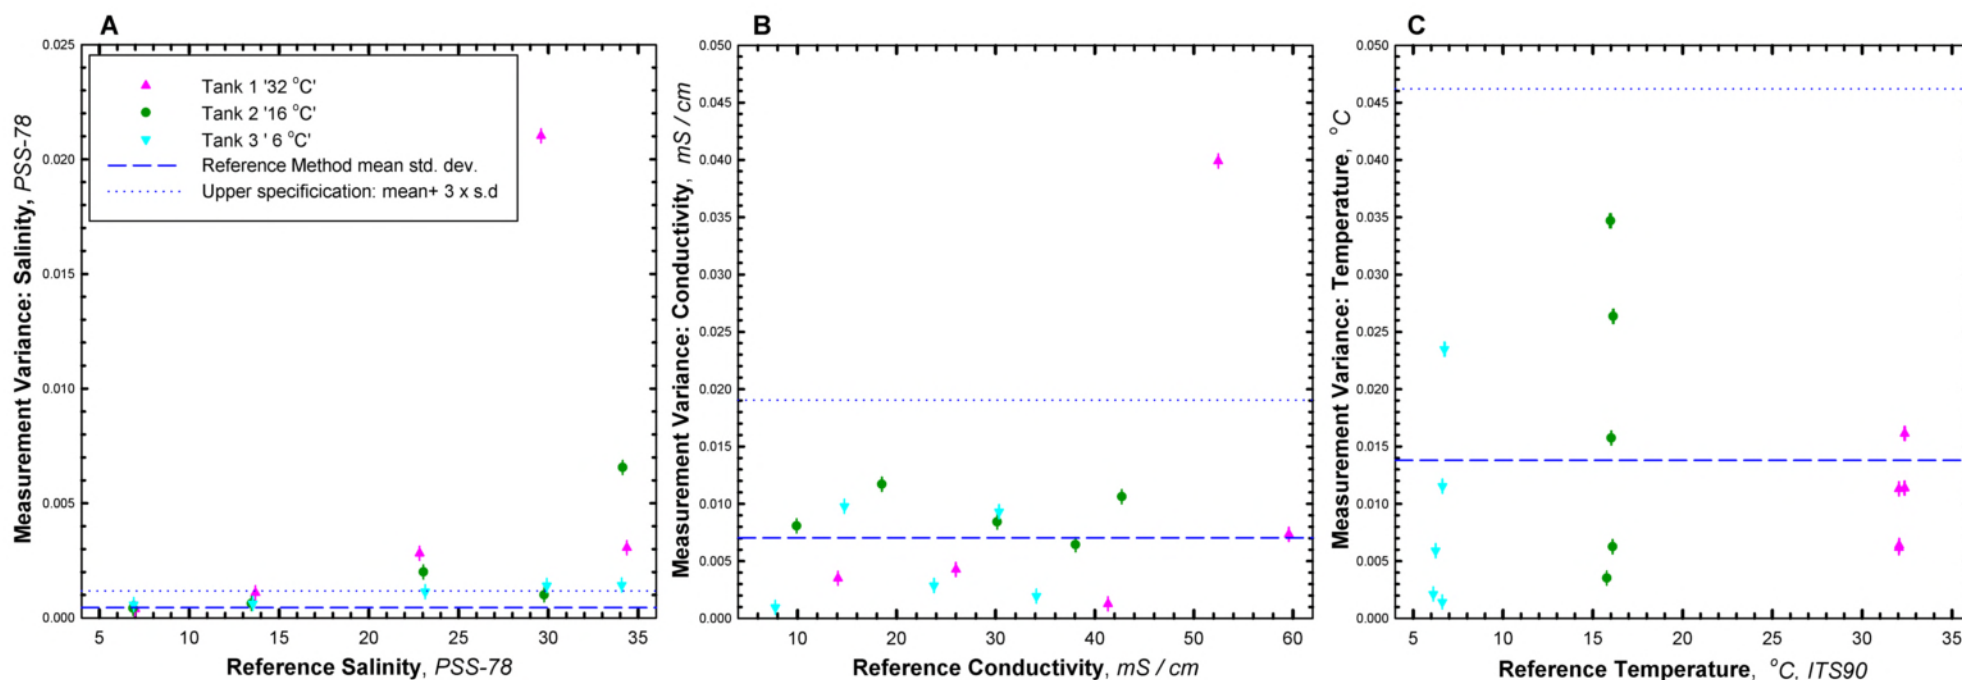
FSI CTD

Figure 4. Evaluation of measurement variation of the FSI conductivity and temperature sensor package achieved during the laboratory exposure trials plotted in **Fig. 3**. Relative measurement variance is presented as the standard deviation from 30 consecutive instrument reads associated with each test exposure. The corresponding reference measurement variance range is provided in each plot as the mean standard deviation (dashed line) and 3x s.d. (dotted line) of consecutive reference samples, averaged across all trials. [*A*] Variance of derived salinity estimates; [*B*] Variance of in situ conductivity measurements; [*C*] Variance of instrument temperature measurements.

Figure 5. Evaluation of the relative accuracy of the FSI conductivity and temperature sensor package achieved during the laboratory exposure tests plotted in **Fig. 3**. Relative accuracy is estimated as the difference or offset between the mean instrument reading and mean reference reading for each exposure test. [*A*] Relative accuracy of derived salinity estimate; [*B*] Relative accuracy of instrument's in situ conductivity measurement; [*C*] Relative accuracy of instrument's temperature measurements. Dotted horizontal line represents no difference between instrument and reference method measurement.

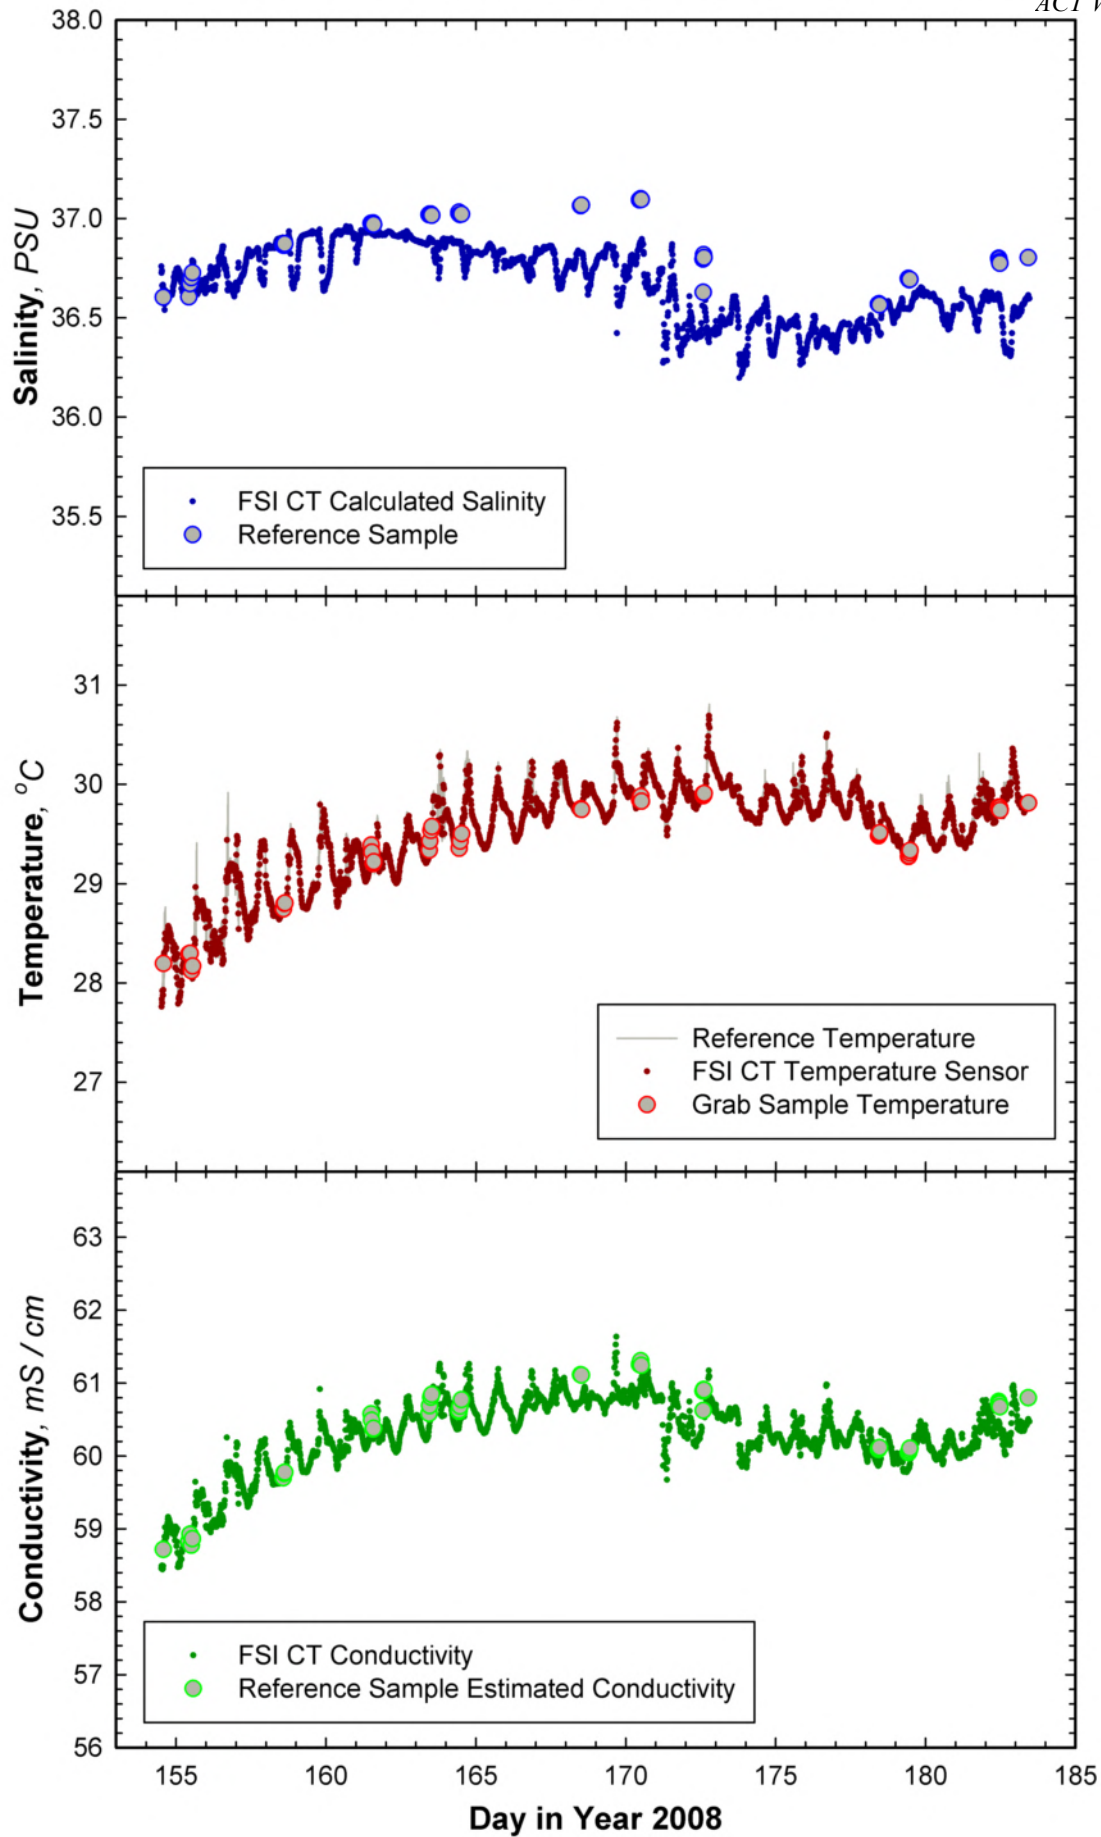
Time series data of in situ measured conductivity and temperature, and derived salinity, for the FL field test were plotted against corresponding results from the laboratory analyzed reference samples (Fig. 7). The relative accuracy of the instrument measurements were depicted as numerical differences from the reference values and plotted over time (Fig. 8). Instrument measurements appeared to be impacted by fouling after approximately 10 days when a noticeable decrease in accuracy was observed but then offset then remained fairly constant over the last 20 days of the deployment test. The amount of offset in the salinity measurements was clearly related to performance of the conductivity cell, and the temperature sensor response was quite consistent throughout the deployment despite the presence of heavy biofouling. The mean offset in the salinity measurements over the entire deployment was -0.1116 ± 0.0930 psu. To distinguish between biofouling impacts and potential instrument drift we compared measurement accuracy in pre- and post-exposure tests after the instrument was cleaned to remove any effects of biofouling using well mixed, reference sampled tanks (Fig 9). The agreement between instrument and reference sample values was actually slightly better in the post-deployment exposure, perhaps due a lower salinity of the test solution which better matched the current calibration settings. The amount of fouling that development on the instrument is shown in figure 10 and the rate of fouling was documented with a time-series of photographs showing the accumulation on PVC tiles (Fig. 11).

Figure 7. Time series of instrument measurements and corresponding reference samples acquired during USF field deployment.

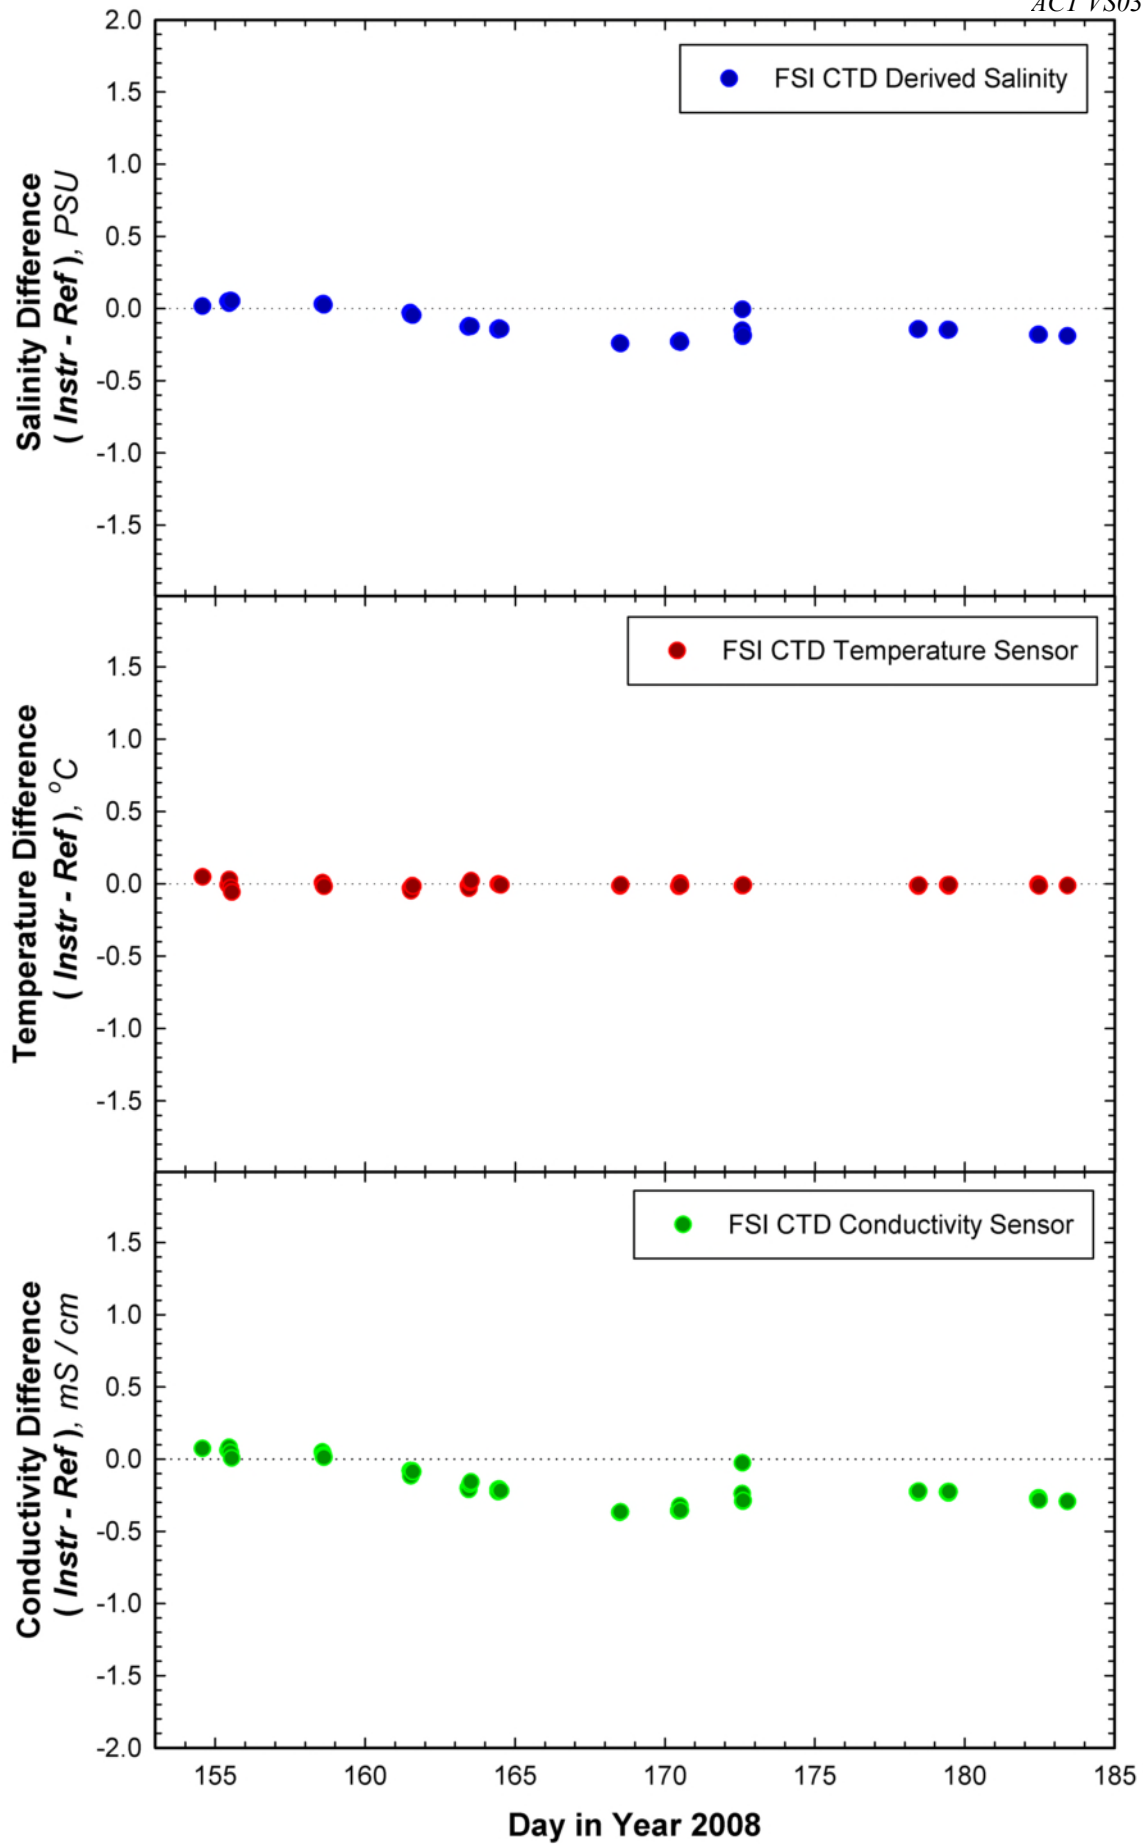
Figure 8. Assessment of relative accuracy of instrument time series measurements during USF field deployment.

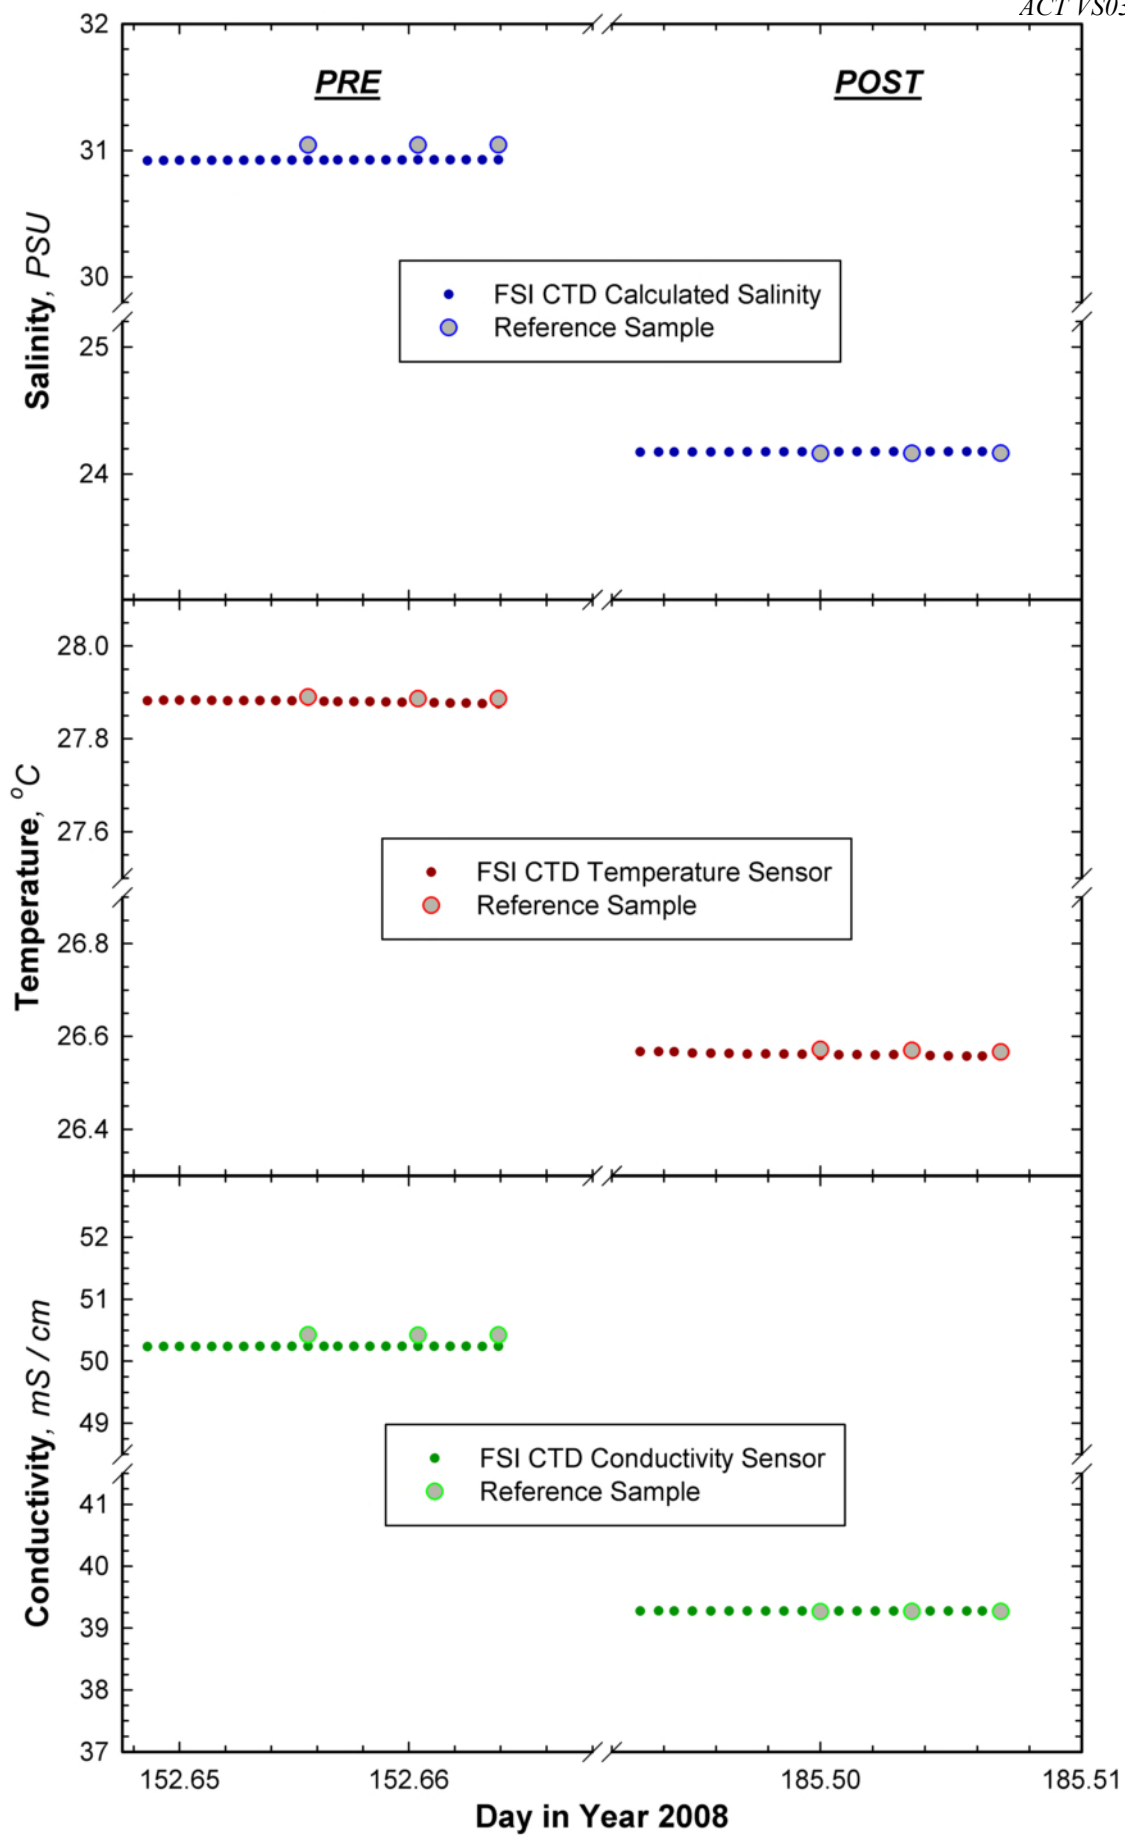
Figure 9. Pre- and Post-deployment reference checks in tanks of natural seawater at USF. Post-deployment tests conducted after cleaning instrument of all fouling material according to manufacturer's recommendations.

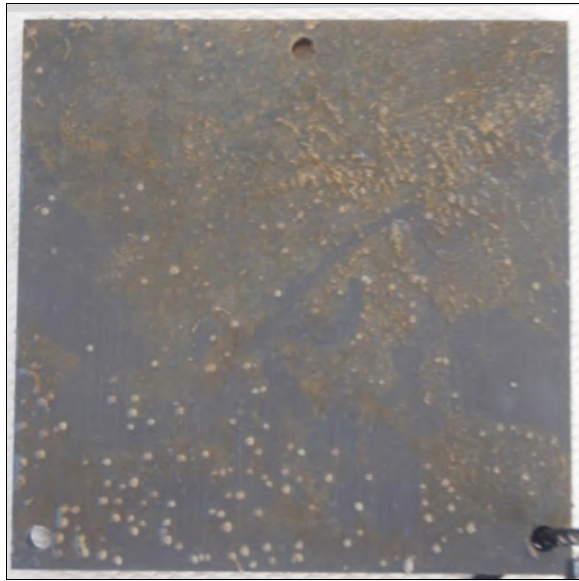
USF Site Week 1

Bio-fouling plates were retrieved and photographed once each week throughout the deployment to help define the rate and extent of biofouling within the test environment (Fig. 11). By the third week of deployment there was an extensive amount of hard, encrusting biofouling at the Florida test site.

Figure 11. Weekly bio-fouling plates retrieved from the Tampa Bay, FL mooring test site.

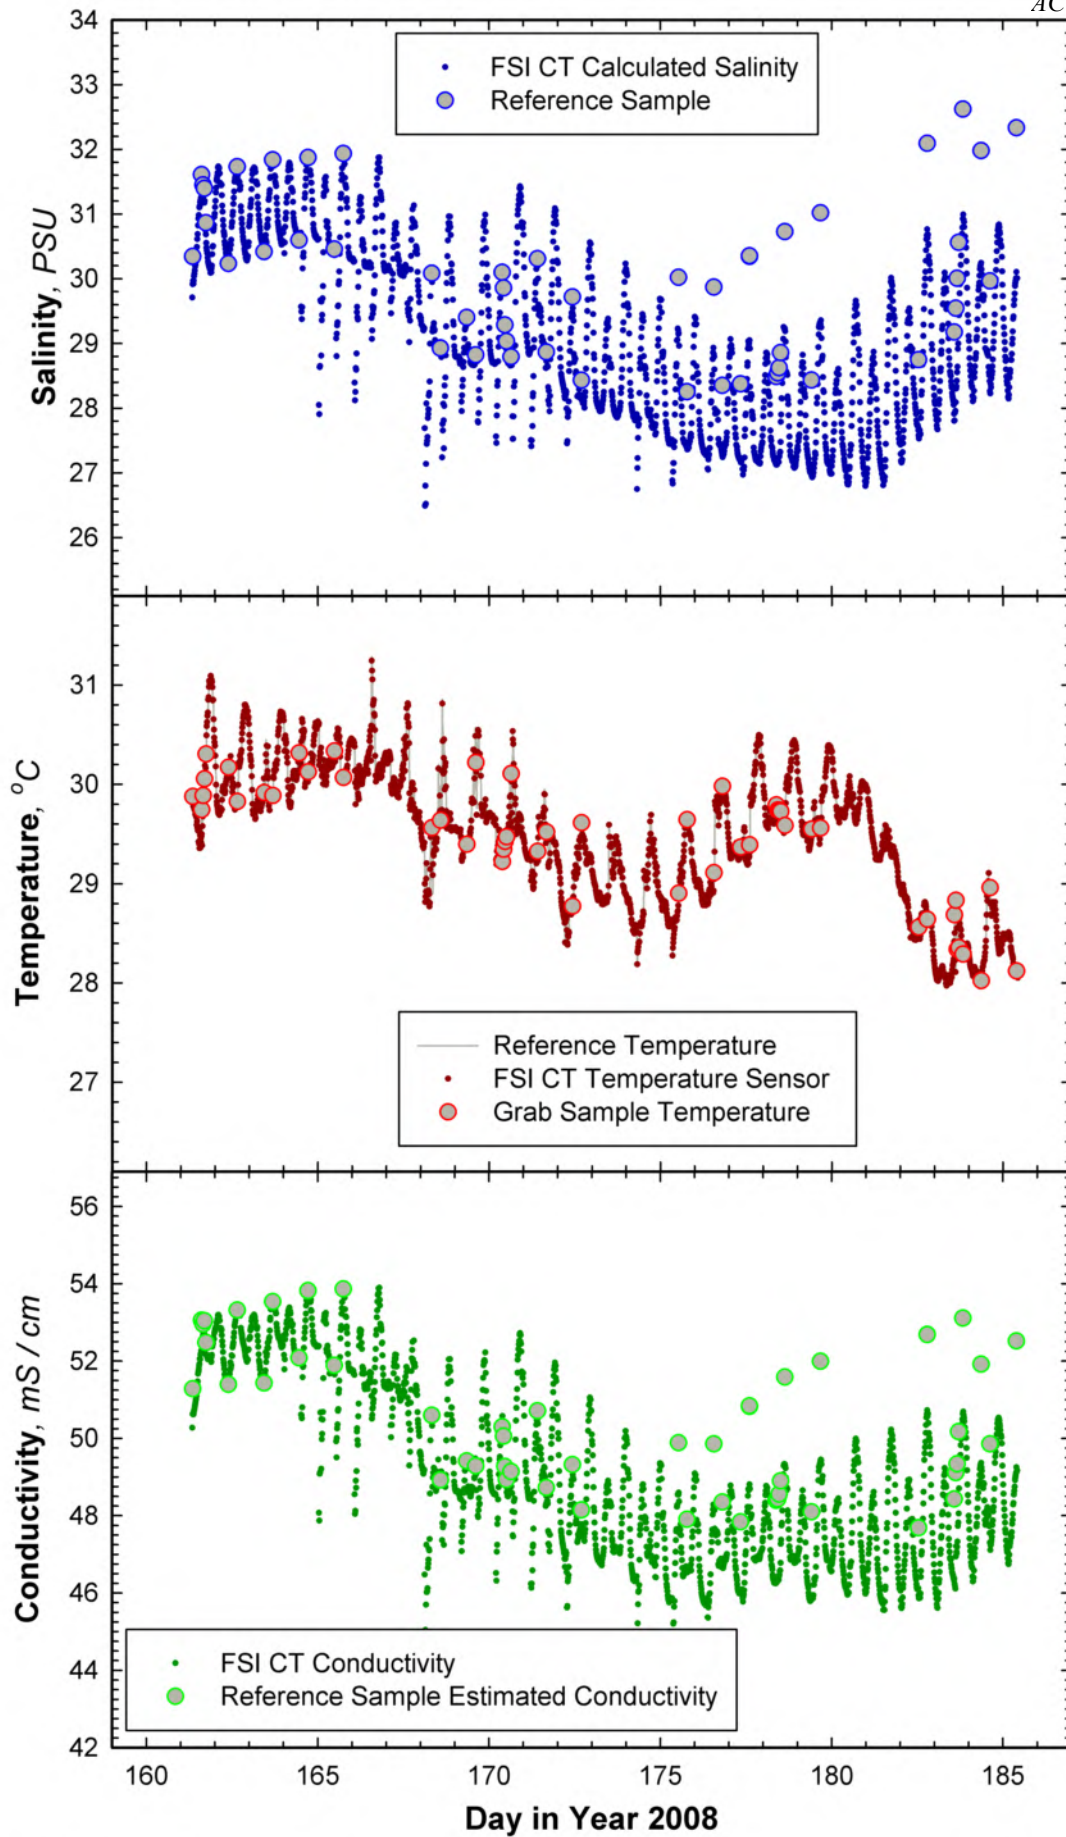
Time series data of in situ measured conductivity and temperature, and derived salinity, for the GA field test were plotted against corresponding results from the laboratory analyzed reference samples (Fig. 13). The initial negative offset for the first 5 readings may have been due to bubbles trapped in the conductivity cells which subsequently were flushed away. Similar to the FL test site, instrument measurements appeared to be impacted by fouling after approximately 10 days when a dramatic decrease in accuracy occurred (Fig. 14). The amount of offset in the salinity measurements was again clearly related to performance of the conductivity cell, and the temperature sensor response was quite consistent throughout the deployment despite the presence of heavy biofouling. The mean offset in the salinity measurements over the entire field test was -0.7204 ± 0.6745 psu, however during day 162 – 166 the offset average only 0.001 psu.. A test to confirm that changes in instrument performance were due to biofouling and not electronic drift was completed by comparing measurement accuracy in pre- and post- exposures in well mixed reference sampled tanks, after the instrument was cleaned to remove all biofouling (Fig 15). The agreement between instrument and reference sample values was significantly better in the post-deployment exposure. As no changes were made in calibration settings, the initial negative offset in instrument readings may again have been due to bubble entrainment. The amount of fouling that developed on the instrument during the deployment is shown in figure 16.

Figure 13. Time series of instrument measurements and corresponding reference samples acquired during the SkIO field deployment.

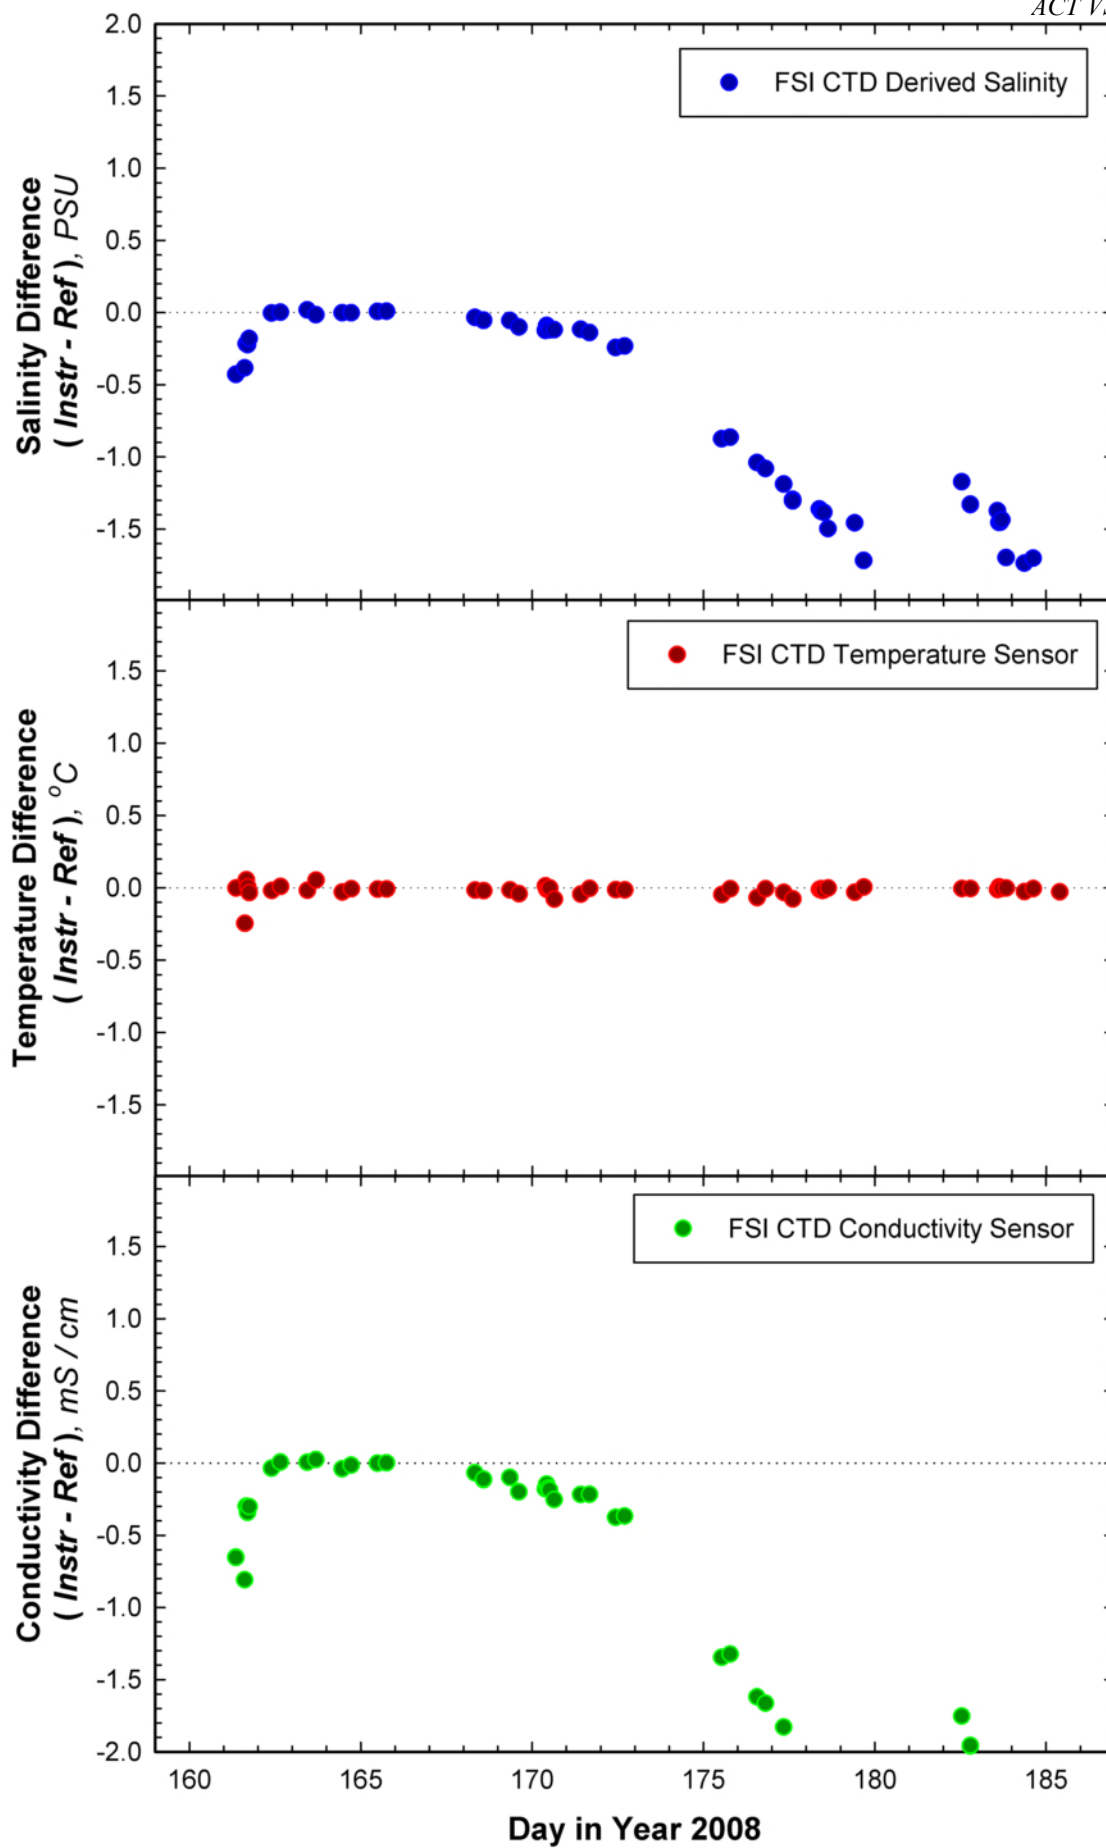
Figure 14. Assessment of relative accuracy of instrument time series measurements during the SkIO field deployment.

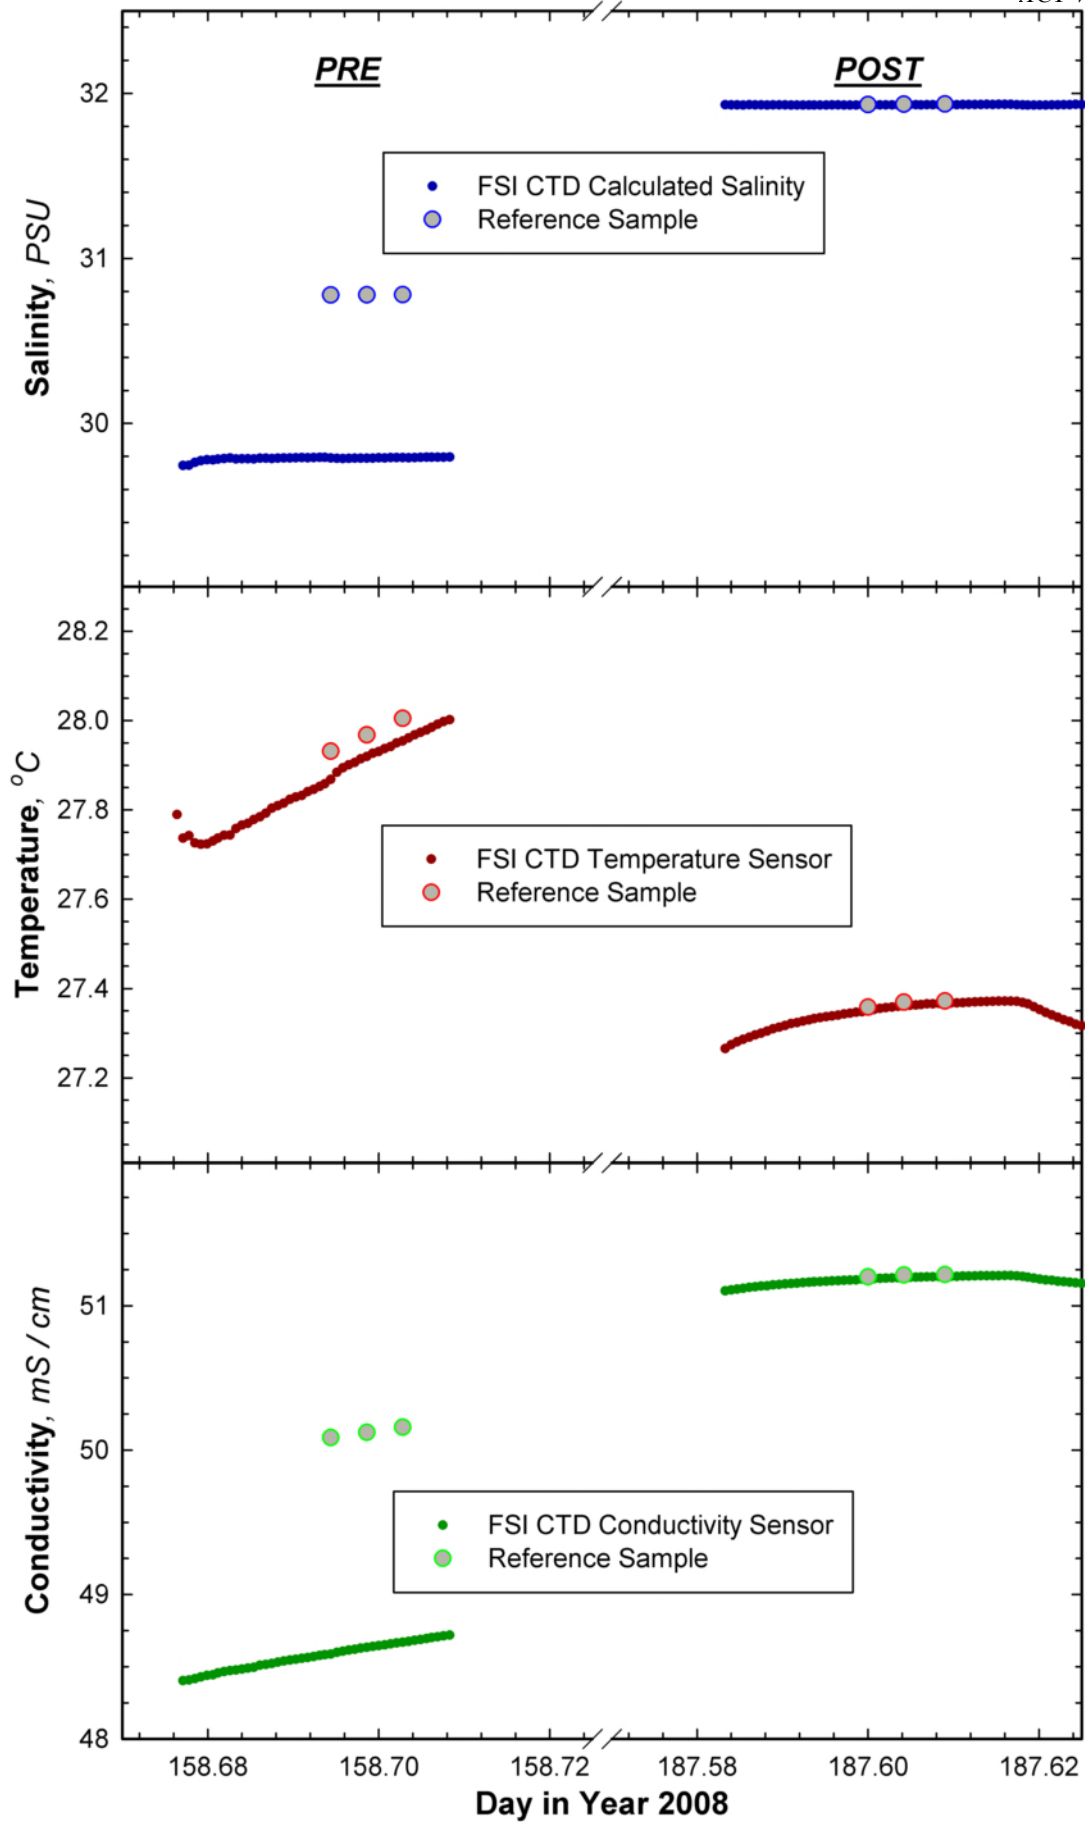
Figure 15. Pre- and Post-deployment reference checks in tanks of natural seawater at SkIO. Post-deployment tests conducted after cleaning instrument of all fouling material according to manufacturer's recommendations.

The consistently low sensor readings during preliminary laboratory testing, as well as in pre-deployment reference testing at the SkIO and post-deployment reference testing at HI is indicative of air bubbles trapped in the sensor. Although air bubbles may be trapped in the sensor under laboratory or shallow-water conditions, these bubbles would typically be dispersed early in the deployment with increased ambient pressure and as the sensor is flushed by the current, as can be seen by the data at the SkIO site.

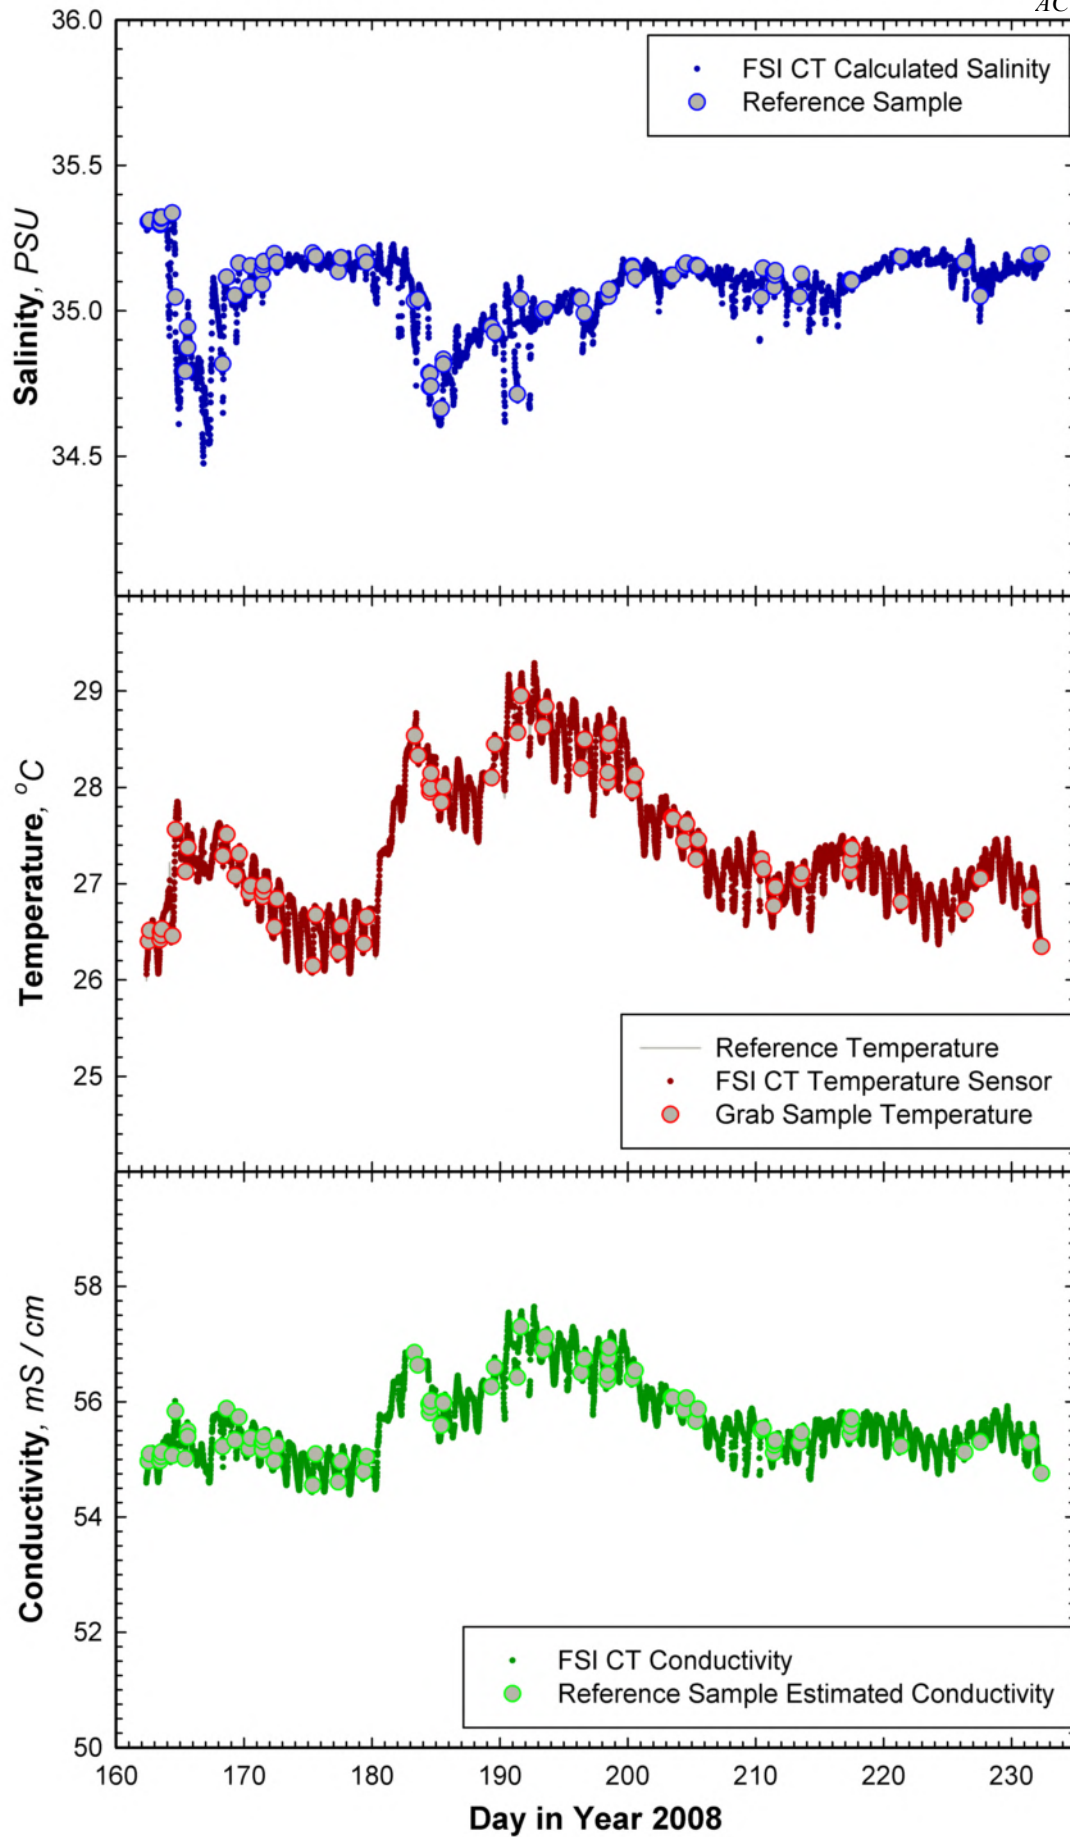
Time series data of in situ measured conductivity and temperature, and derived salinity, for the HI field test were plotted against corresponding results from the laboratory analyzed reference samples (Fig. 19). The FSI NXIC salinity measurements closely matched reference sample measurements throughout the entire 60 day deployment. The amount of offset in salinity, conductivity and temperature measurements averaged -0.0179 psu, -0.0073 mS/cm, and 0.0196 ^{o}C, respectively over the deployment (Fig. 20). The offset in the instrument salinity and conductivity measurements for the post-deployment exposure test (Fig. 21) was again likely due to bubble entrainment and not calibration drift; since the instrument was performing significantly (fifty times) better in the field immediately prior to the final tank test. The amount of fouling that developed on the instrument during the deployment is shown in figure 22 and the rate of fouling was documented with a time-series of photographs showing the accumulation on PVC tiles (Fig. 23).

Figure 19. Time series of instrument measurements and corresponding reference samples acquired during the HI field deployment.
