PERFORMANCE VERIFICATION STATEMENT
for the FSI NXIC-CTD-BIO-AUTO Salinity Sensor

TECHNOLOGY TYPE:	Coupled conductivity and temperature sensors with instrument based algorithms for estimation of salinity
APPLICATION:	In situ estimates of salinity for coastal moored and profiled deployments
PARAMETERS EVALUATED:	Response linearity, accuracy, precision and reliability
TYPE OF EVALUATION:	Laboratory and Field Performance Verification
DATE OF EVALUATION:	Testing conducted from May through October 2008
EVALUATION PERSONNEL:	S. Gilbert, K. Gundersen, T. Johengen, T. McKissack, M. McIntyre, A. Pinchuk, H. Purcell, C. Robertson, D. Schar, G.J. Smith, M. Tamburri and D. Wells.

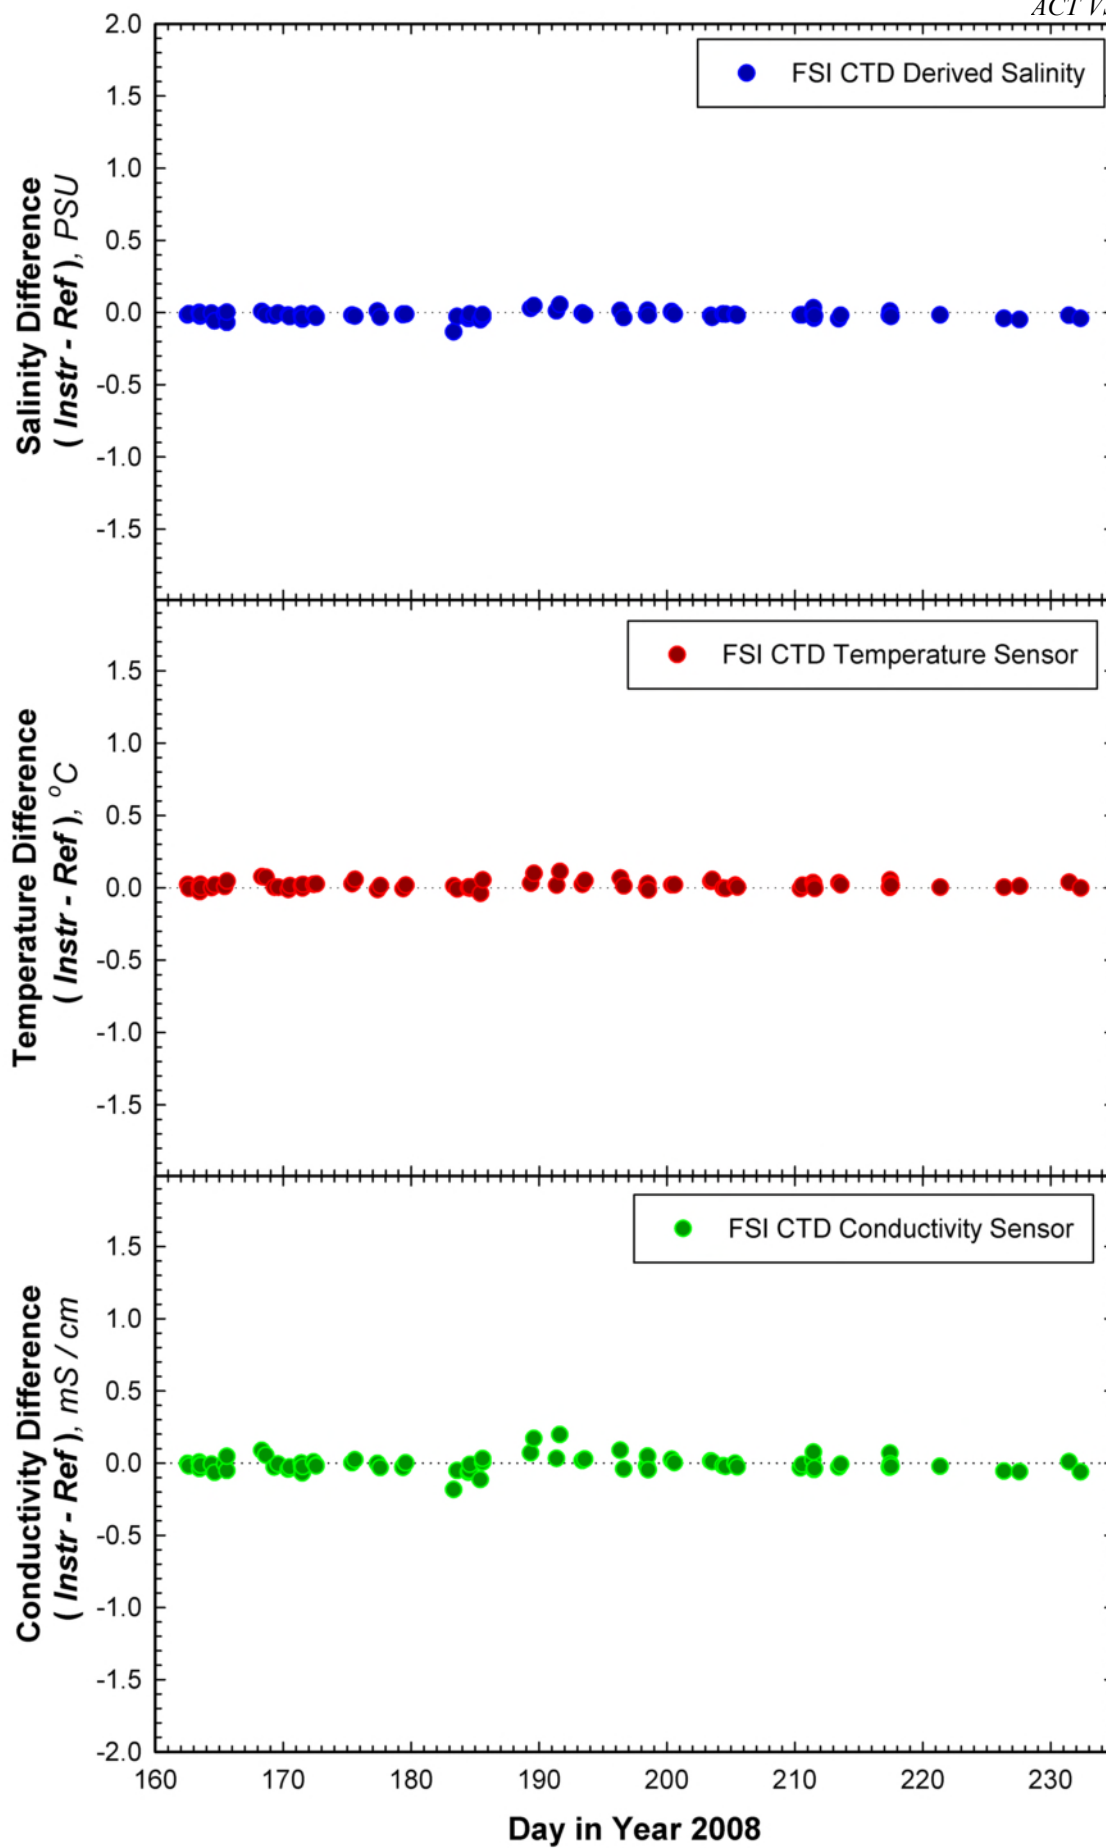
Figure 20. Assessment of relative accuracy of instrument time series measurements during the HI field deployment.

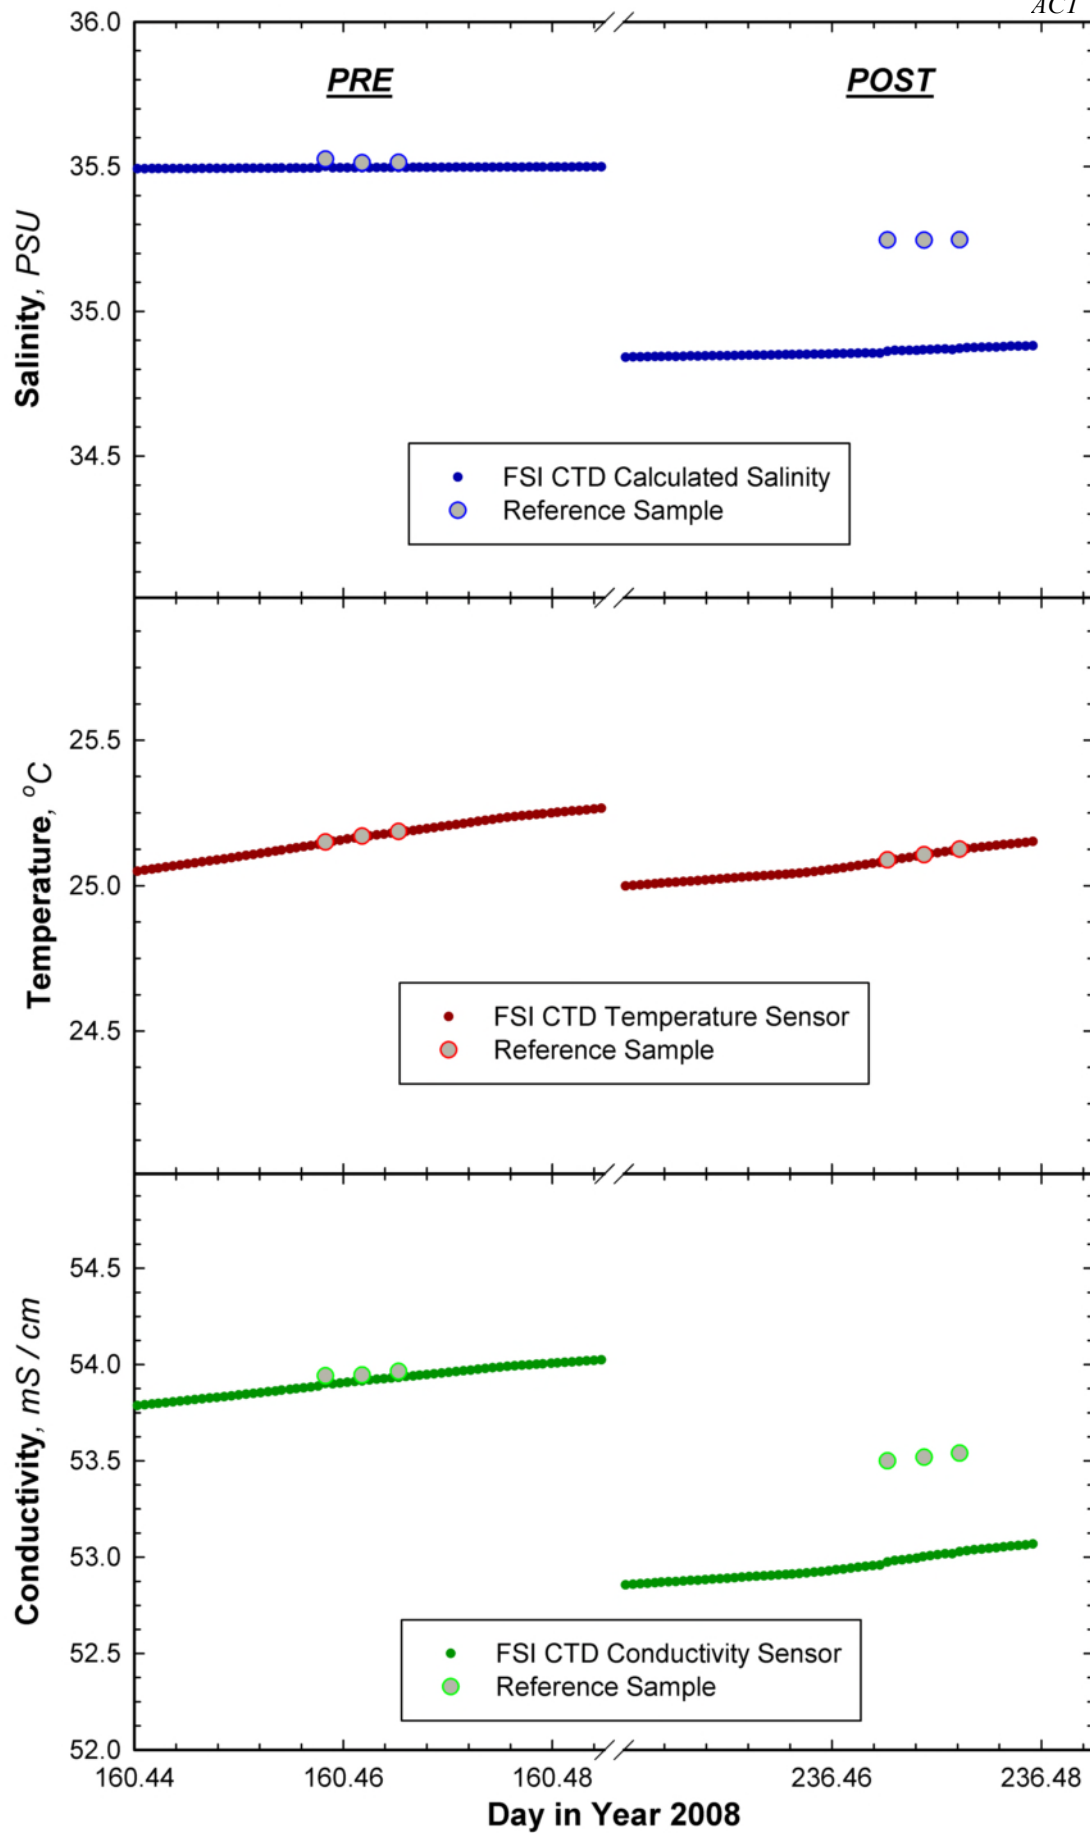
Figure 21. Pre- and Post-deployment reference checks in tanks of natural seawater at HI. Post-deployment tests conducted after cleaning instrument of all fouling material according to manufacturer's recommendations.

The consistently low sensor readings during preliminary laboratory testing, as well as in pre-deployment reference testing at the SkIO and post-deployment reference testing at HI is indicative of air bubbles trapped in the sensor. Although air bubbles may be trapped in the sensor under laboratory or shallow-water conditions, these bubbles would typically be dispersed early in the deployment with increased ambient pressure and as the sensor is flushed by the current, as can be seen by the data at the SkIO site.

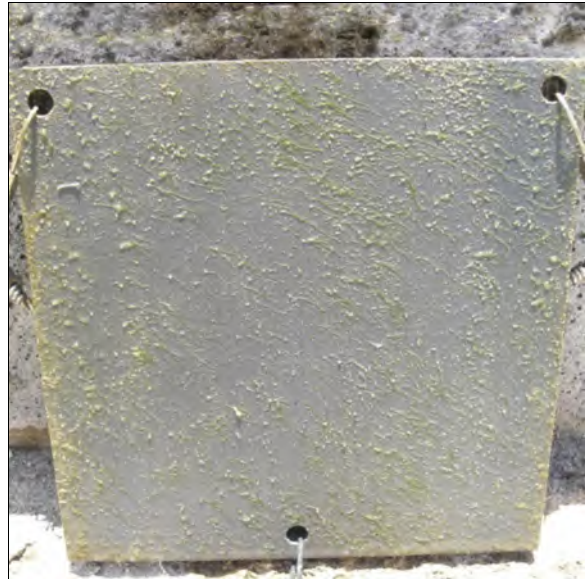
HI Site Week 2

Bio-fouling plates were retrieved and photographed once each week throughout the deployment to help define the rate and extent of biofouling within the test environment. A sub-set of the plate photographs covering weeks 1, 2, 4, and 8 are shown in Figure 23. The extent of bio-fouling was significantly less at this test site relative to FL or GA despite the longer deployment period and was mostly comprised of plant material and worm cases.

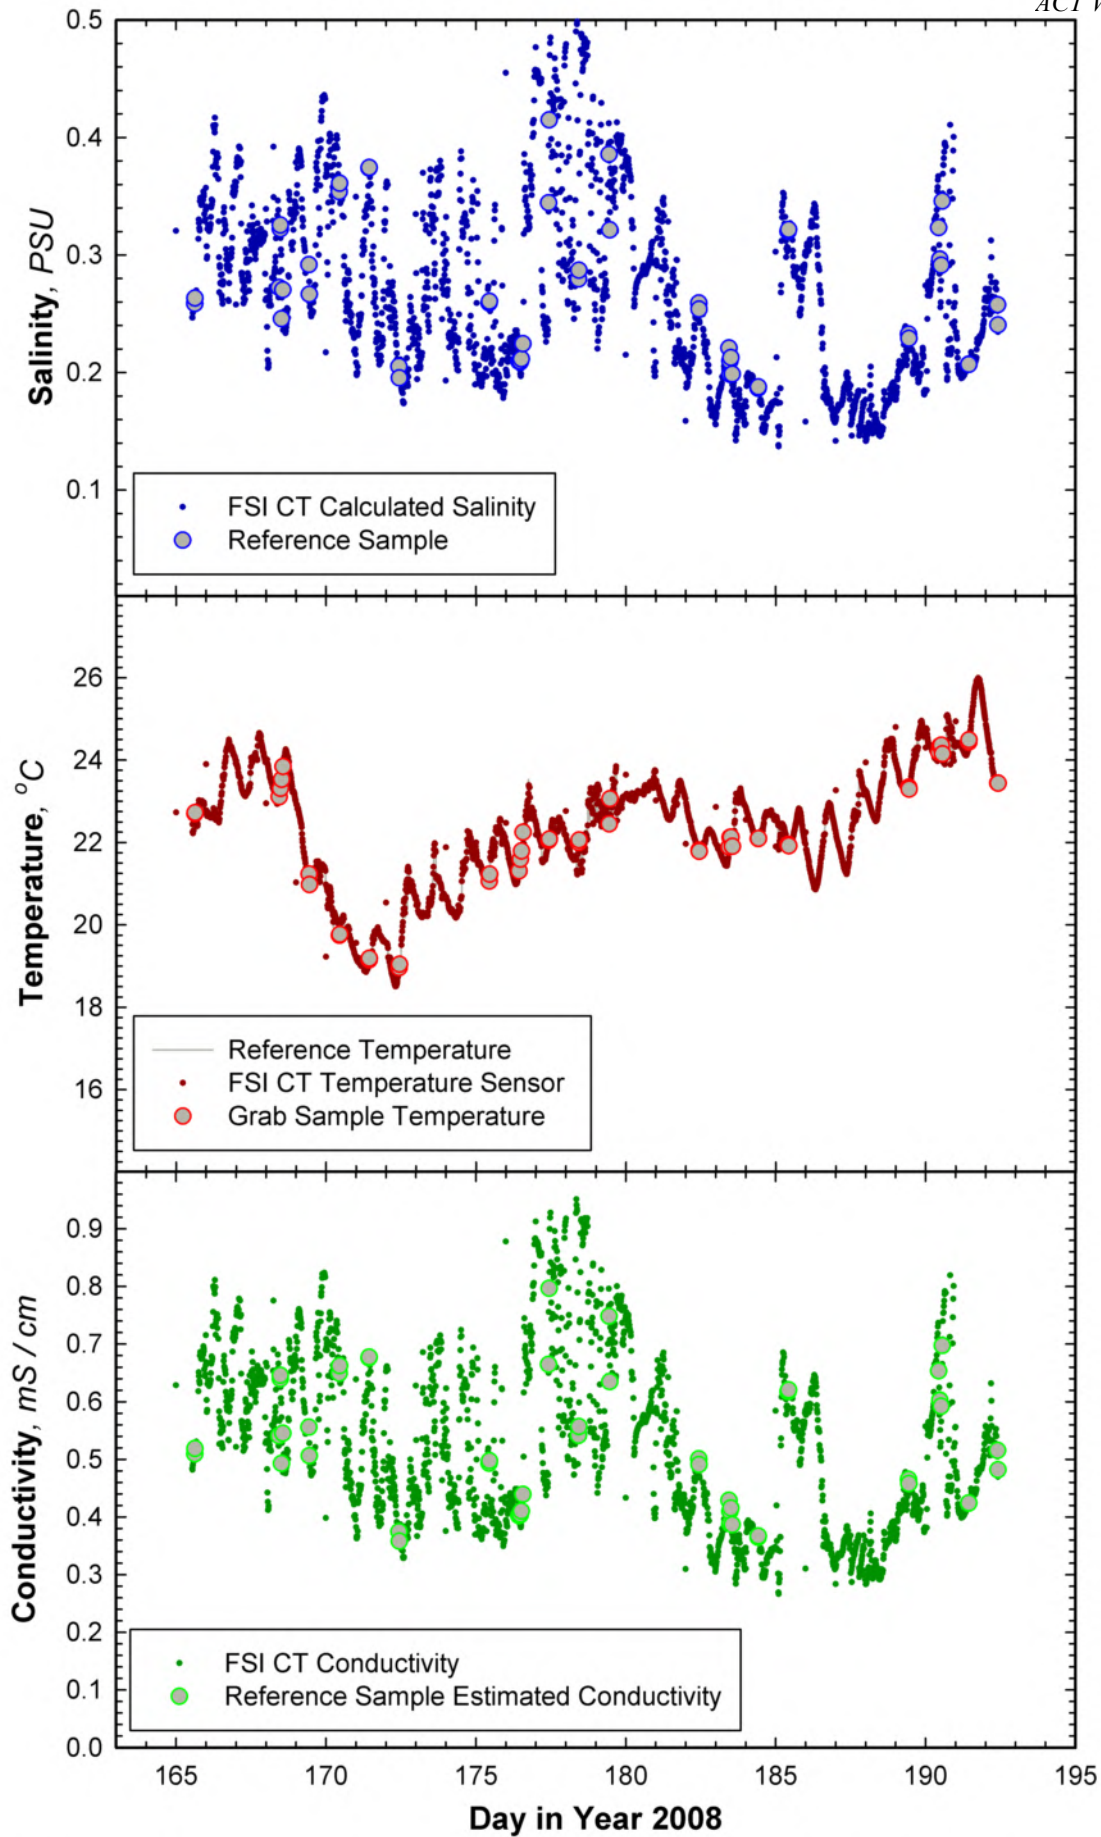
Time series data of in situ measured conductivity and temperature, and derived salinity, for the GL field test were plotted against corresponding results from the laboratory analyzed reference samples (Fig. 25). The FSI NXIC measurements closely matched reference sample measurements throughout the entire 29 day deployment despite the lower riverine conductivity levels and rather sharp temporal gradients experienced at the site. The amount of offset in salinity, conductivity and temperature averaged -0.0018 psu, -0.0038 mS/cm, and $0.0093\ ^oC$, respectively over the deployment (Fig. 26). The occasional greater offset in temperature could easily be explained by heterogeneity around the mooring and the distance between the instrument and reference temperature logger. The offset in the instrument salinity, conductivity, and temperature measurements was nearly identical between the pre- and post-deployment exposure tests (Fig. 21). In general there was very little fouling impact at this site and the amount of fouling that developed on the instrument during the deployment is shown in figure 27 and the rate of fouling was documented with a time-series of photographs showing the accumulation on PVC tiles (Fig. 28).

Figure 25. Time series of instrument measurements and corresponding reference samples acquired during the GL field deployment.

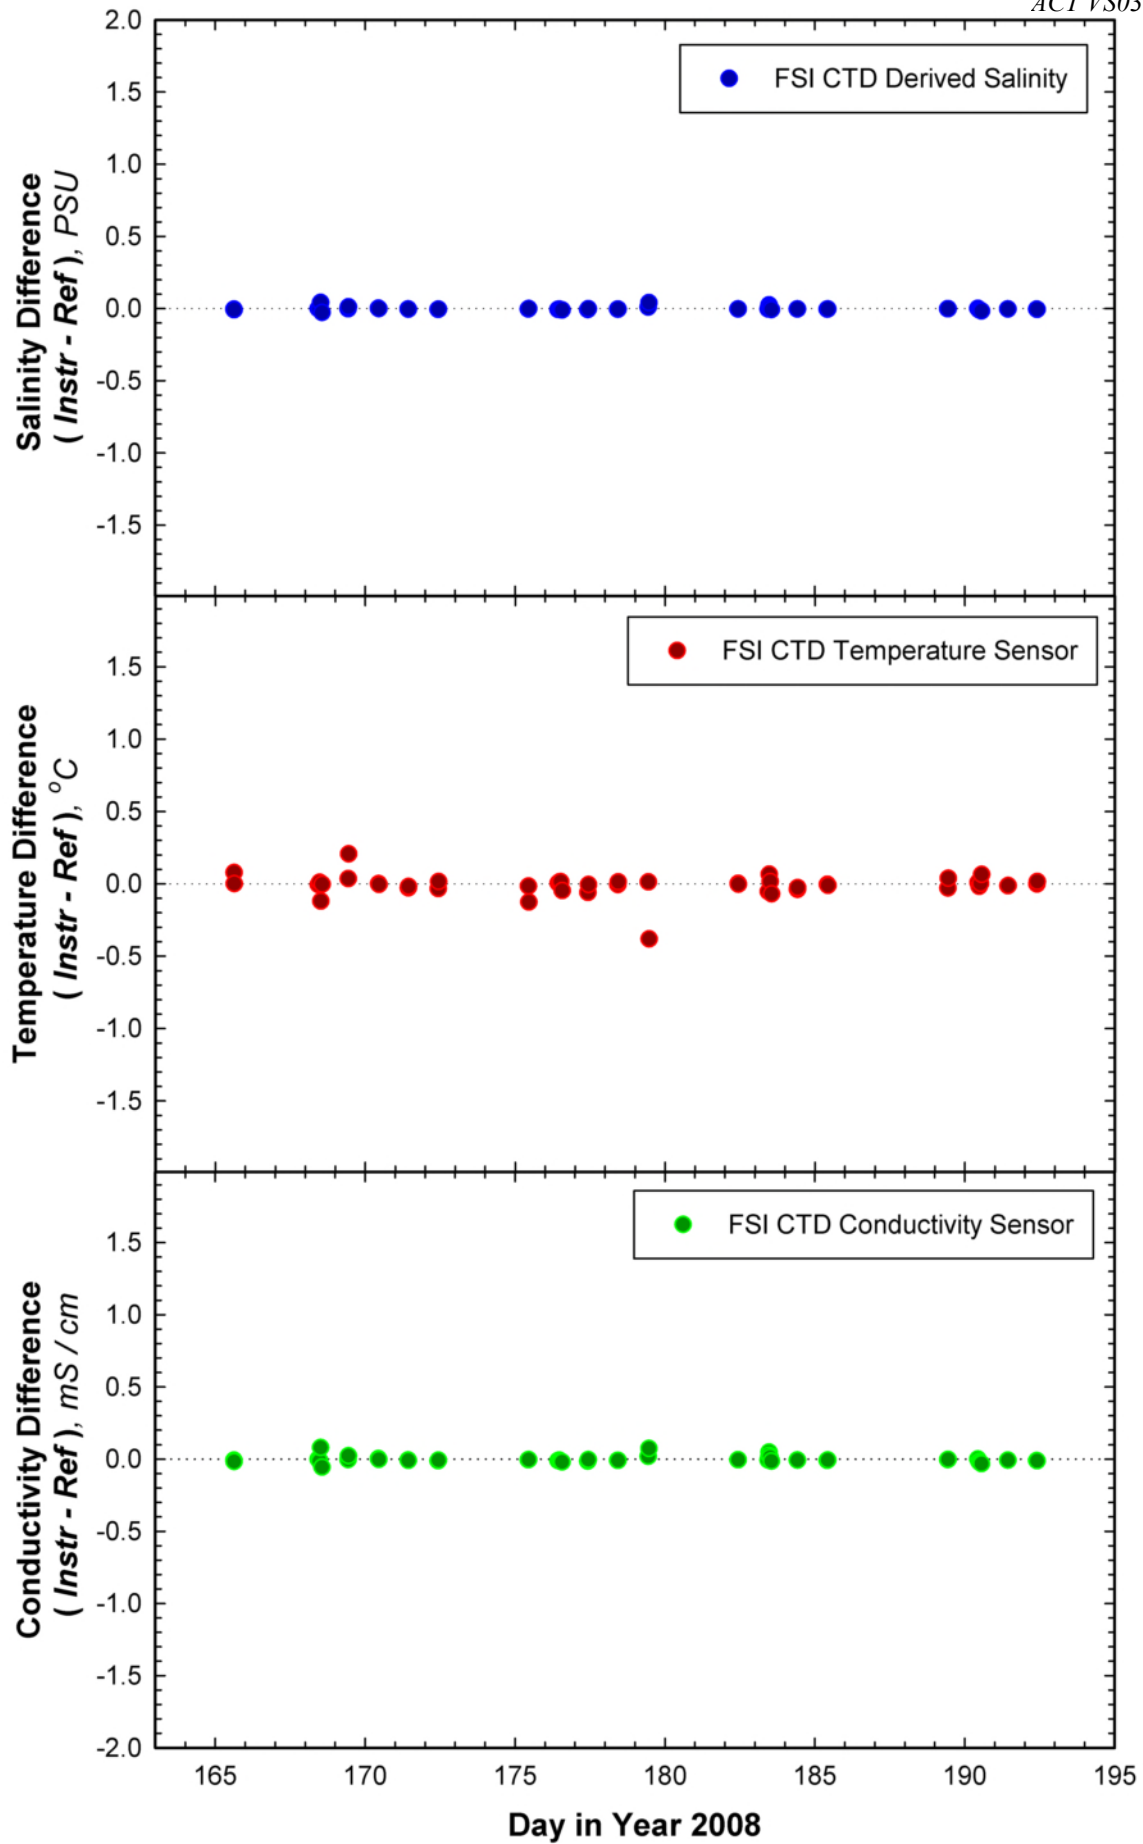
Figure 26. Assessment of relative accuracy of instrument time series measurements during the GL field deployment.

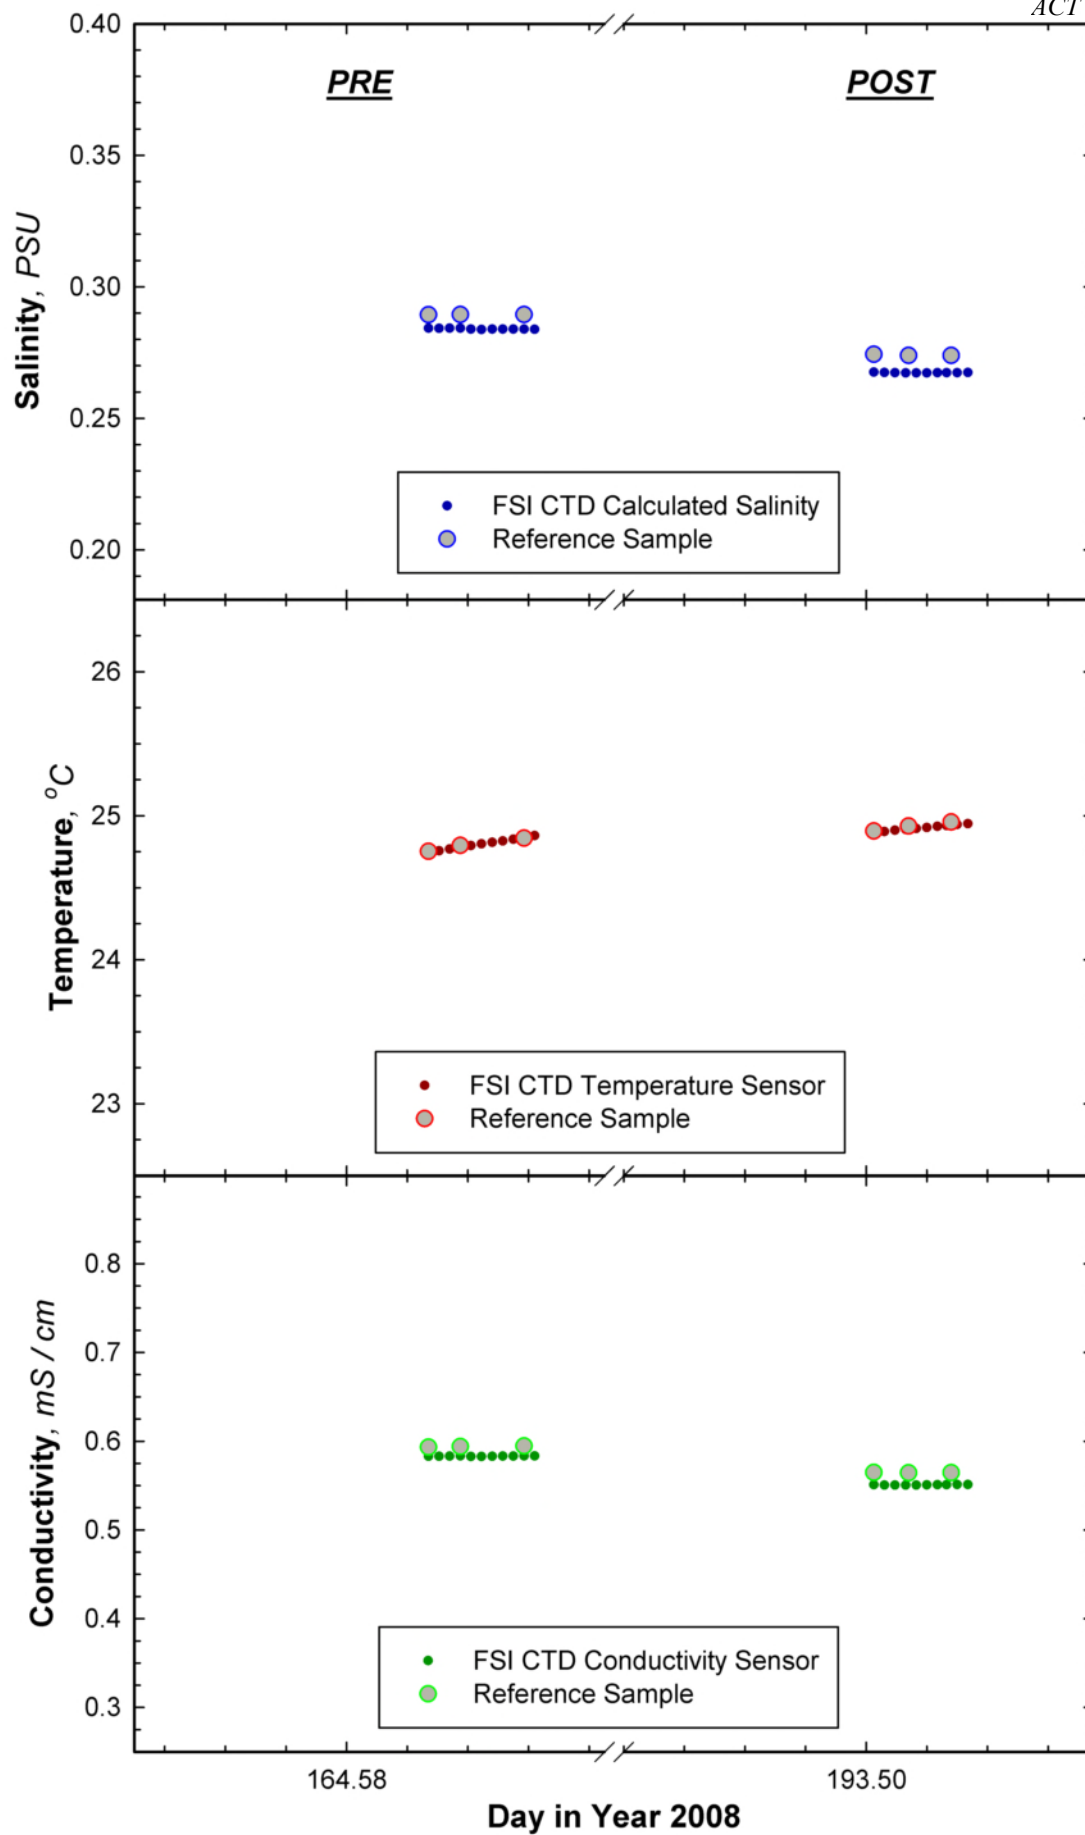
Figure 27. Pre- and Post-deployment reference checks in tanks of river water at GL. Post-deployment tests conducted after cleaning instrument of all fouling material according to manufacturer's recommendations.

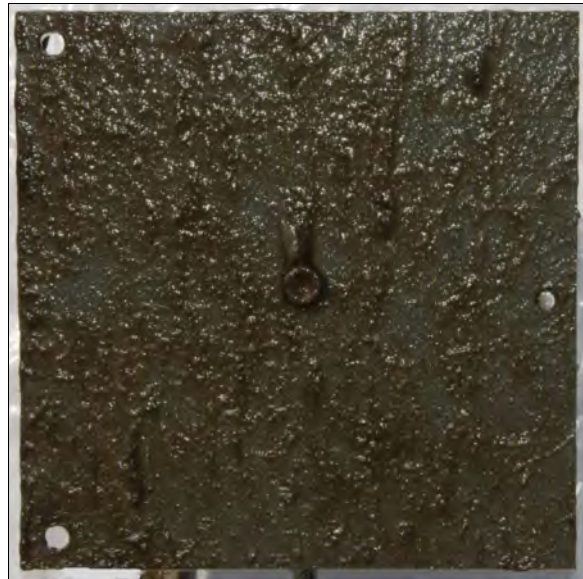
After Deployment (Close-up)

Figure 28. FSI NXIC instrument photos from the Clinton River, MI test site before and after deployment

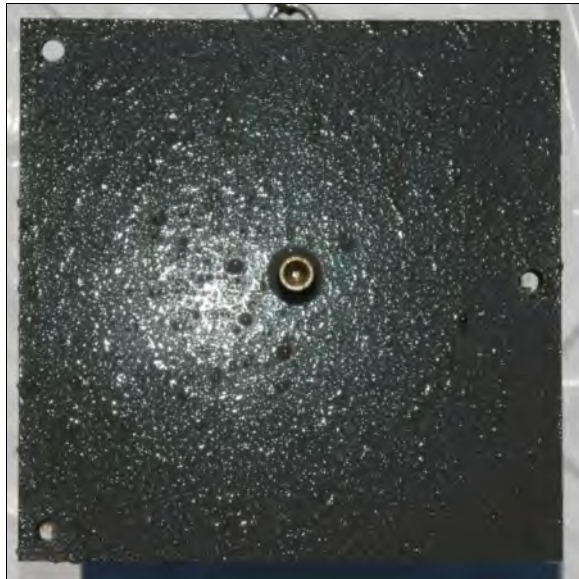
Great Lakes Site Week 1	Great Lakes Site Week 2
Great Lakes Site Week 3	Great Lakes site Week 4

Bio-fouling plates were retrieved and photographed once each week throughout the deployment to help define the rate and extent of biofouling within the test environment (Fig. 29). Biofouling material was mostly comprised of plant material and developed rather quickly but did not appear to accumulate significantly once the original surface was covered.

Figure 29. Weekly bio-fouling plates retrieved from the Great Lakes test site on the Clinton River, MI.

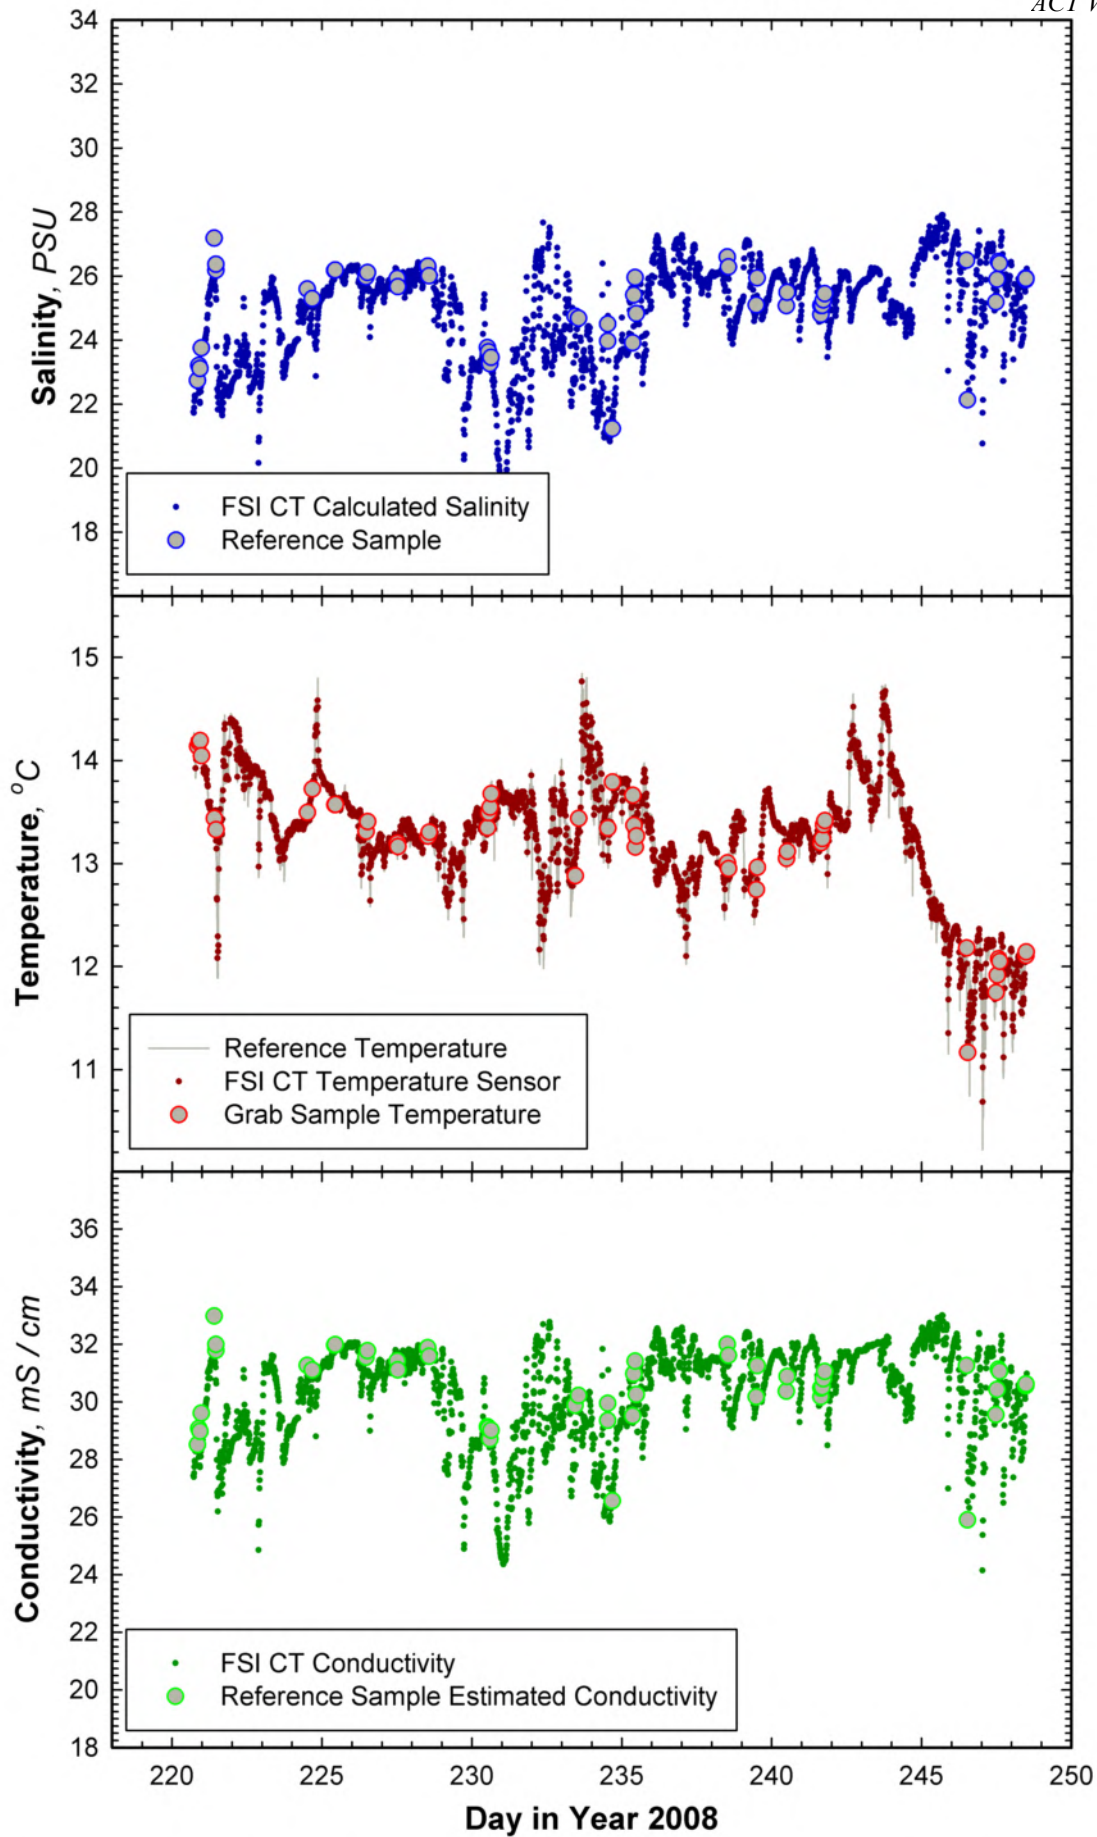
Time series data of in situ measured conductivity and temperature, and derived salinity, for the AK field test were plotted against corresponding results from the laboratory analyzed reference samples (Fig. 31). Instrument measurements tracked daily and weekly variations throughout the entire deployment; however, mixing events likely resulted in sharp gradients around the mooring and led to greater disagreements between instrument and reference sample measurements. The relative accuracy of the in situ measurements were depicted as numerical differences from the reference values and plotted over time (Fig. 32). Several lines of evidence suggest the greater offset was due to heterogeneity and not instrument performance or biofouling. First, measurement accuracy returned to near specifications following most large scale deviations, even at the very end of the test. Secondly, comparison of instrument accuracy and precision measured during pre- and post-deployment exposure tests, following instrument cleaning, revealed no measureable performance drift over the deployment period of 29 days (Fig. 33).   Lastly, precision among field replicates was significantly lower at this site than for the other sites. The amount and type of biofouling at this site was similar to observed in HI and MI where very little impact on instrument performance was noted (Fig. 34).

Figure 31. Time series of instrument measurements and corresponding reference samples acquired during the AK field deployment.

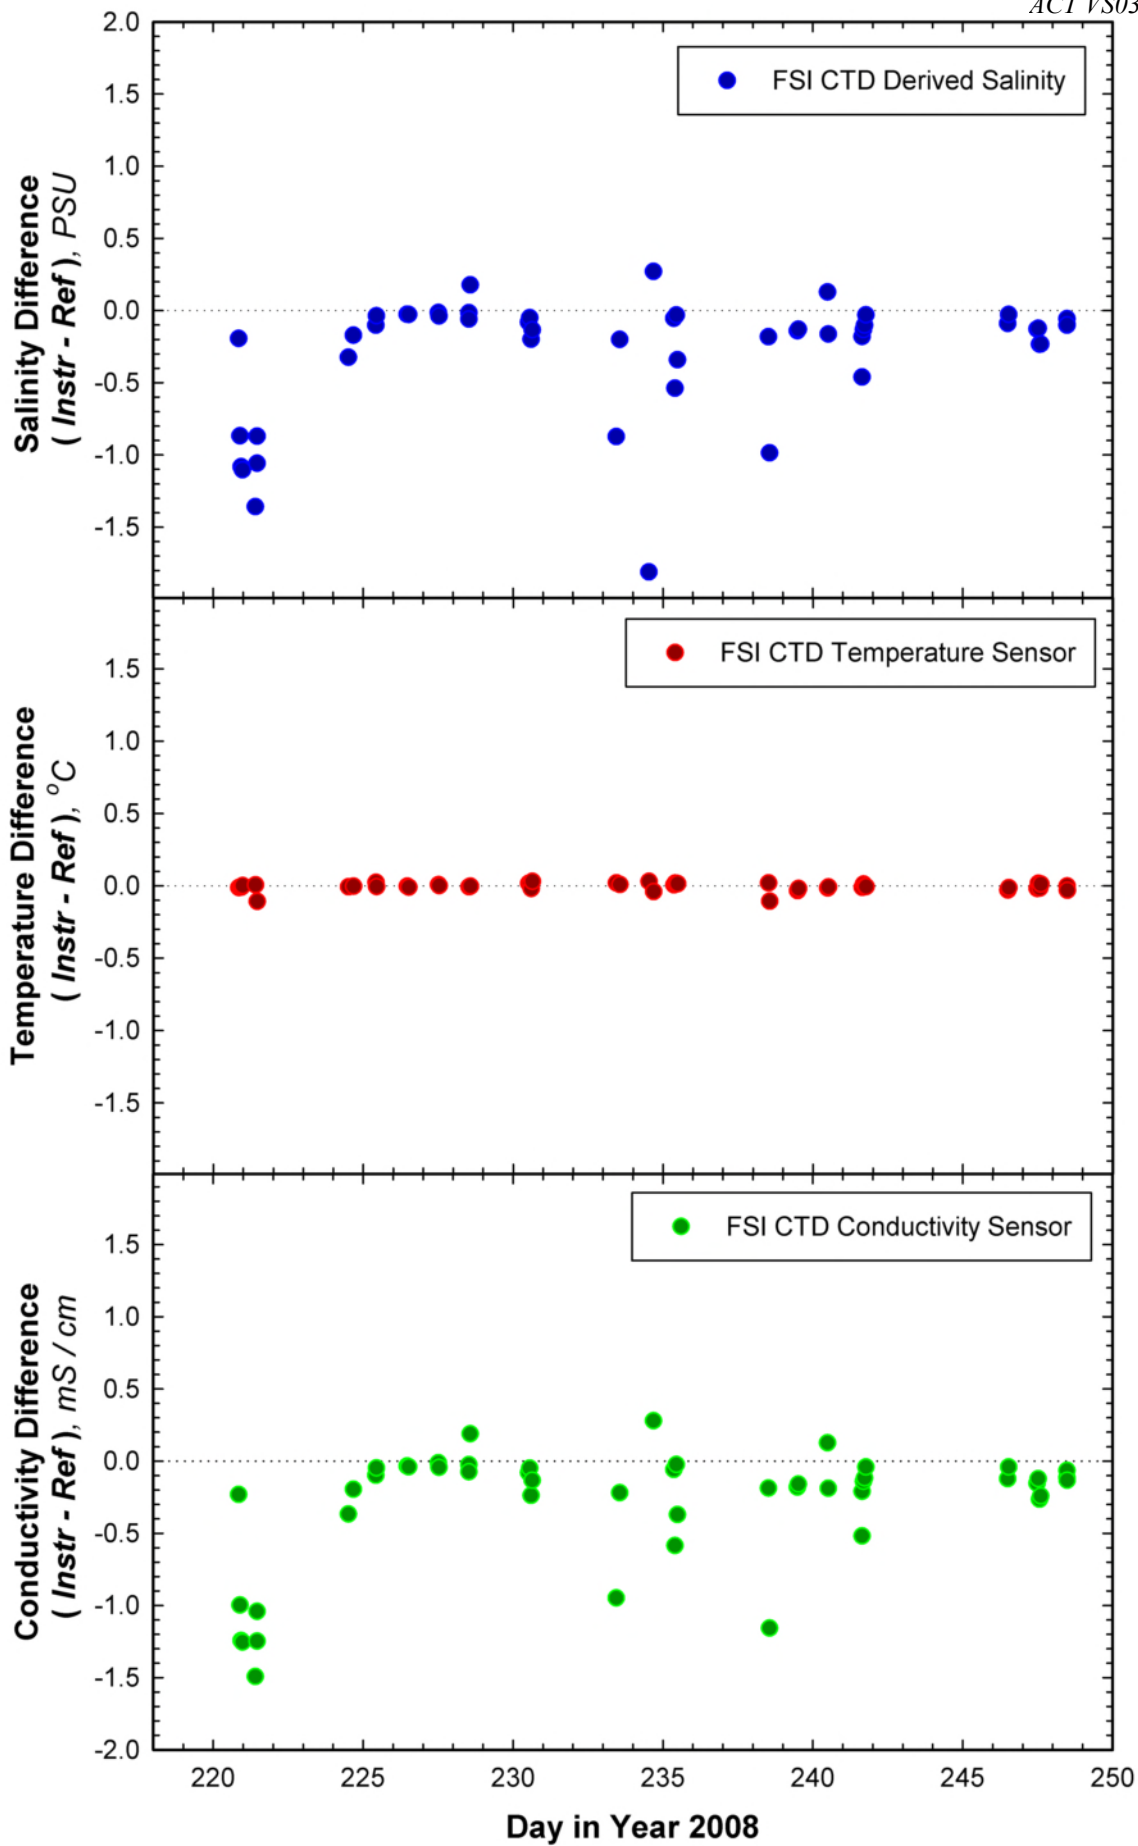
Figure 32. Assessment of relative accuracy of instrument time series measurements during the AK field deployment.

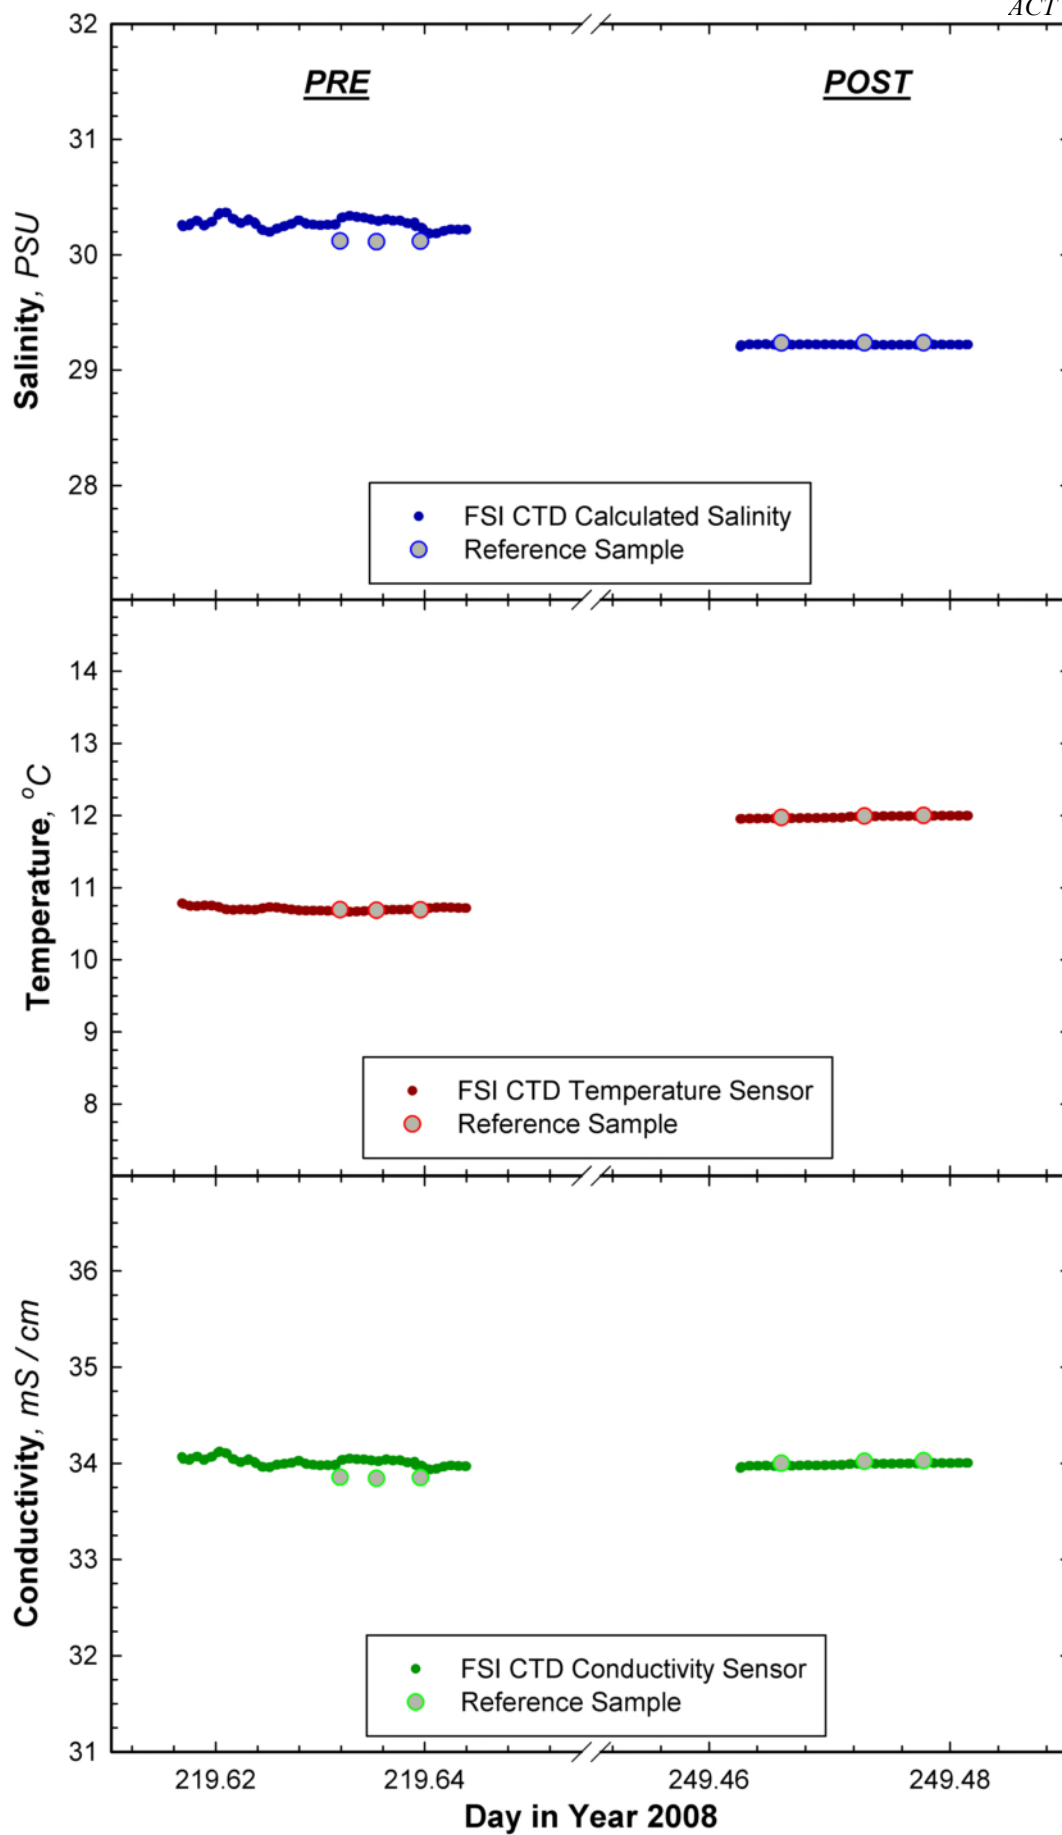
Figure 33. Pre- and Post-deployment reference checks in tanks of natural seawater at AK. Post-deployment tests conducted after cleaning instrument of all fouling material according to manufacturer's recommendations.

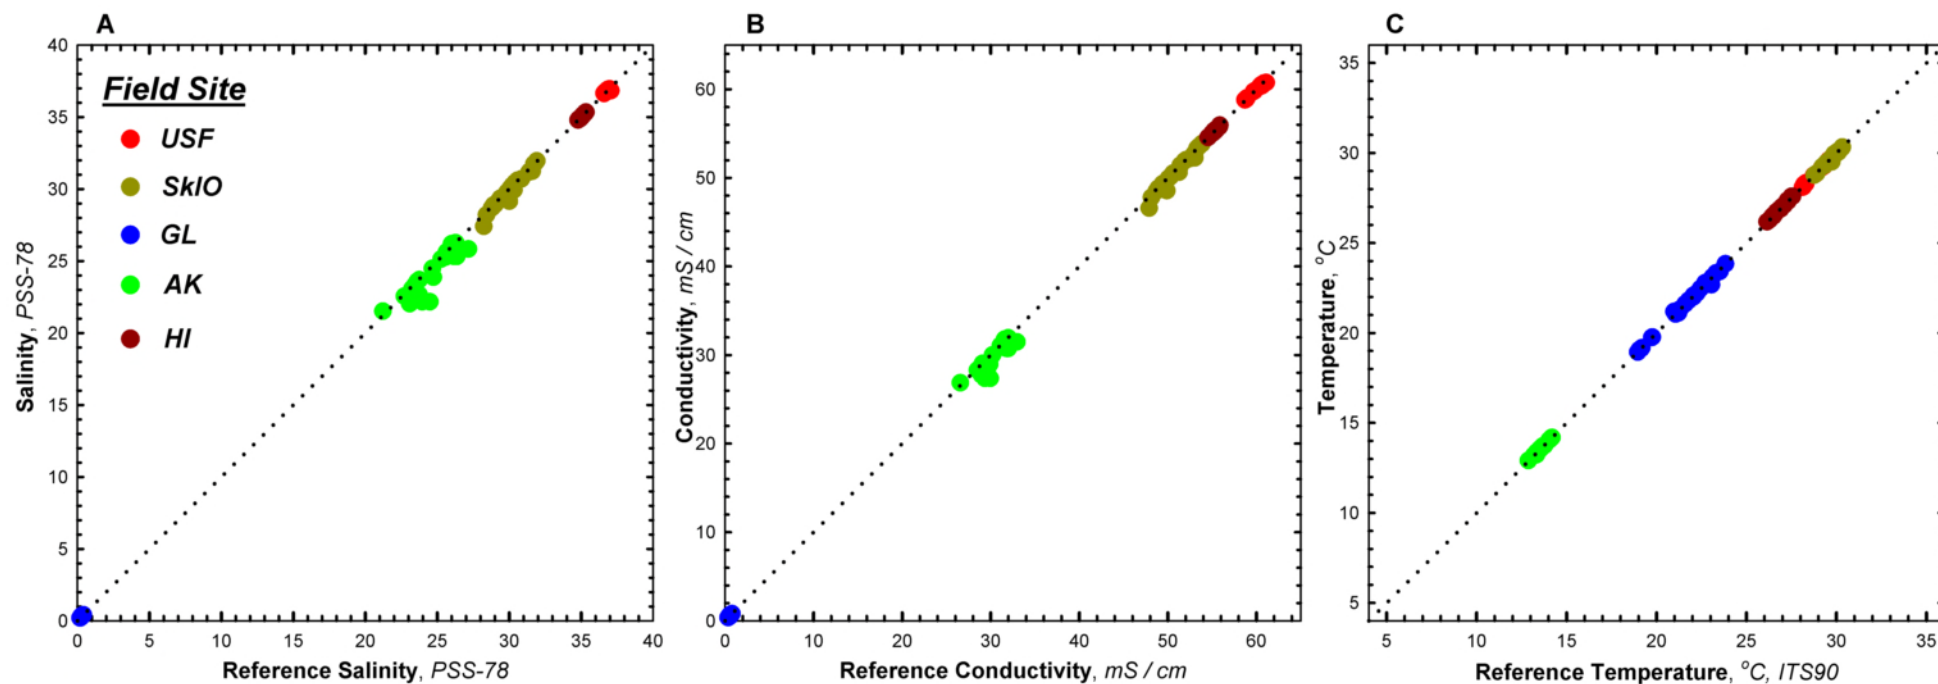
Field deployment results were composited for all five test sites to provide an overall comparison of instrument performance across the range of environmental conditions present at out test sites. Data were restricted to the first 14 days of the deployments at each site to minimize the effects of biofouling. The data are analyzed as in situ instrument measured plotted against reference sample measurements for salinity, conductivity, and temperature (Fig. 36). These results allow a field-based performance assessment similar to the range of test conditions applied within the laboratory test. The effects of biofouling or calibration offsets can be viewed as the vertical deviations from the 1:1 data correspondence trend line. In general the response of instrument derived salinity was highly linear across the range of field test conditions with an R^2 = 0.999, a standard error of 0.353, and a slope of 0.998. These results are quite comparable to the instrument response observed within the laboratory test. As was noted individually at the test sites, the response of the temperature sensor was more stable than the conductivity sensor and appeared much less impacting by biofouling.

Figure 36. Composite summary of field performance over the first 14 days of deployment for the four Falmouth Scientific CTD units tested during the five evaluation trials. Instrument output plotted against paired field reference sample assay and color indexed by field test site. Dotted line represents 1:1 data correspondence trend line. Scatter around trend line represents occurence of site-specific fouling effects on conductivity cell performance.

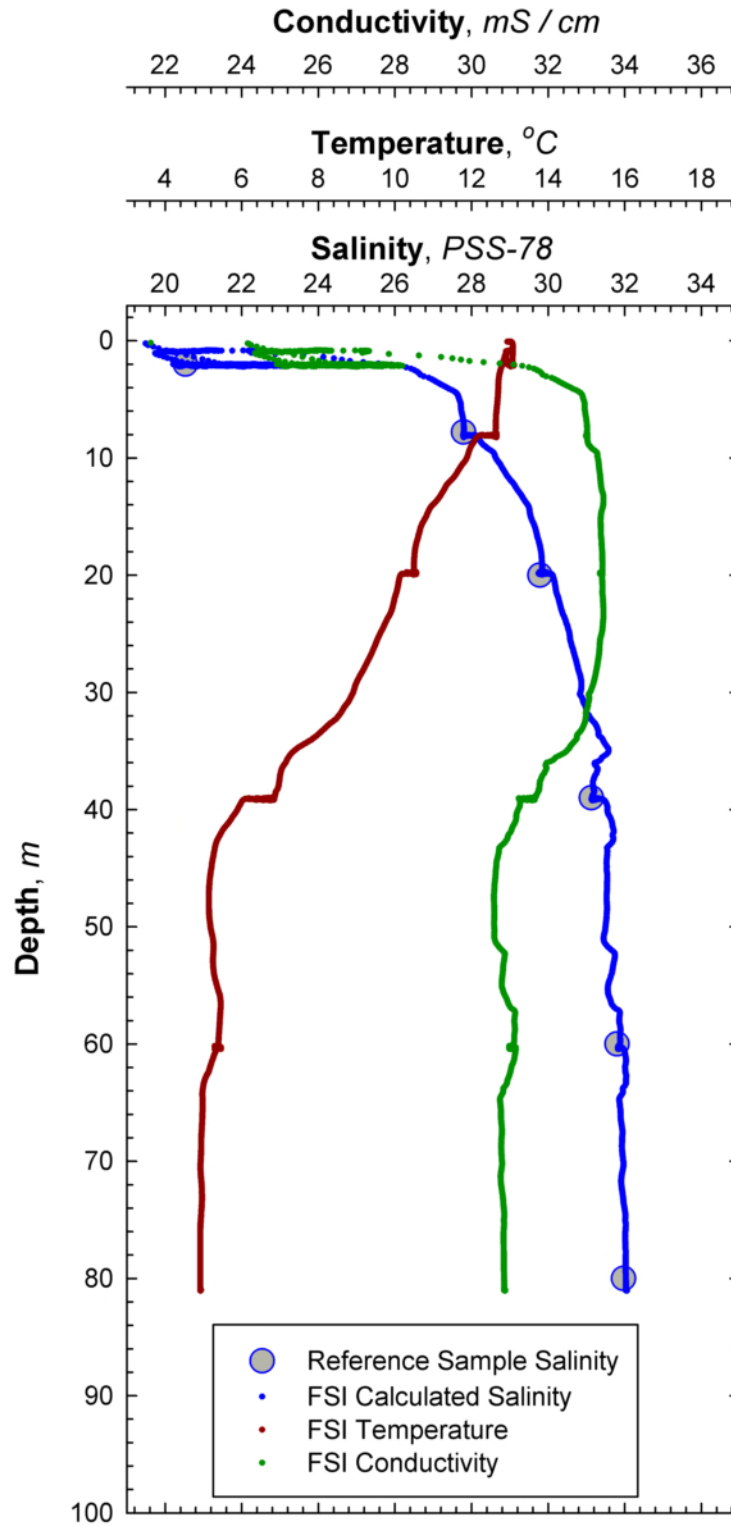
Profiling results showing the instrument measurements and corresponding reference sample comparisons for the nearshore and offshore sites are shown in figure 37 and 38, respectively. The instrument measured salinity closely tracked the salinity profile as defined by the reference sample measurements. The accuracy and precision were similar at all depth for both of the profiles. The average measurement error for all profiling samples was 0.0528 ±0.0207 psu. Separate conductivity and temperature responses were not generated for the profiles.

Figure 37. Vertical profile data from the FSI CTD deployed offshore of the Seward Marine Life Center within Resurrection Bay, AK. Sharp pycnocline at 2 m indicative of influence of glacial runoff at this site.
