PERFORMANCE VERIFICATION STATEMENT
for the FSI NXIC-CTD-BIO-AUTO Salinity Sensor

TECHNOLOGY TYPE:	Coupled conductivity and temperature sensors with instrument based algorithms for estimation of salinity
APPLICATION:	In situ estimates of salinity for coastal moored and profiled deployments
PARAMETERS EVALUATED:	Response linearity, accuracy, precision and reliability
TYPE OF EVALUATION:	Laboratory and Field Performance Verification
DATE OF EVALUATION:	Testing conducted from May through October 2008
EVALUATION PERSONNEL:	S. Gilbert, K. Gundersen, T. Johengen, T. McKissack, M. McIntyre, A. Pinchuk, H. Purcell, C. Robertson, D. Schar, G.J. Smith, M. Tamburri and D. Wells.

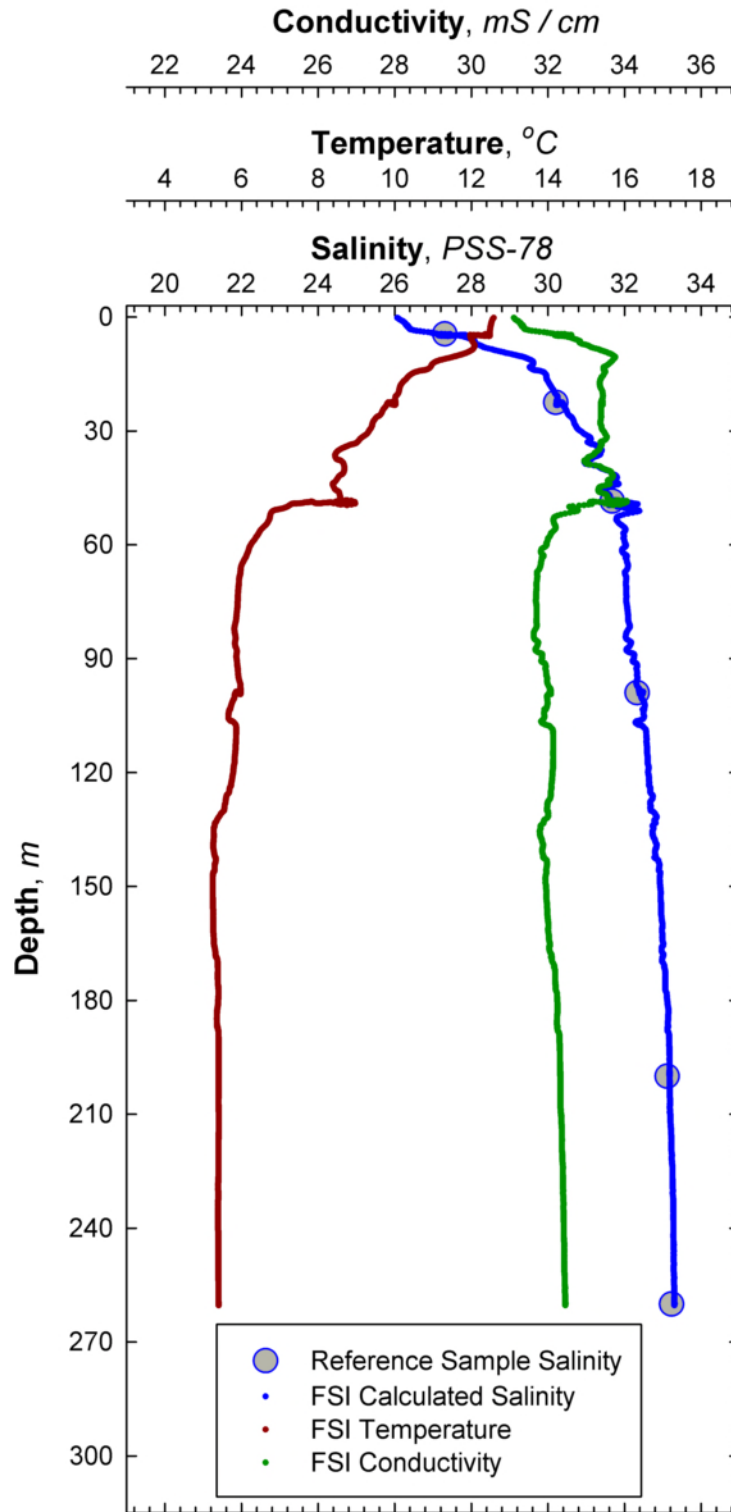
Profiling results showing the instrument measurements and corresponding reference sample comparisons for the nearshore and offshore sites are shown in figure 37 and 38, respectively. The instrument measured salinity closely tracked the salinity profile as defined by the reference sample measurements. The accuracy and precision were similar at all depth for both of the profiles. The average measurement error for all profiling samples was 0.0528 ±0.0207 psu. Separate conductivity and temperature responses were not generated for the profiles.

Figure 38. Vertical profile data from the FSI CTD deployed in deep water off the shelf outside of Resurrection Bay, AK. Deeper and narrower pycnocline reflects mixing of offshore and bay waters.

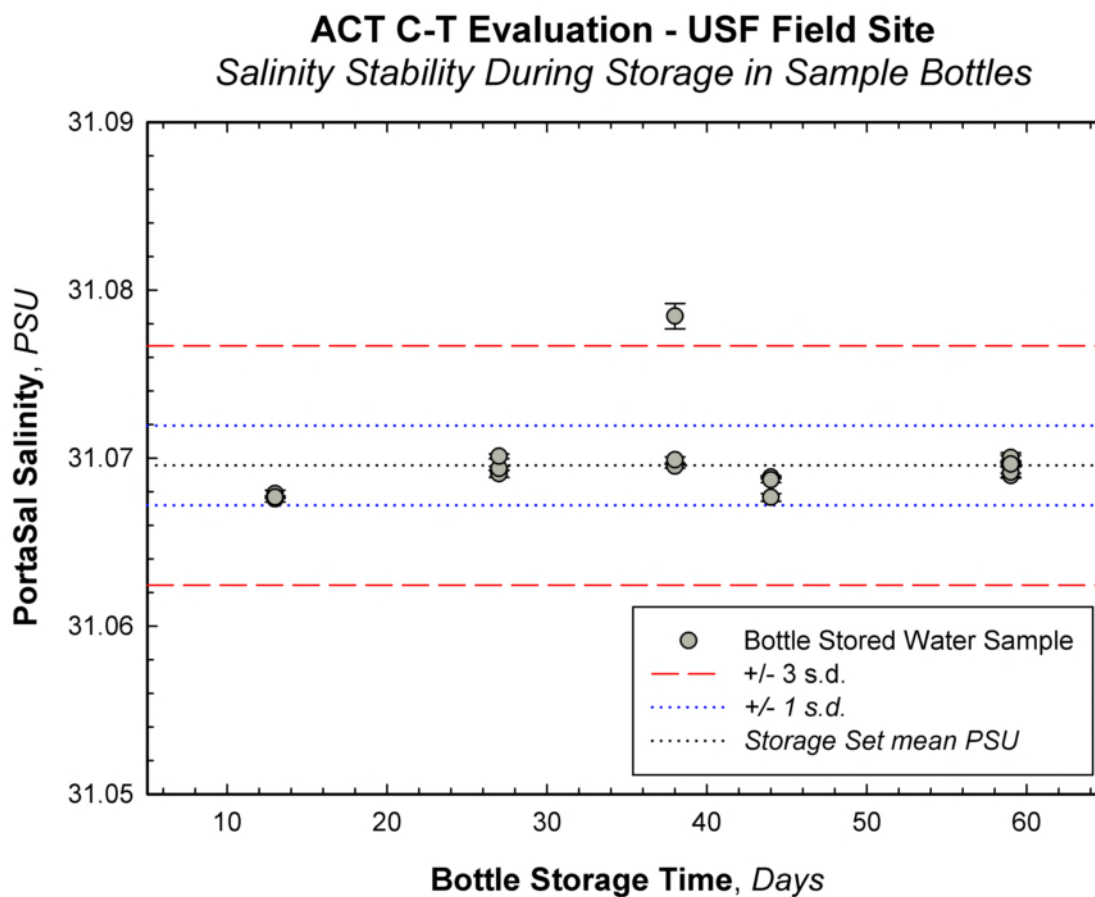
Results of the reference sample storage and shipping test for each site are provided in figures 39 – 43. Values for stored bottles (between 20-80 days from collection) generally agreed with one standard deviation to the values determined for the first set of samples that were shipped and analyzed. There was a noticeable upward trend in salinity values for the storage time series at SkIO. This pattern may have resulted from the initial collection when all of the salinity bottles were being filled from an open bath that was subject to evaporation. The collected samples were numbered and analyzed sequentially instead of first being randomized, thereby allowing for the increasing trend. The other sites filled all bottles from a single well mixed carboy that likely minimized any variation among the storage bottle set.

Figure 39. Assessment of drift in laboratory salinity measures associated with sample storage in field reference sample bottles. Sample bottles filled from single batch of test site surface water and subsets included in each sample shipment to MLML. Storage time reflects total time (days) since initial water collection.

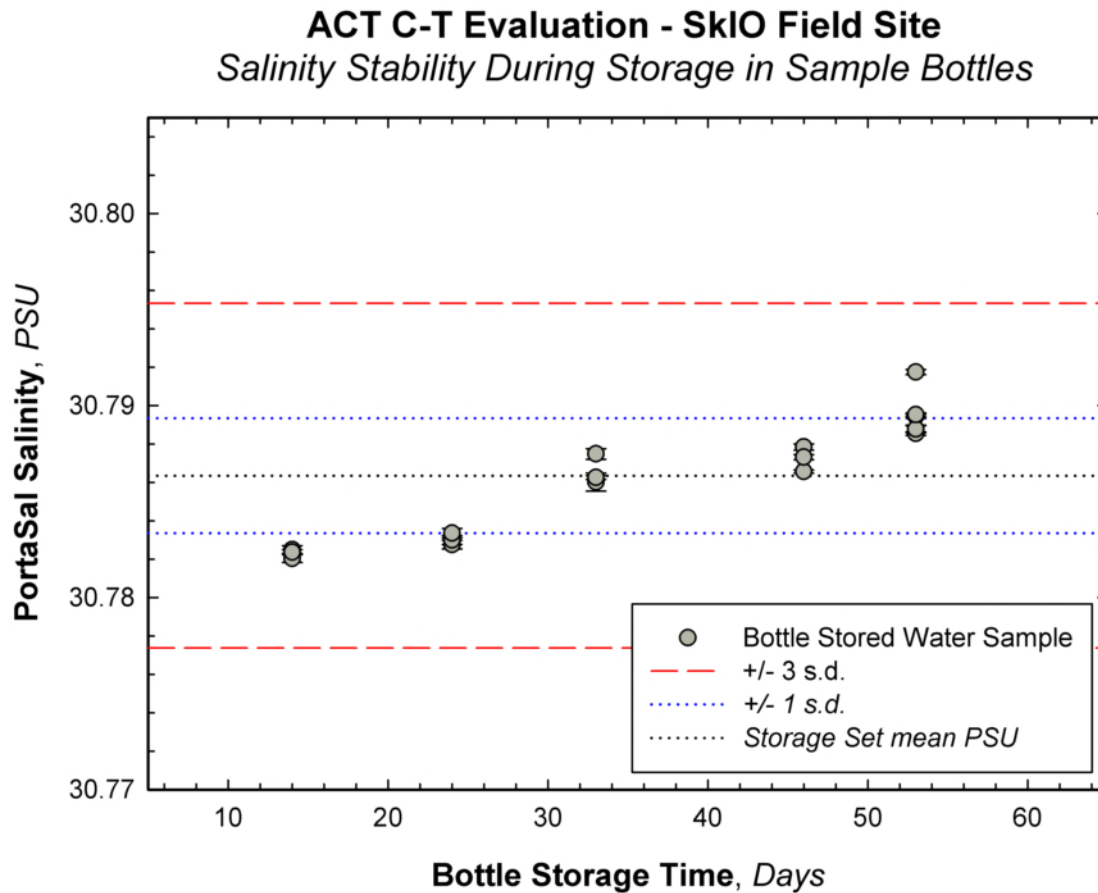
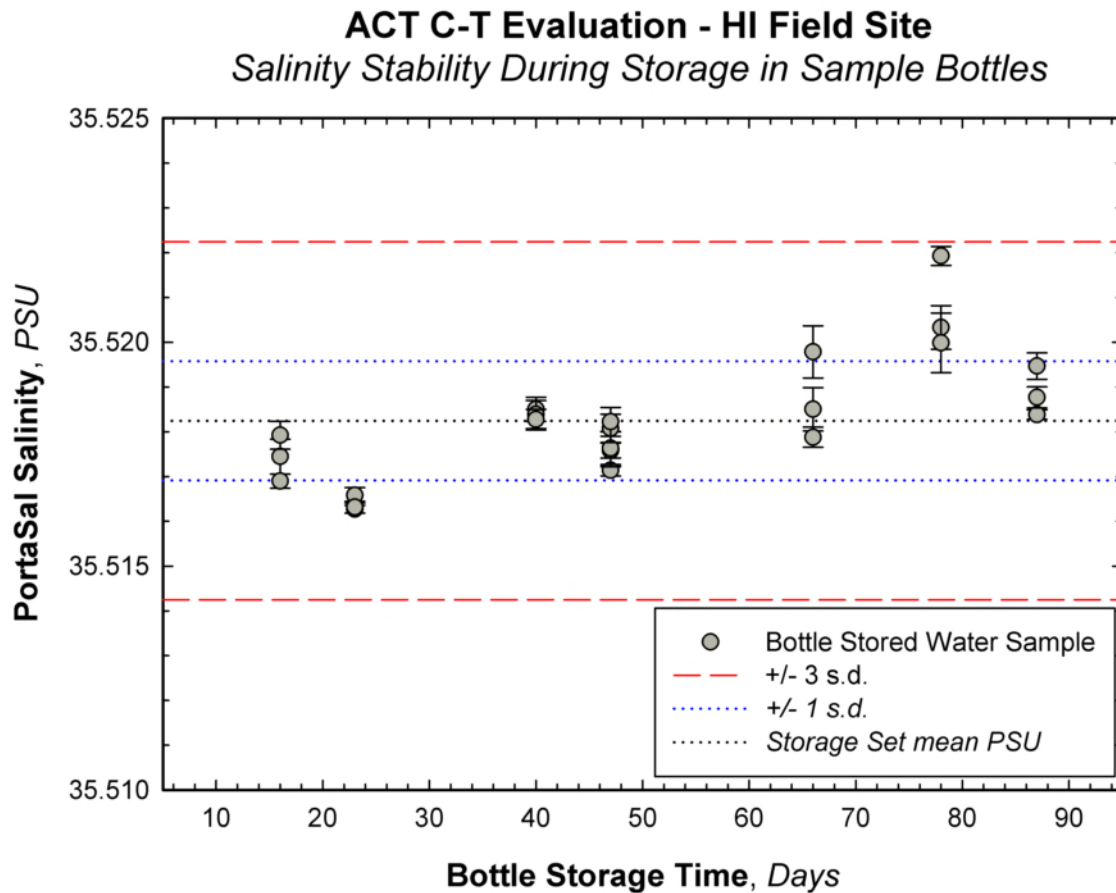
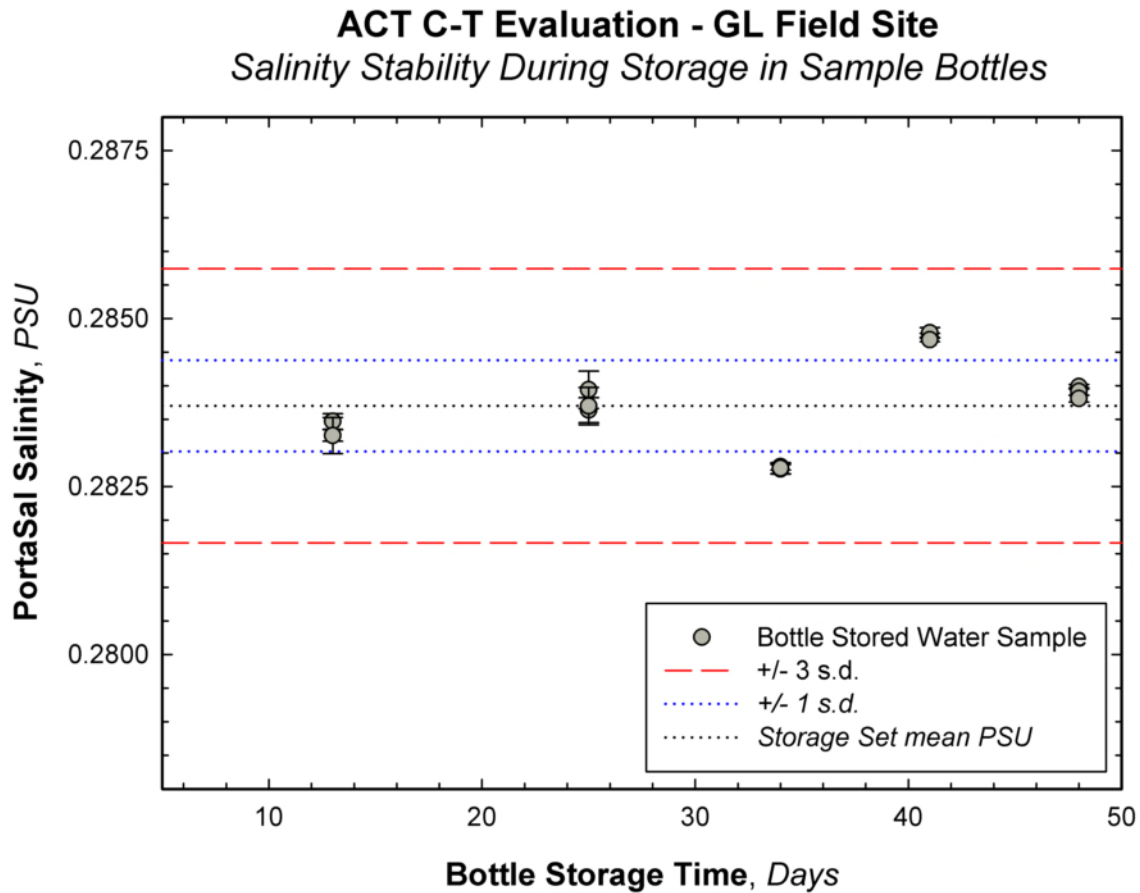
Figure 40. Assessment of drift in laboratory salinity measures associated with sample storage in field reference sample bottles. Sample bottles filled from single batch of test site surface water and subsets included in each sample shipment to MLML. Storage time reflects total time (days) since initial water collection.

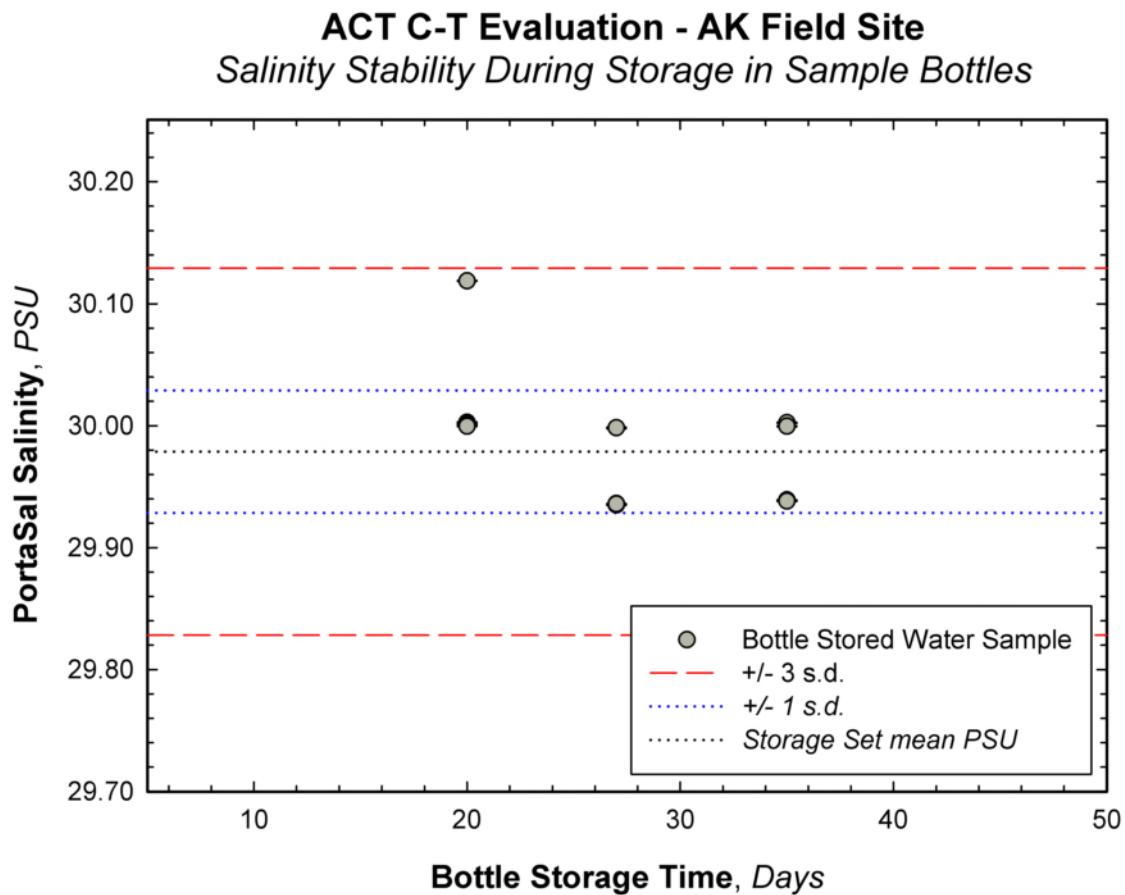
Figure 41. Assessment of drift in laboratory salinity measures associated with sample storage in field reference sample bottles. Sample bottles filled from single batch of test site surface water and subsets included in each sample shipment to MLML. Storage time reflects total time (days) since initial water collection.

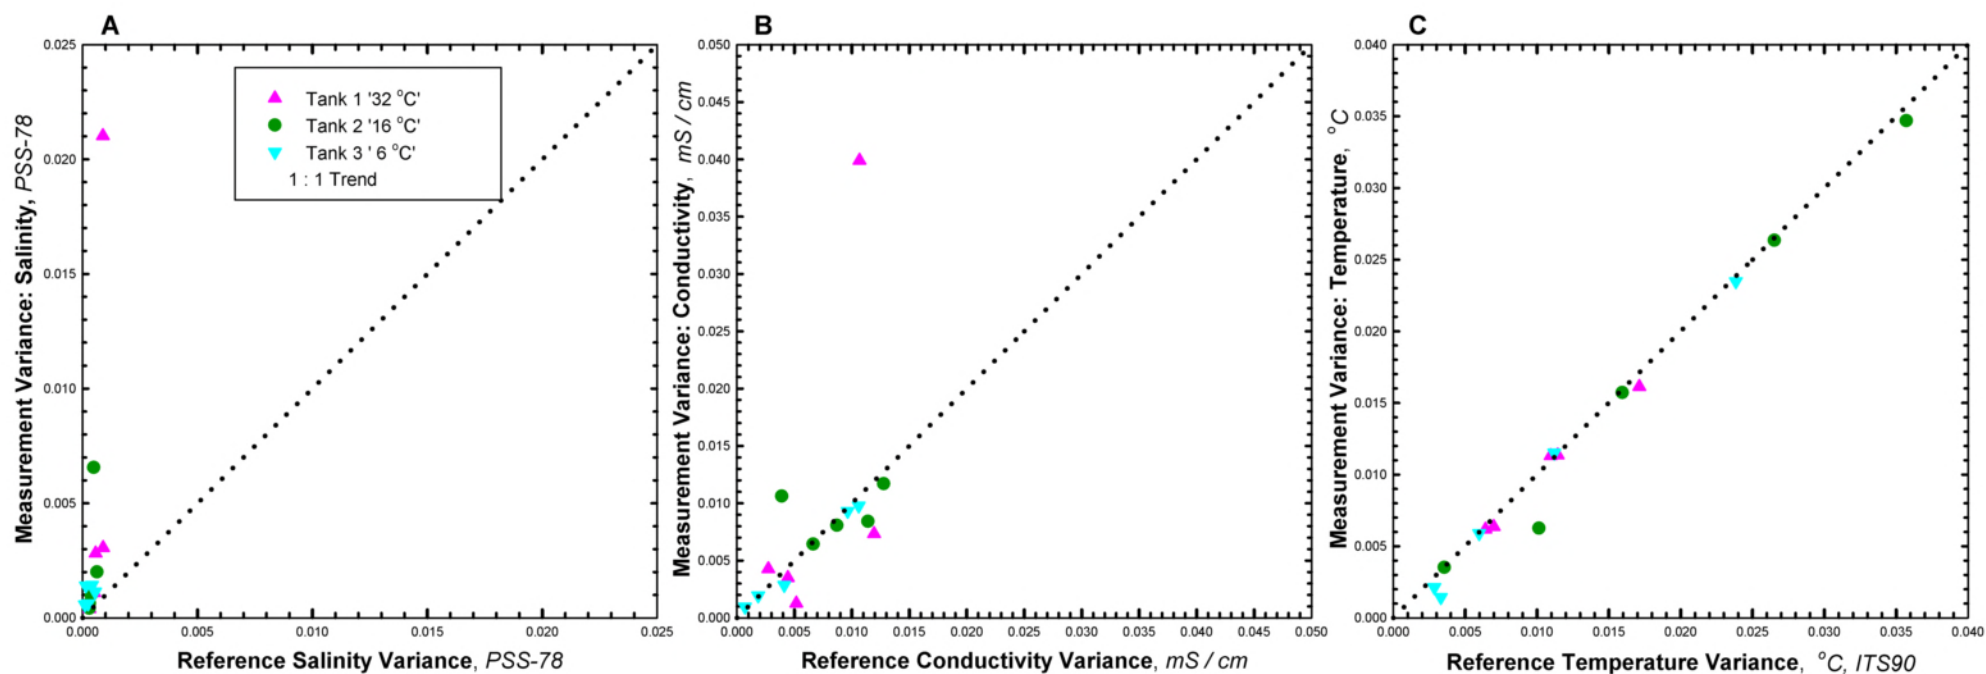
Figure 4. Evaluation of measurement variation of the FSI conductivity and temperature sensor package achieved during the laboratory exposure trials plotted in **Fig. 3**. Instrument measurement variance is presented as the standard deviation from 30 consecutive instrument reads recorded during the 30 min reference sampling for each test exposure and plotted against the corresponding variation in the reference measure. The 1:1 correspondence line (dotted) is provided for comparison, with points below the line indicating lower and above higher-instrument measurement variation than obtained by our reference methods and test conditions. [*A*] Co-variation of derived salinity estimates; [*B*] Co-variation of in situ conductivity measurements; [*C*] Co-variation of instrument temperature measurements.
