## PERFORMANCE VERIFICATION STATEMENT for the JFE ALEC CTW and CTW-FS Salinity Sensors

<b>TECHNOLOGY TYPE:</b>	Coupled conductivity and temperature sensors with instrument based algorithms for estimation of salinity
<b>APPLICATION:</b>	In situ estimates of salinity for coastal moored and profiled deployments
<b>PARAMETERS EVALUATED:</b>	Response linearity, accuracy, precision and reliability
<b>TYPE OF EVALUATION:</b>	Laboratory and Field Performance Verification
<b>DATE OF EVALUATION:</b>	Testing conducted from May through October 2008
<b>EVALUATION PERSONNEL:</b>	S. Gilbert, K. Gundersen, T. Johengen, T. McKissack, M. McIntyre, A. Pinchuk, H. Purcell, C. Robertson, D. Schar, G.J. Smith, M. Tamburri and D. Wells.

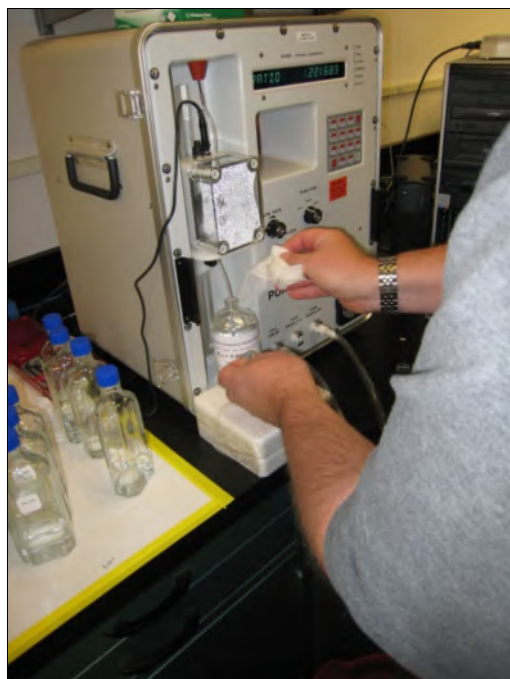
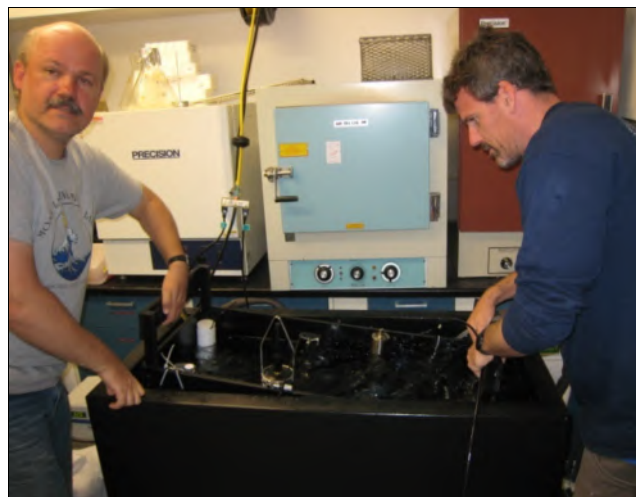
**Figure 1.** Analytical instrumentation (Portasal 8410A) used for laboratory analysis of salinity reference samples and one of the test baths and instrument racks used for the laboratory tests.

Laboratory tests focused on verifying the manufacturers' stated performance characteristics of accuracy and precision using controlled laboratory settings to obtain the highest degree of accuracy and precision for corresponding reference standards. The instrument package was tested at five different salinity levels including 35, 30, 25, 16 and 6 on the practical salinity scale (PSS-78; 60 to 6 mS/cm conductivity), each at three different temperatures including 32 °C, 16 °C and 6 °C. The instrument was pre-equilibrated to the controlled bath test conditions for 60 minutes prior to the start of reference sampling. The instrument was set to measure in situ conductivity and temperature using its own algorithms to derive a practical salinity estimate from these values at 1-minute intervals. Ten reference water samples were collected at sensor depth into sealed pre-rinsed glass salinity bottles at 3 minute intervals over 30 minutes. Each reference sample set was stored at room temperature and analyzed after 24 hours on the Portasal 8410A (Fig. 1).

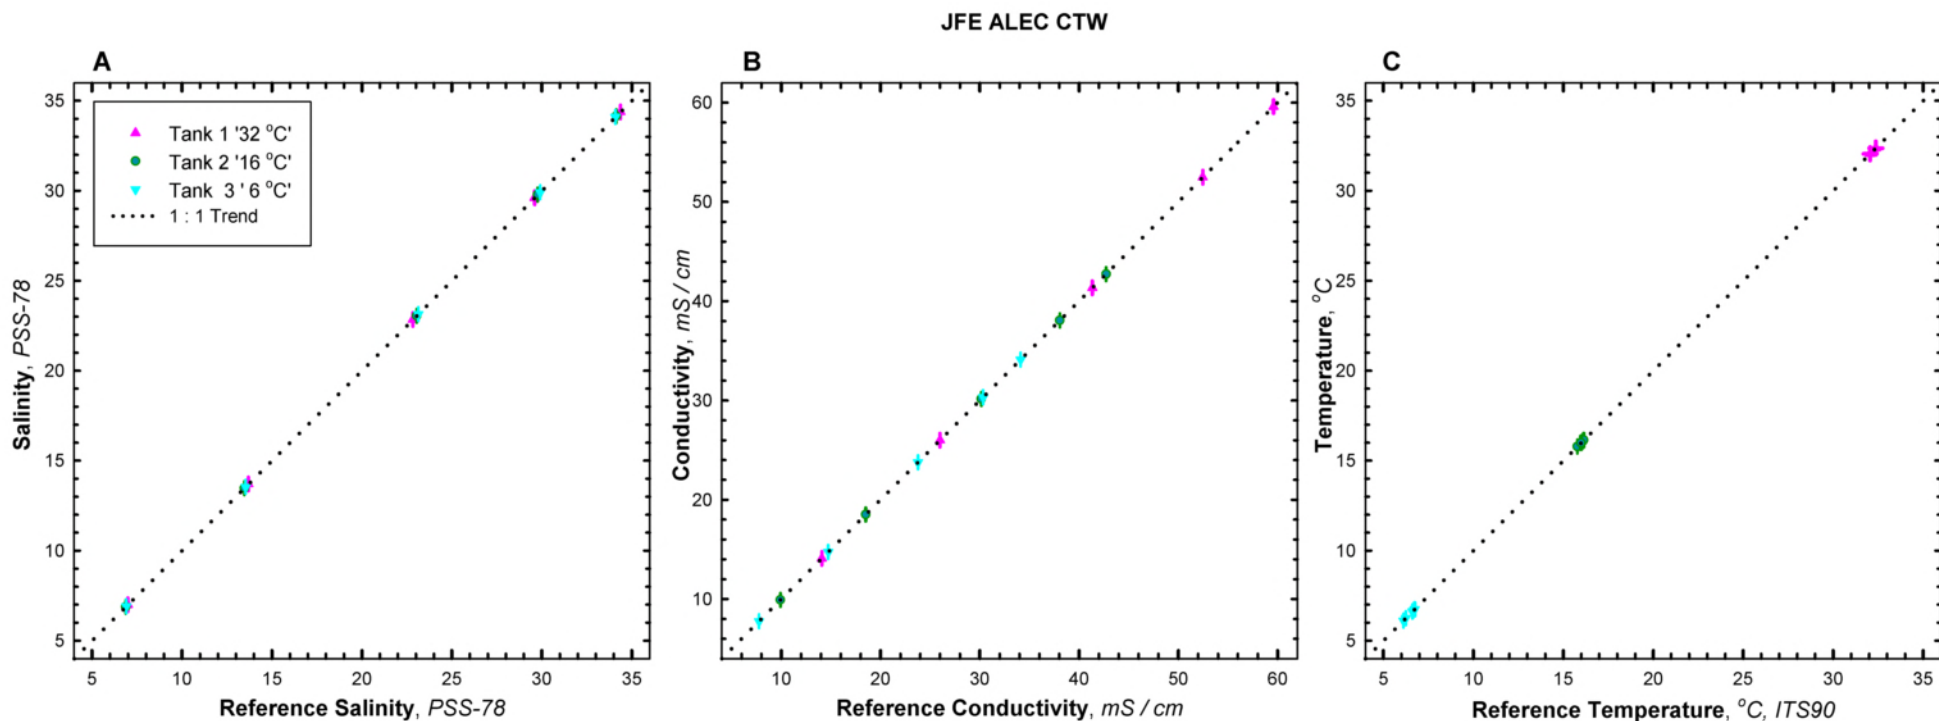
**Figure 3.** Evaluation of the response linearity for JFE ALEC's model CTW conductivity and temperature sensor package during controlled laboratory exposures to a combination of natural seawater dilutions and temperatures. Consecutive test exposures ranged between 35 to 6 on the practical salinity scale (PSS-78; 60 to 6 mS/cm conductivity) and 33 to 6 °C. [A] Correspondence of instrument derived salinity to Portasal reference measurements; [B] Correspondence of instrument in situ conductivity measurement to conductivity estimate derived from the Portasal salinity and reference temperature measurement by inversion of the seawater equations of state (IAPSO PSS-78); [C] Correspondence of instrument temperature measurement to bath reference temperature recorded by a calibrated RBR 1060 logging thermometer. Data points are represented as mean  $\pm$  standard deviation of and 10 reference water samples. Dotted lines represent 1:1 ideal correlation of measures.

Analyzed across all five salinity levels and all three temperatures, the CTW exhibited a strong linear response to the test solutions with  $R^2 > 0.9999$ , standard error = 0.0021 and slope = 0.9998 for measured salinity (Fig. 3). The conductivity and temperature sensors of the instrument responded with similar linearity and accuracy across the test conditions. The variance in 30 repeated measurements taken at one minute intervals for each of the laboratory trials is shown in Figure 4. The plots are not a measure of engineering precision as environmental conditions within the test baths did change during the sampling process. The variation in instrument derived measurements is plotted relative to the average standard deviation and 3-times the standard deviation upper specification limit of reference salinity, conductivity, and temperature measurements taken over corresponding time intervals for all lab tests. An alternative version of this figure showing a direct comparison of instrument versus reference sample variance for each individual trial is given in Appendix 1. Instrument offsets in salinity, conductivity and temperature were computed for each test run as the difference in the mean instrument measure from the mean reference measure for that test bath condition (Fig. 5). There were no noticeable differences in instrument performance across the range of salinity and temperature tested. The overall mean of the offsets in instrument measured salinity across all treatments was  $0.0035 \pm 0.0021$  psu. When examined independently for conductivity and temperature, the mean of the offsets were  $-0.0028 \pm 0.0038$  mS/cm and  $-0.0003 \pm 0.0056$  °C, respectively.

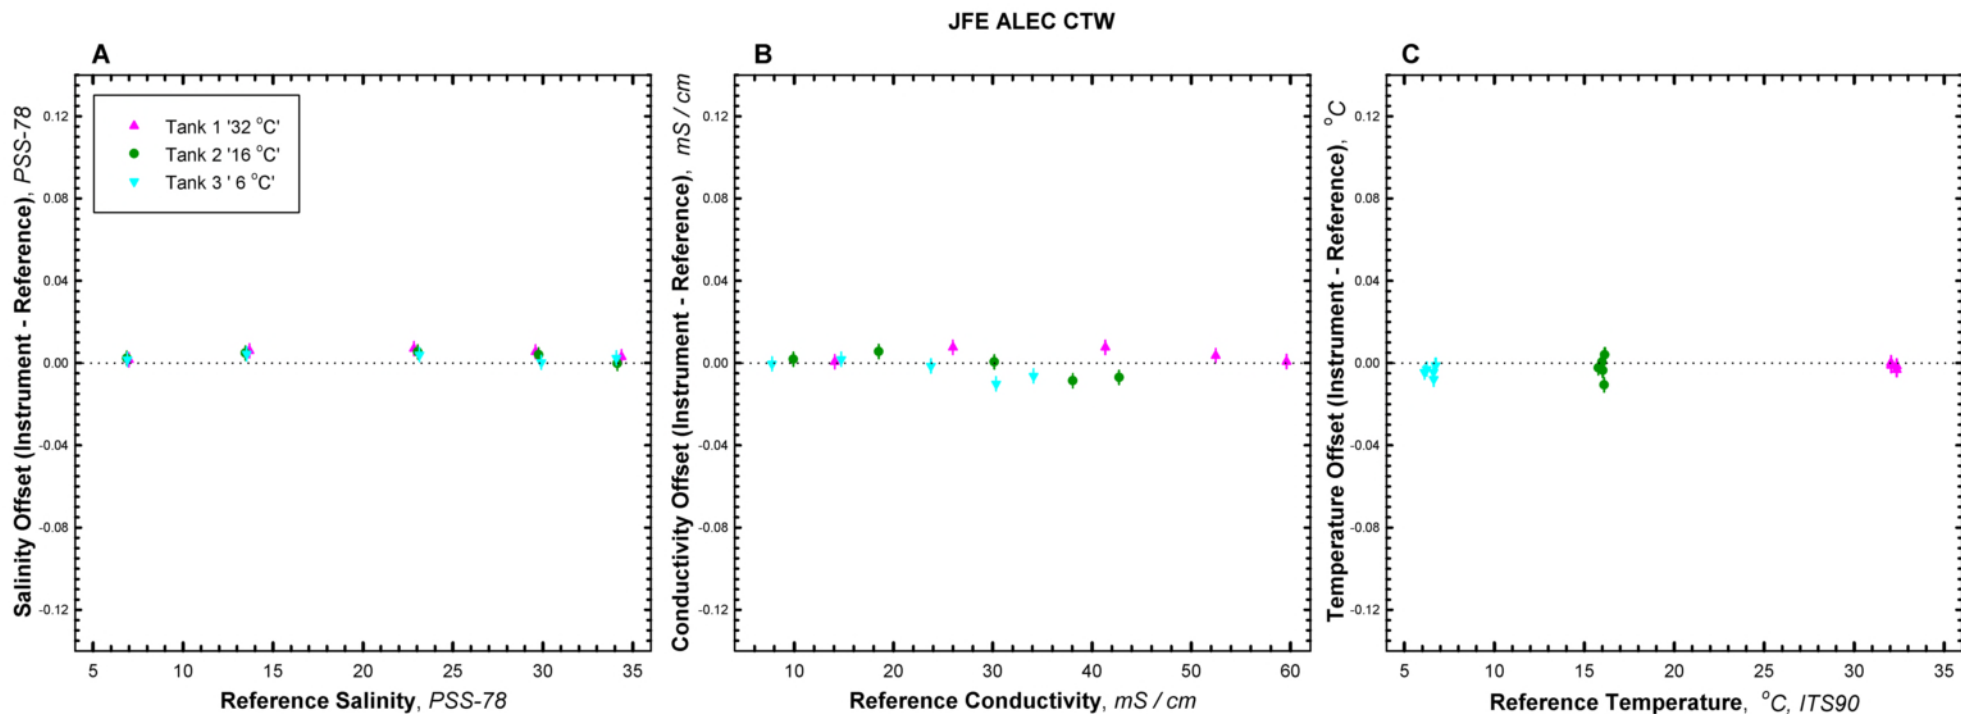
**Figure 5.** Evaluation of the relative accuracy of JFE ALEC's model CTW conductivity and temperature sensor package achieved during the laboratory exposure tests plotted in Fig. 3. Relative accuracy is estimated as the difference or offset between the mean instrument reading and mean reference reading for each exposure test. [A] Relative accuracy of derived salinity estimate; [B] Relative accuracy of instrument's in situ conductivity measurement; [C] Relative accuracy of instrument's temperature measurements. Dotted horizontal line represents no difference between instrument and reference method measurement.

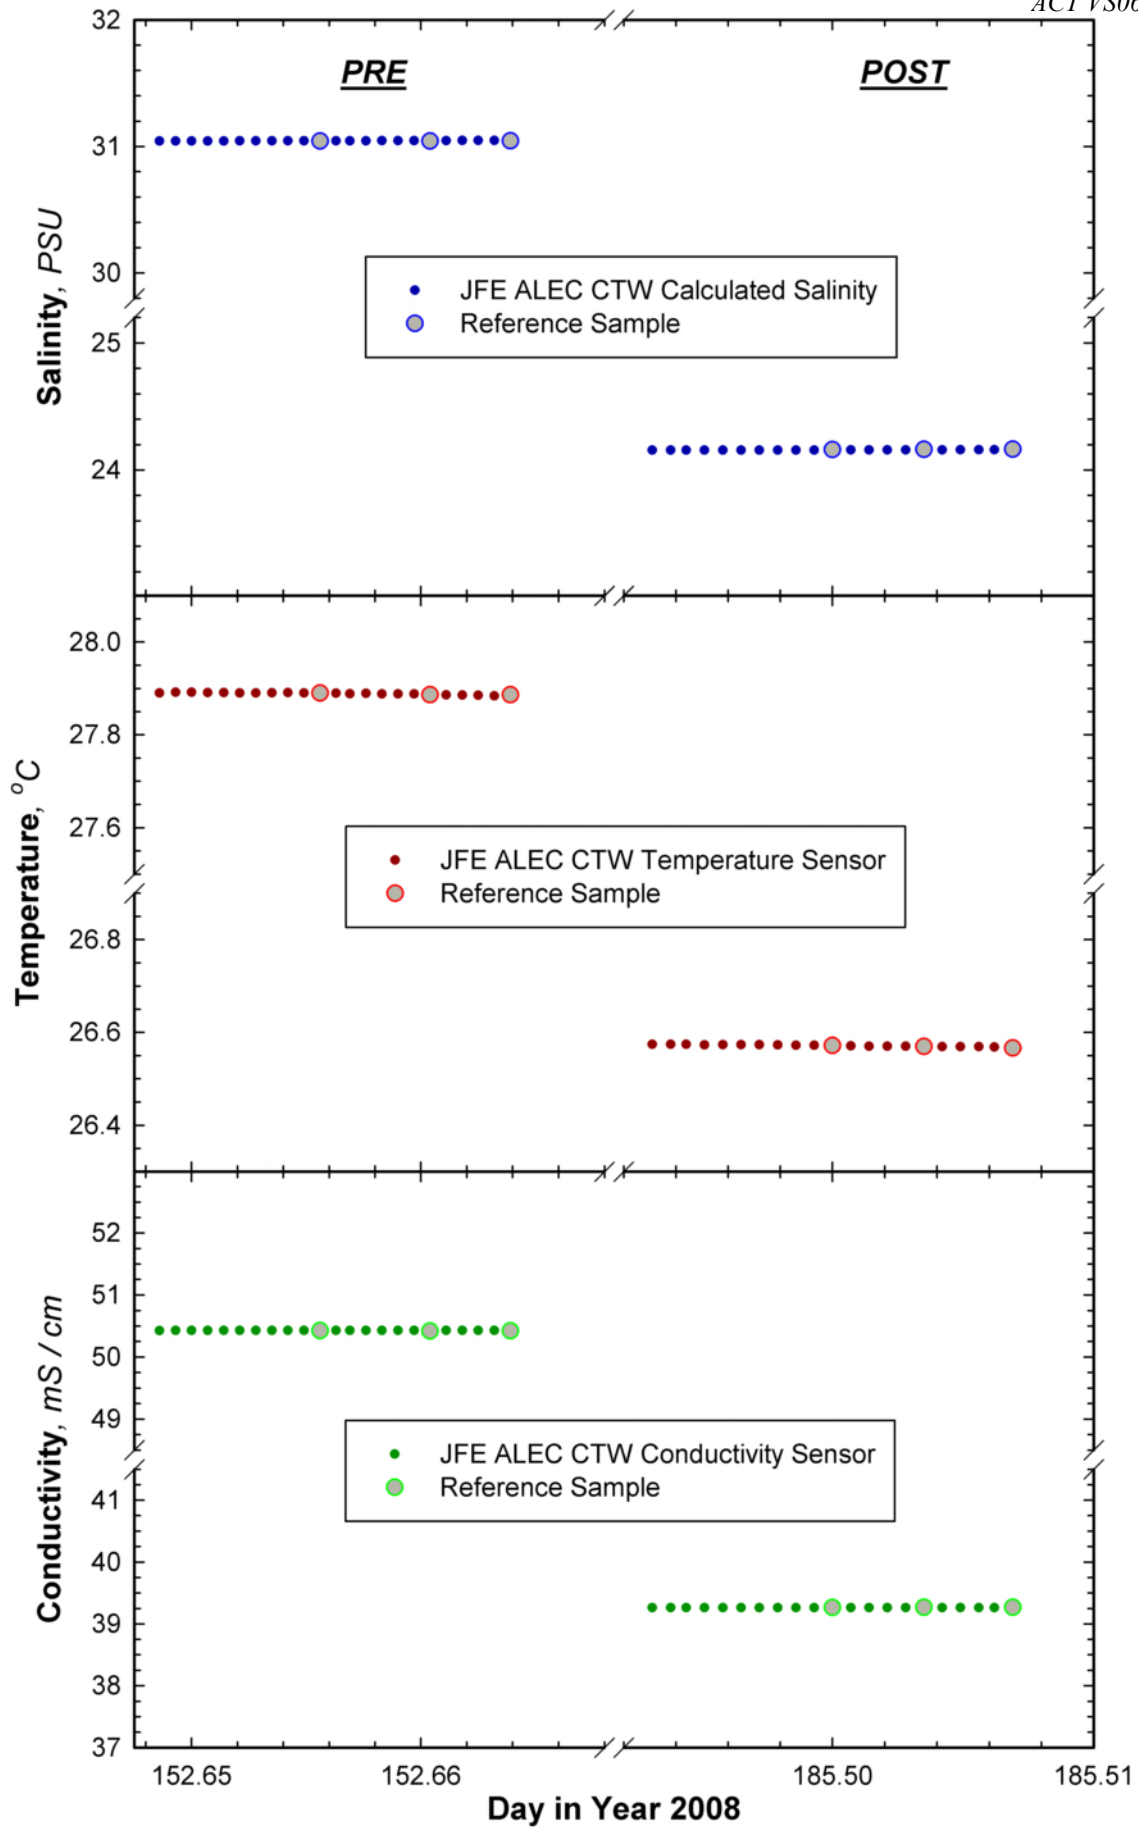
**Figure 9.** Pre- and Post-deployment reference checks in tanks of natural seawater at USF. Post-deployment tests conducted after cleaning instrument of all fouling material according to manufacturer's recommendations.

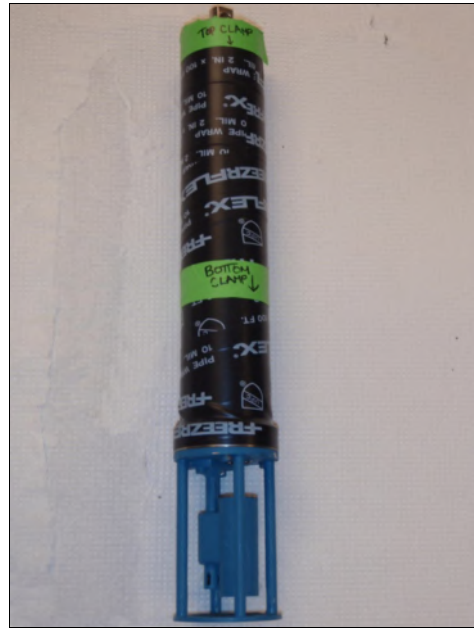
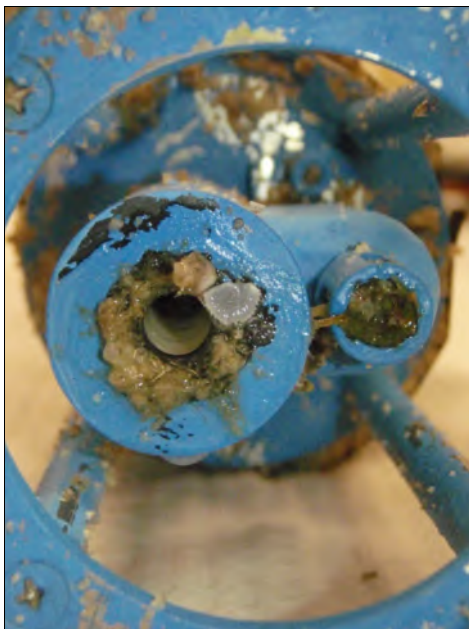
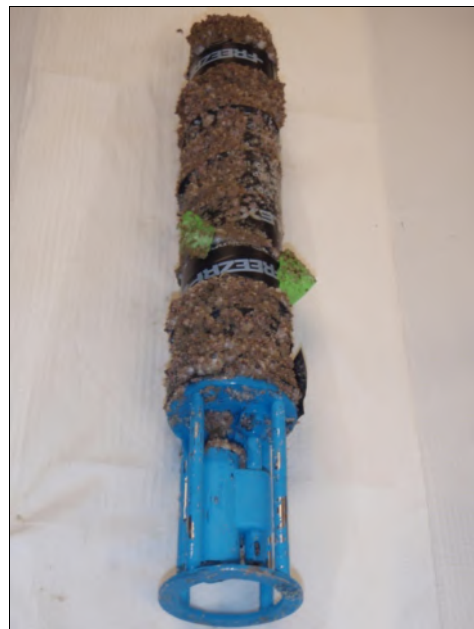
Before and after photos were taken of the instrument to examine the extent and possible impacts of bio-fouling (Fig. 10). A significant amount of hard, encrusting bio-fouling was evident across most of the instrument body by the end of the deployment; however, the conductivity sensor cell appeared to stay clean as a result of the plunger wiping system.

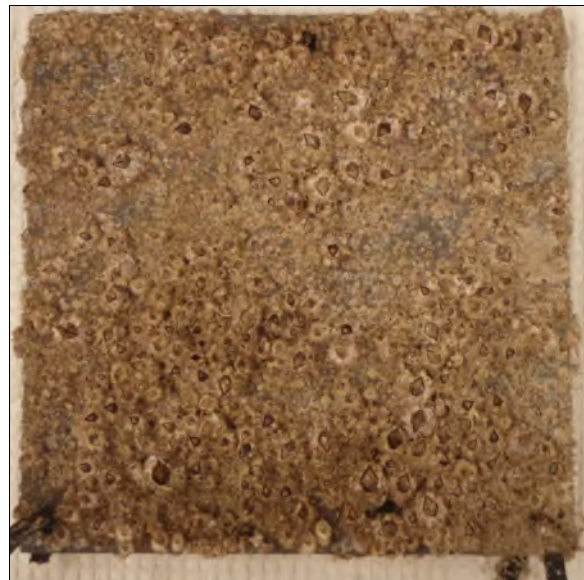
Bio-fouling plates were retrieved and photographed once each week throughout the deployment to help define the rate and extent of biofouling within the test environment (Fig. 11). By the third week of deployment there was an extensive amount of hard, encrusting biofouling at the Florida test site.

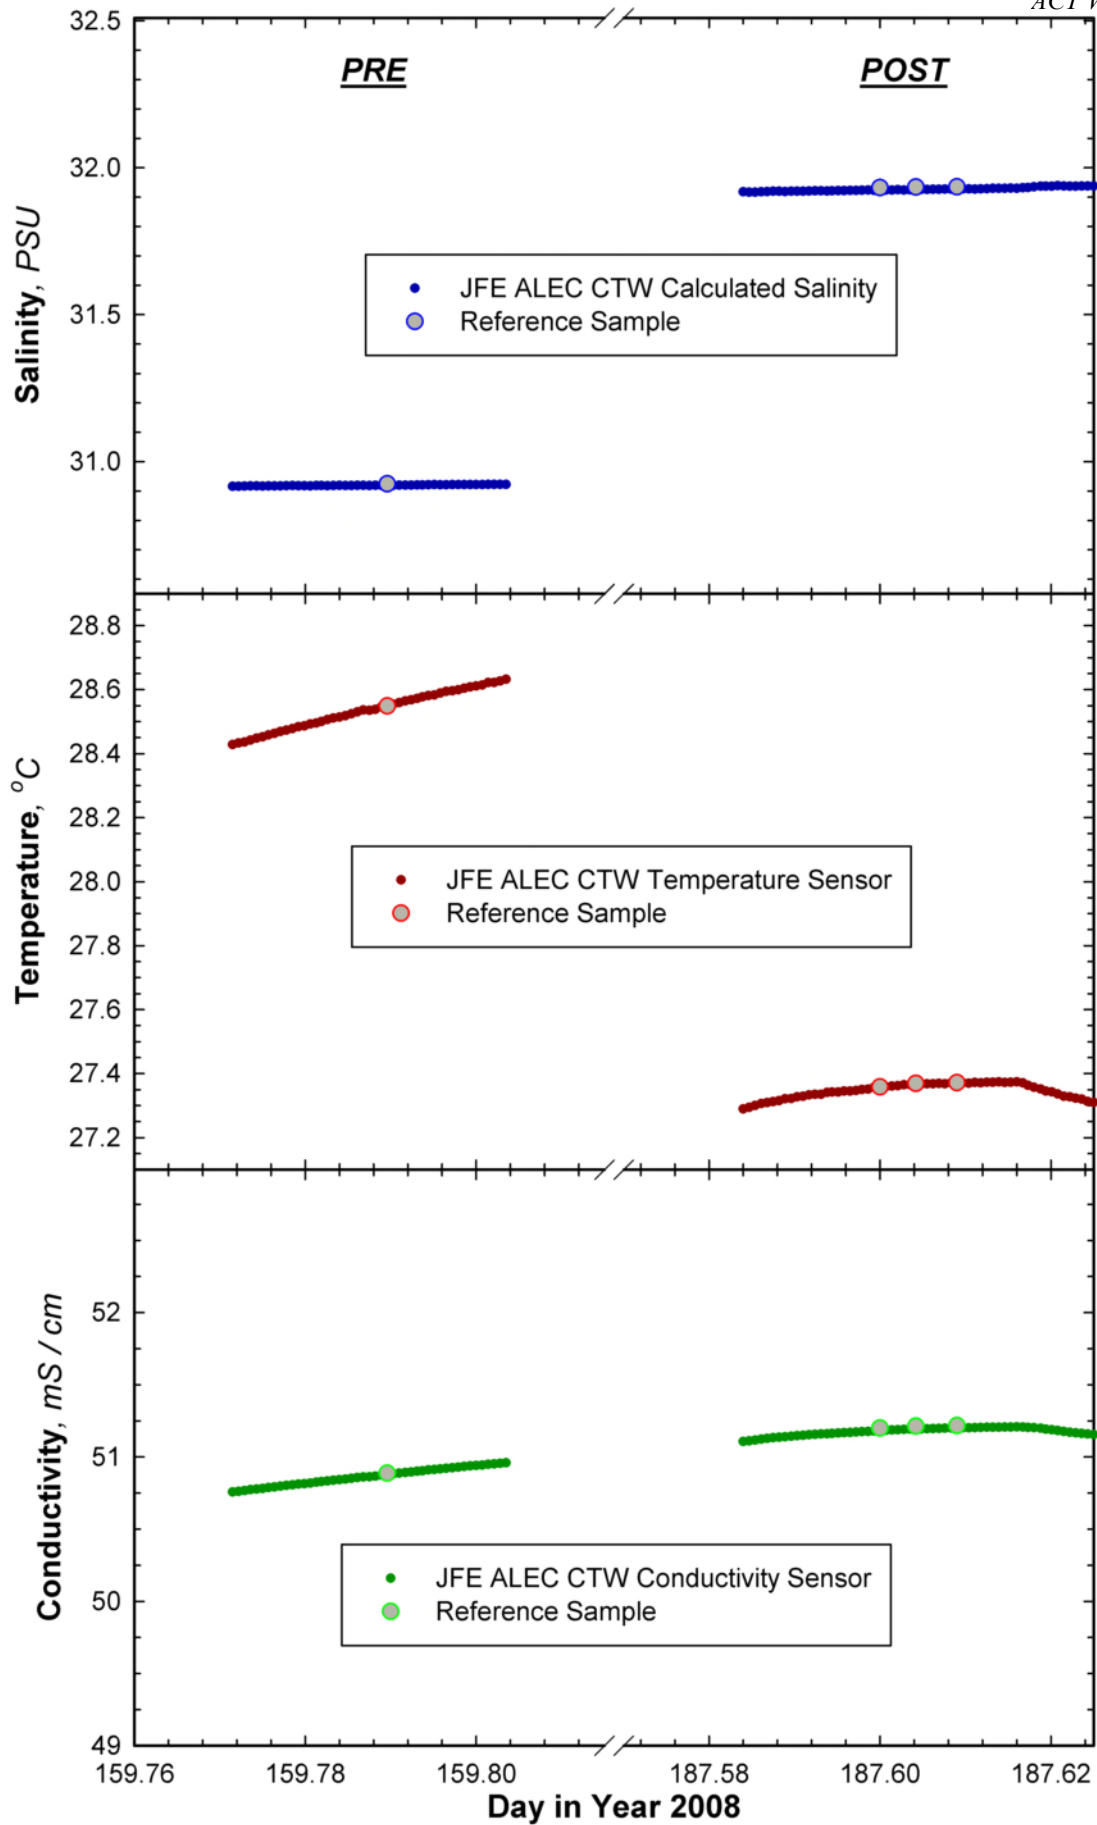
**Figure 15.** Pre- and Post-deployment reference checks in tanks of natural seawater at SkIO. Post-deployment tests conducted after cleaning instrument of all fouling material according to manufacturer's recommendations.

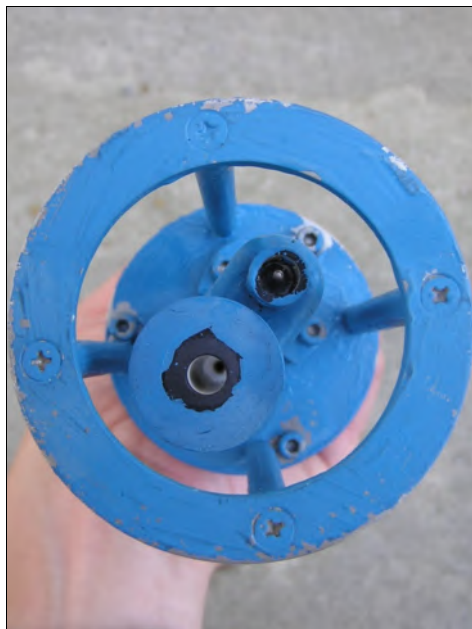
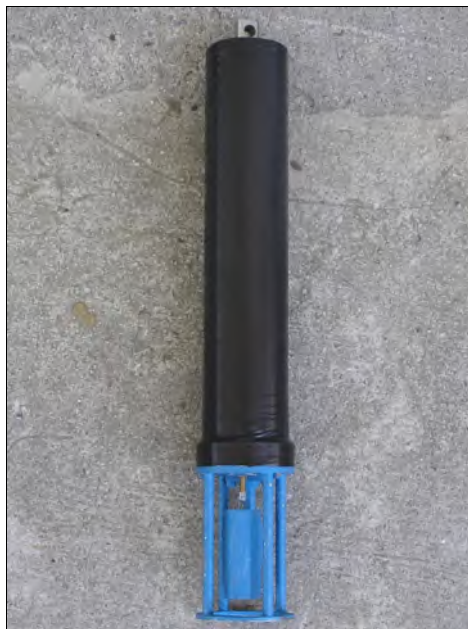
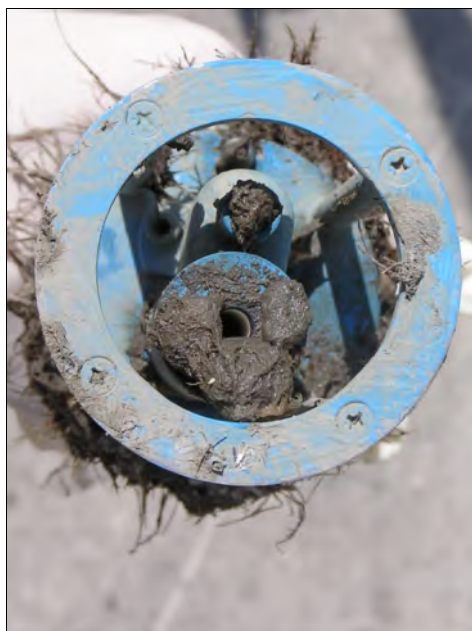
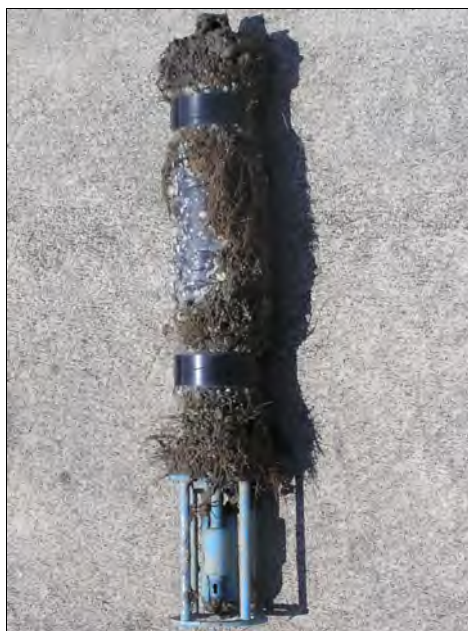
Before and after photos were taken of the instrument to examine the extent and possible impacts of bio-fouling (Fig. 16). A significant amount of soft (plant material) and hard (calcified) bio-fouling was evident across most of the instrument body by the end of the deployment; however, the conductivity sensor cell appeared to stay clean as a result of the plunger wiping system.

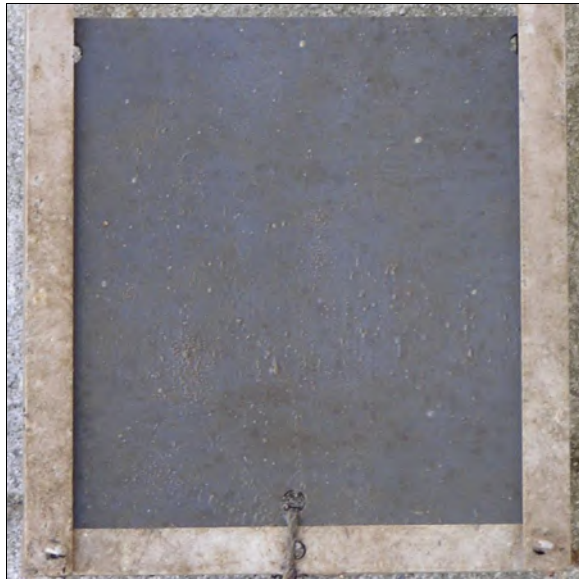
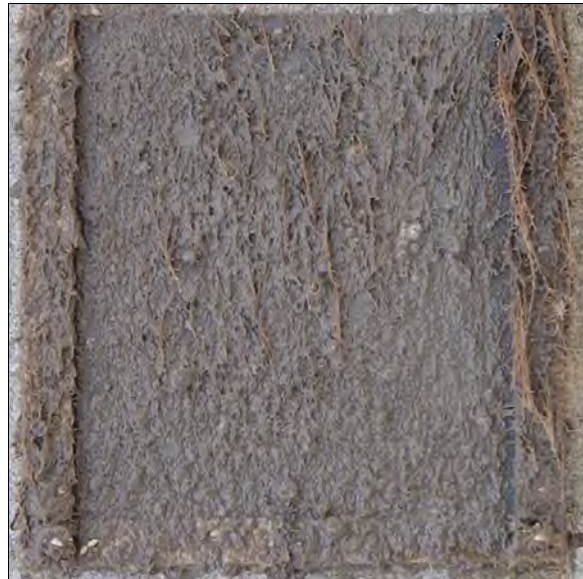
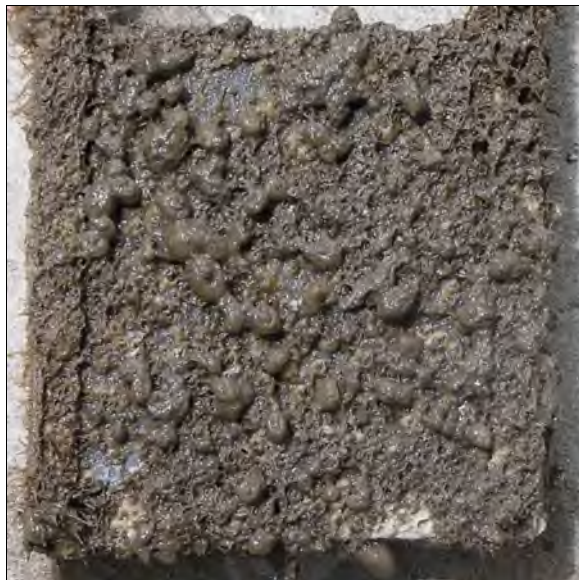
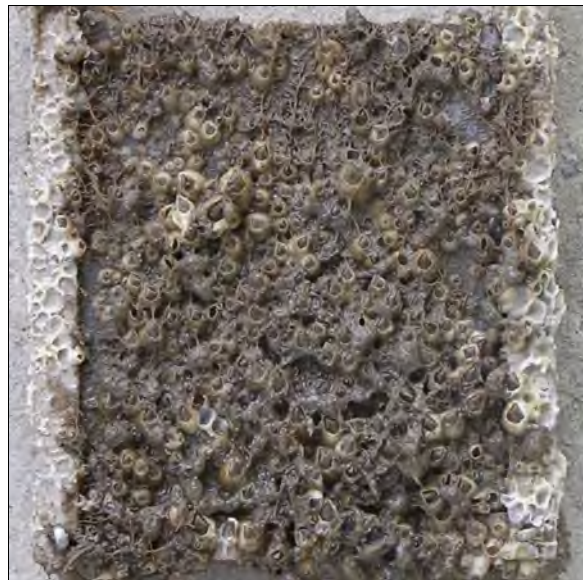
Bio-fouling plates were retrieved and photographed once each week throughout the deployment to help define the rate and extent of biofouling within the test environment (Fig. 17). Significant amounts of soft biofouling were evident by week 2 and progressed into heavy amounts of hard, encrusting biofouling at the Georgia test site.

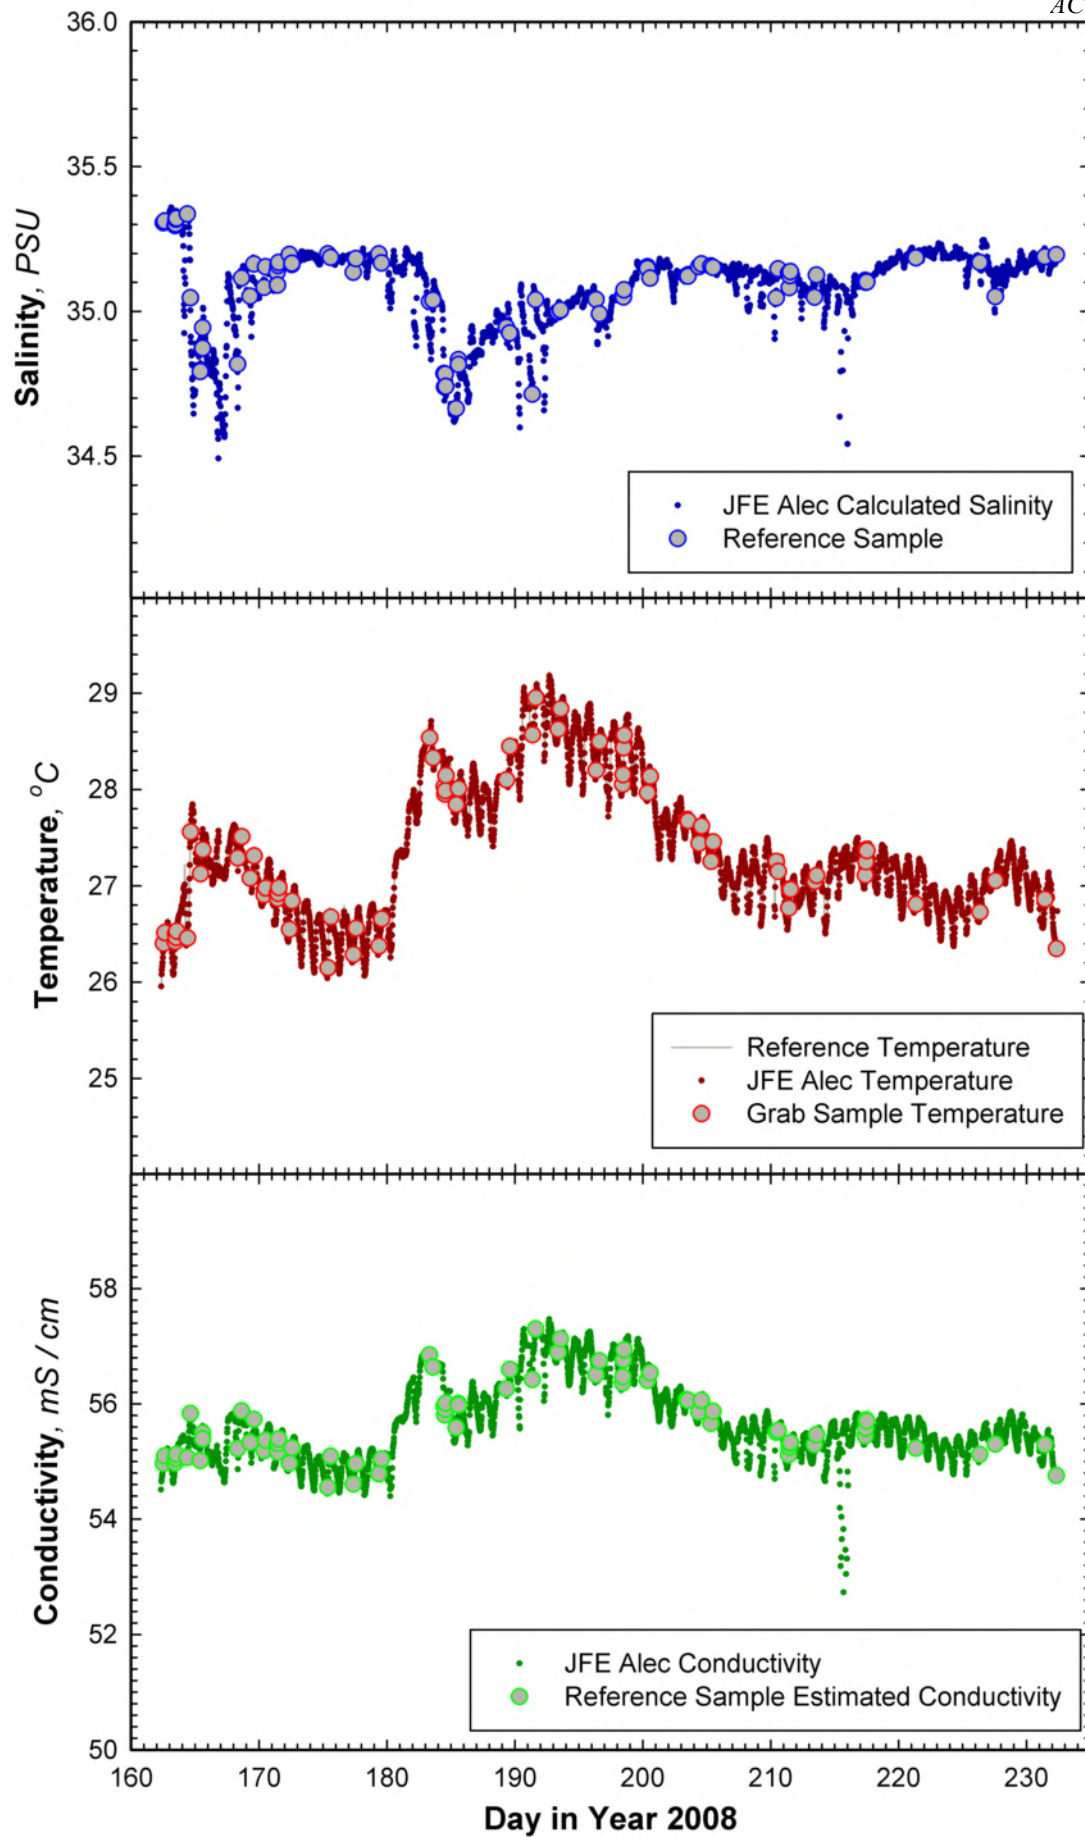
**Figure 19.** Time series of instrument measurements and corresponding reference samples acquired during HI field deployment.

Time series data of in situ measured conductivity and temperature, and derived salinity, for the HI field test were plotted against corresponding results from the laboratory analyzed reference samples and reference temperature logger (Fig. 19). Instrument measurements tracked daily and weekly variations quite closely throughout the entire deployment period. The notable excursion in conductivity measurements around day 216 did not have any corresponding reference samples to substantiate whether these readings were accurate. The relative accuracy of the in situ measurements were depicted as numerical differences from the reference values and plotted over time (Fig. 20). The average offset in instrument measured parameters over the entire deployment was 0.0013 psu, -0.01081 mS/cm, and -0.0078 °C for salinity, conductivity, and temperature, respectively. Comparison of instrument accuracy and precision measured during pre- and post-deployment exposure tests, following instrument cleaning, revealed no measureable performance drift over the deployment period of 60 days (Fig 21). The amount of fouling that developed on the instrument is shown in figure 22 and the rate of fouling was also documented with a time-series of photographs showing the accumulation on PVC tiles (Fig. 23).

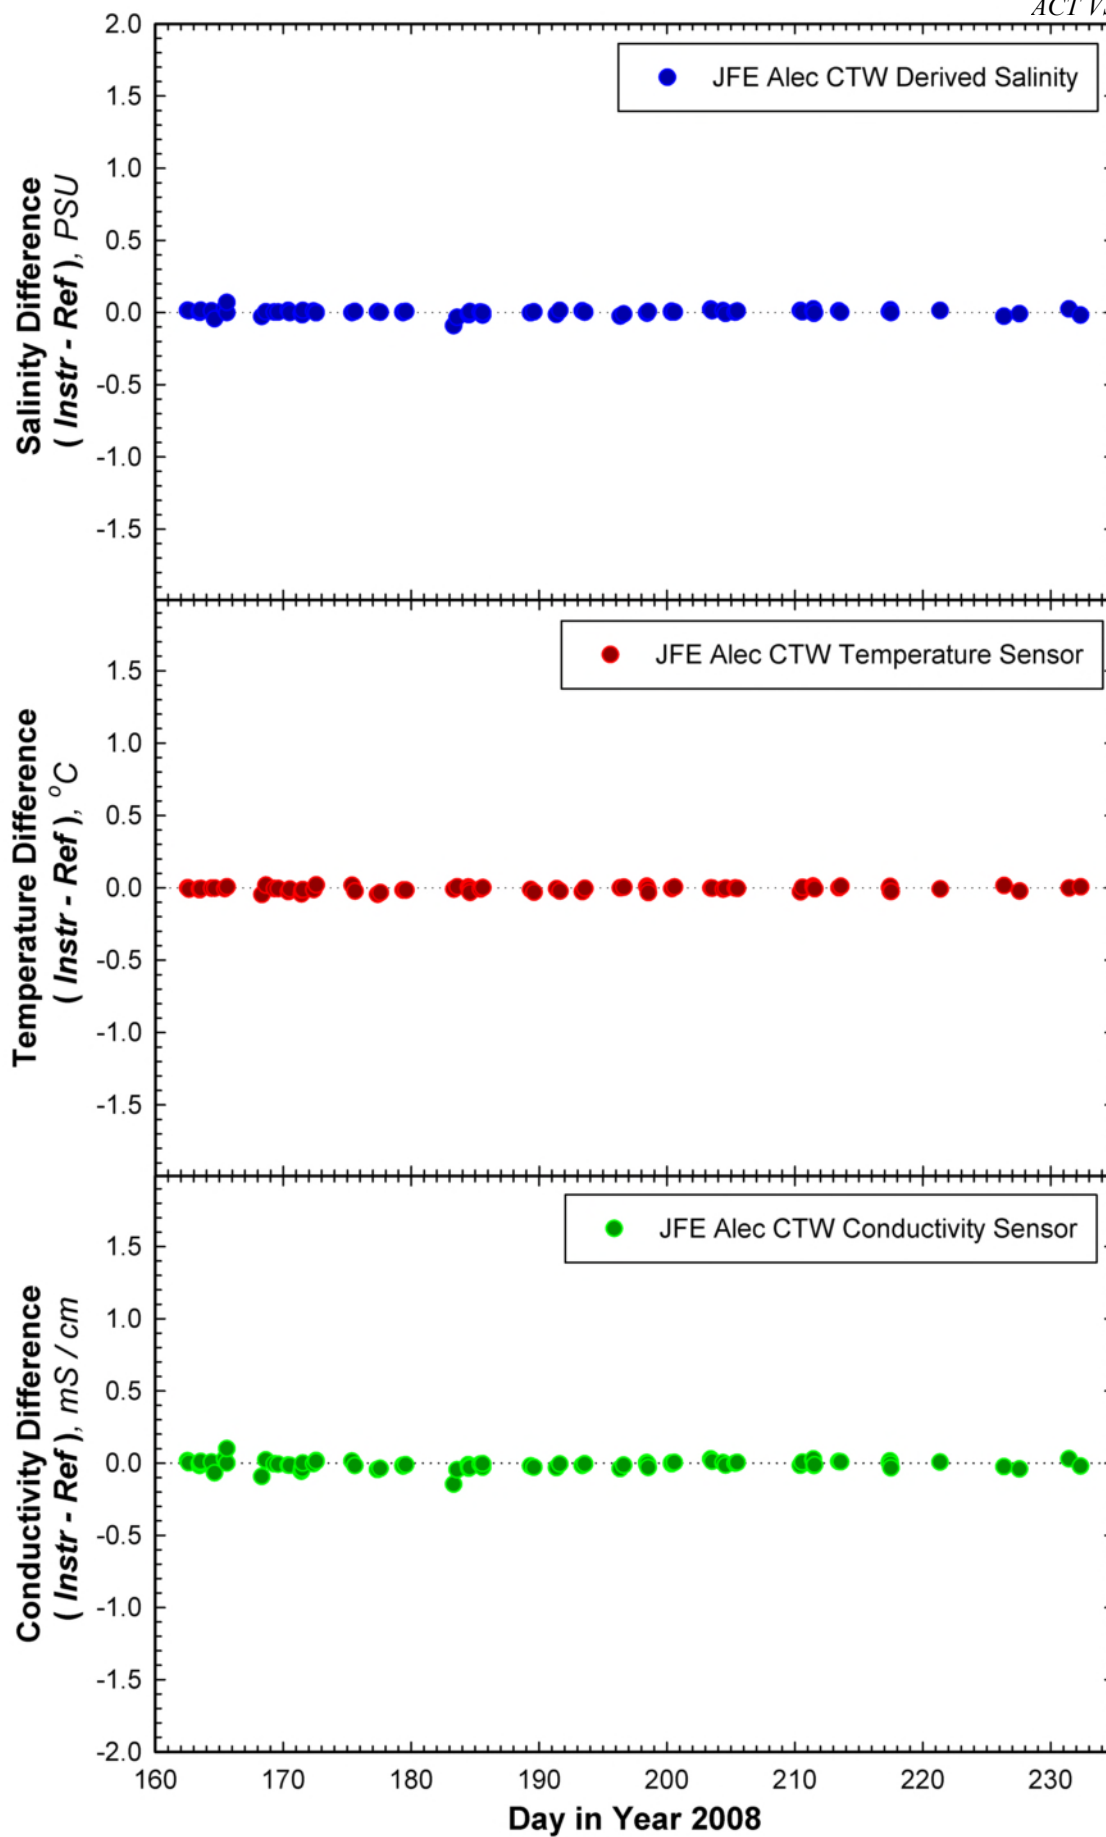
Figure 20. Assessment of relative accuracy of instrument time series measurements during HI field deployment.

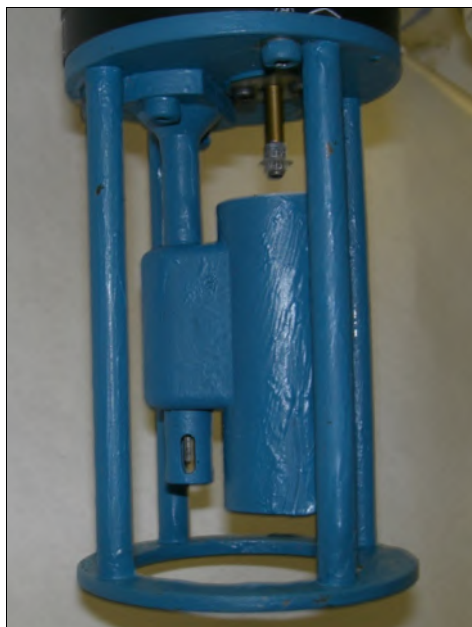
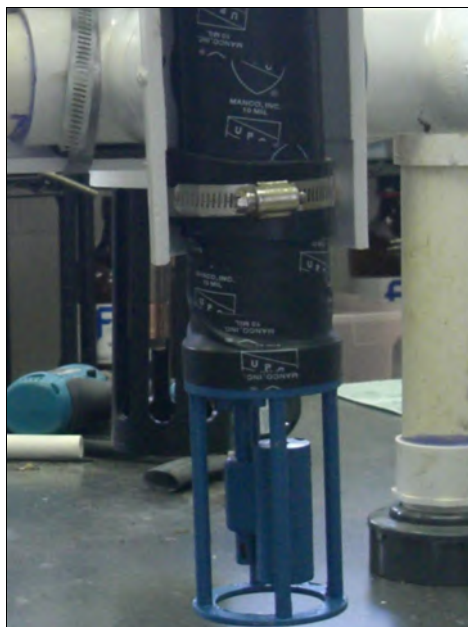
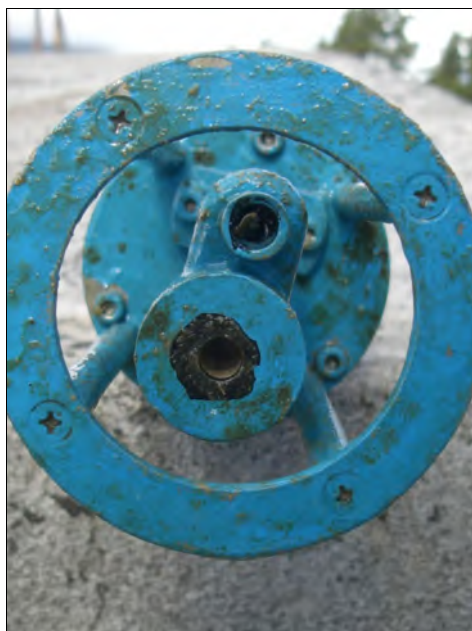
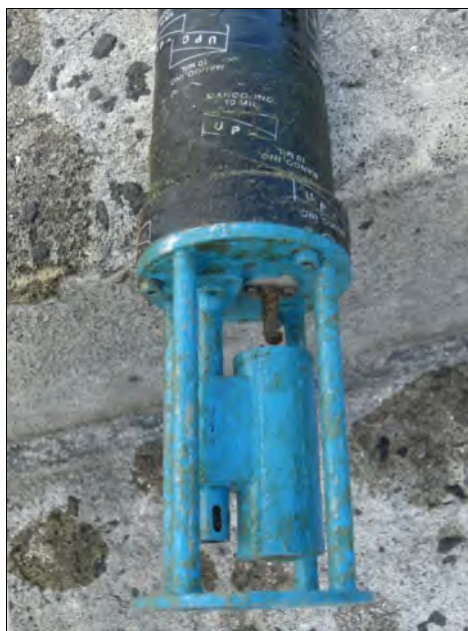
Before and after photos were taken of the instrument to examine the extent and possible impacts of bio-fouling (Fig. 22). The extent of bio-fouling was significantly less at this test site relative to FL or GA despite the longer deployment period and was mostly comprised of plant material and worm cases.

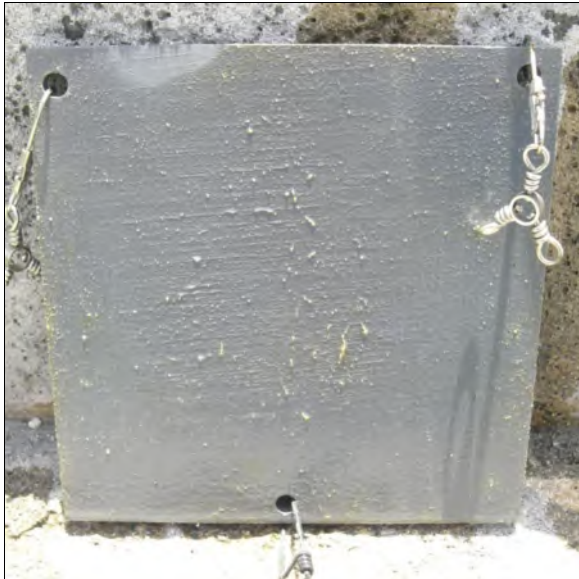
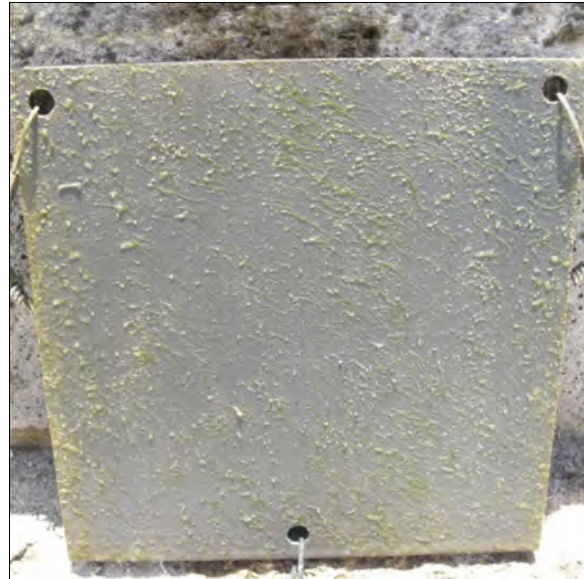
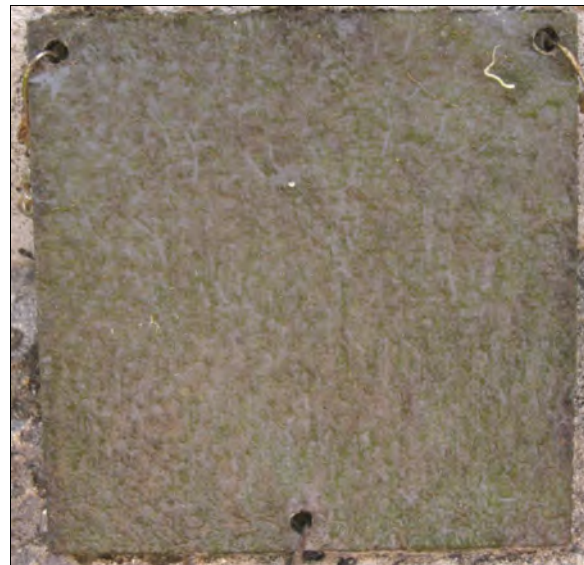
Bio-fouling plates were retrieved and photographed once each week throughout the deployment to help define the rate and extent of biofouling within the test environment. A subset of the plate photographs covering weeks 1, 2, 4, and 8 are shown in Figure 23. The extent of bio-fouling was significantly less at this test site relative to FL or GA despite the longer deployment period and was mostly comprised of plant material and worm cases.

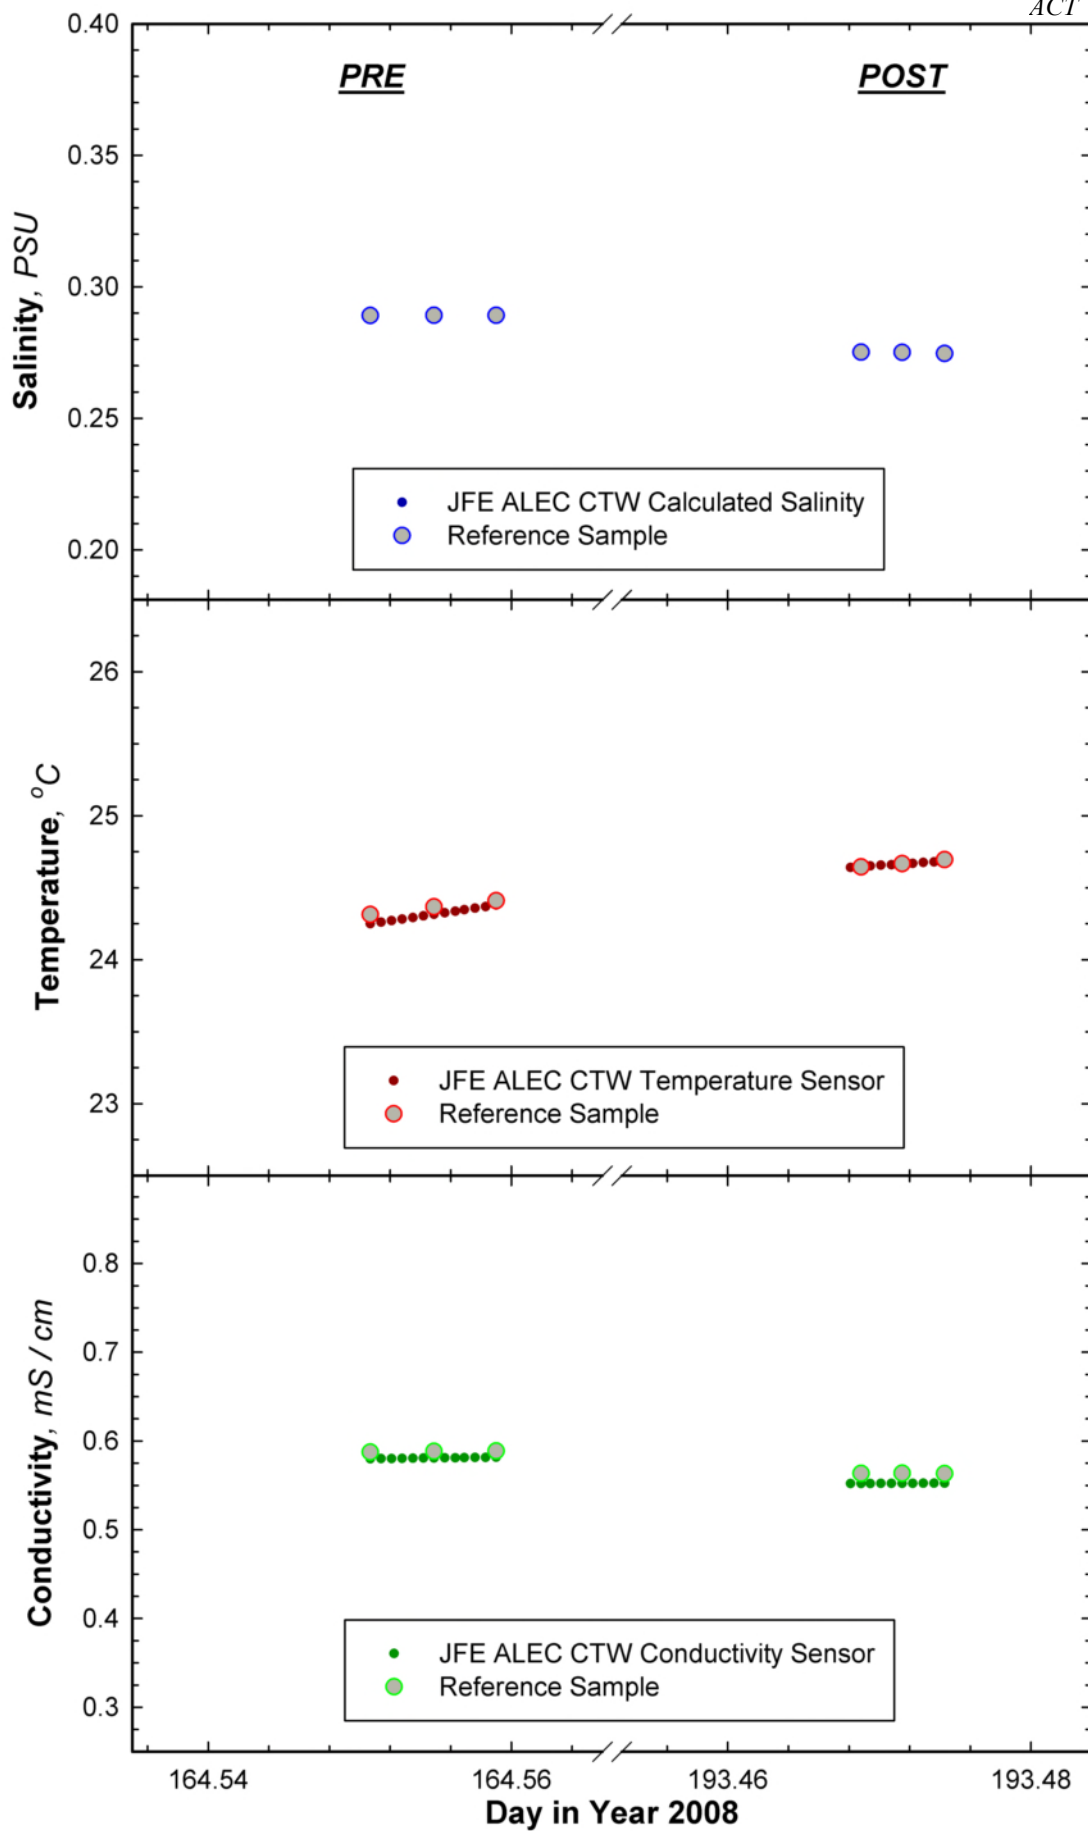
Figure 27. Pre- and Post-deployment reference checks in tanks of river water at GL. Post-deployment tests conducted after cleaning instrument of all fouling material according to manufacturer's recommendations.

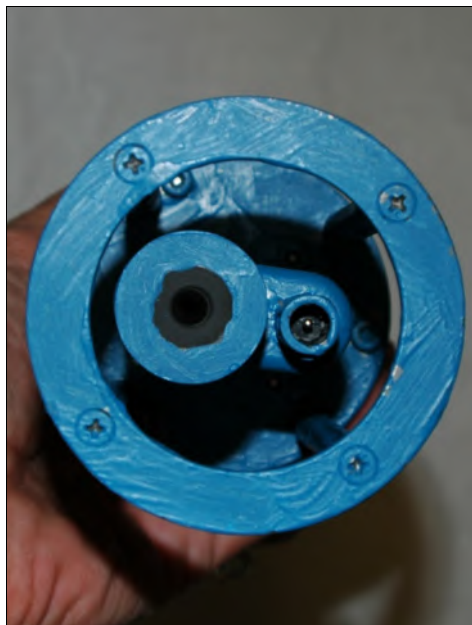
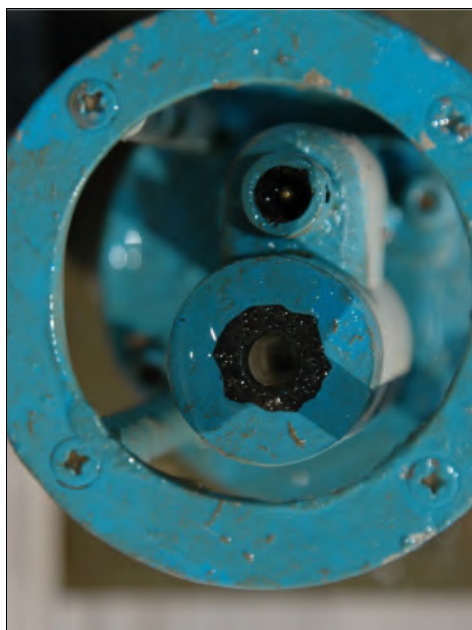
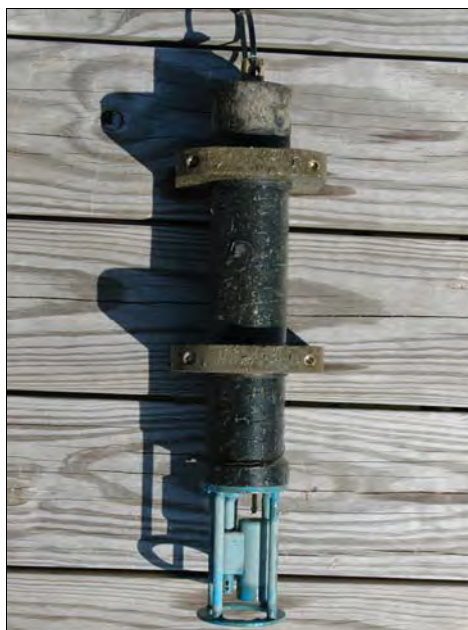
Before and after photos were taken of the instrument to examine the extent and possible impacts of bio-fouling (Fig. 28). The extent of bio-fouling was quite low at the MI test site and consisted of only soft plant material.
