## PERFORMANCE VERIFICATION STATEMENT for the JFE ALEC CTW and CTW-FS Salinity Sensors

<b>TECHNOLOGY TYPE:</b>	Coupled conductivity and temperature sensors with instrument based algorithms for estimation of salinity
<b>APPLICATION:</b>	In situ estimates of salinity for coastal moored and profiled deployments
<b>PARAMETERS EVALUATED:</b>	Response linearity, accuracy, precision and reliability
<b>TYPE OF EVALUATION:</b>	Laboratory and Field Performance Verification
<b>DATE OF EVALUATION:</b>	Testing conducted from May through October 2008
<b>EVALUATION PERSONNEL:</b>	S. Gilbert, K. Gundersen, T. Johengen, T. McKissack, M. McIntyre, A. Pinchuk, H. Purcell, C. Robertson, D. Schar, G.J. Smith, M. Tamburri and D. Wells.

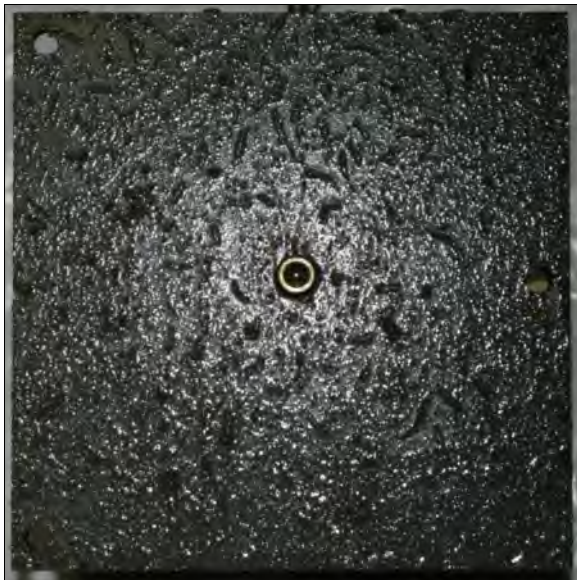
Bio-fouling plates were retrieved and photographed once each week throughout the deployment to help define the rate and extent of biofouling within the test environment (Fig. 29). Biofouling material was mostly comprised of plant material and developed rather quickly but did not appear to accumulate significantly once the original surface was covered.

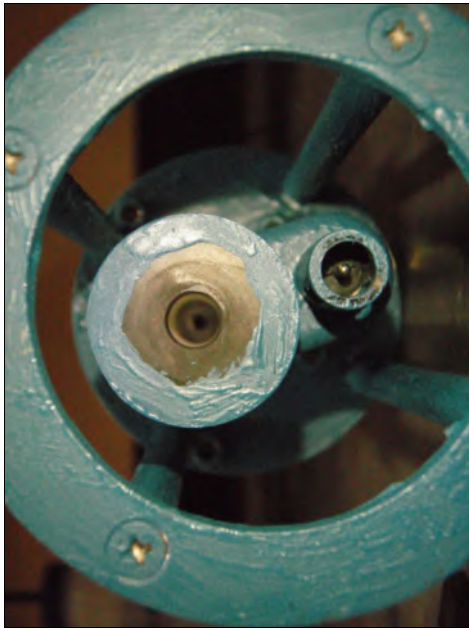
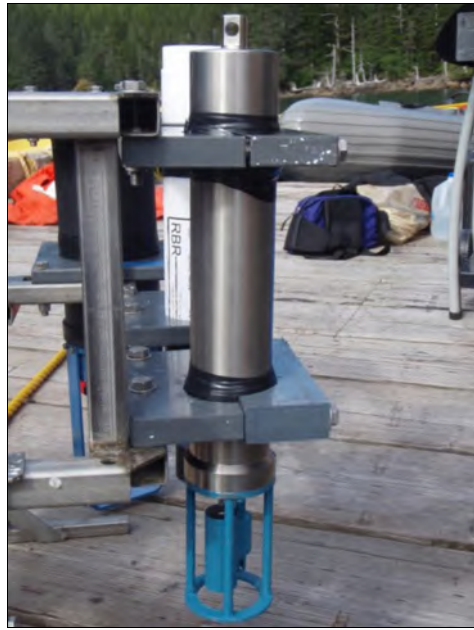
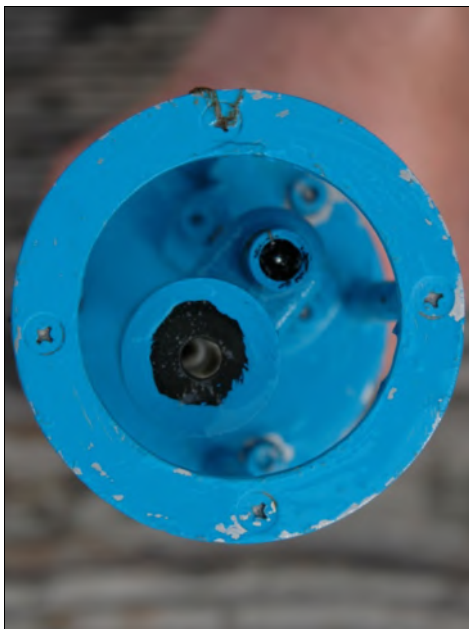
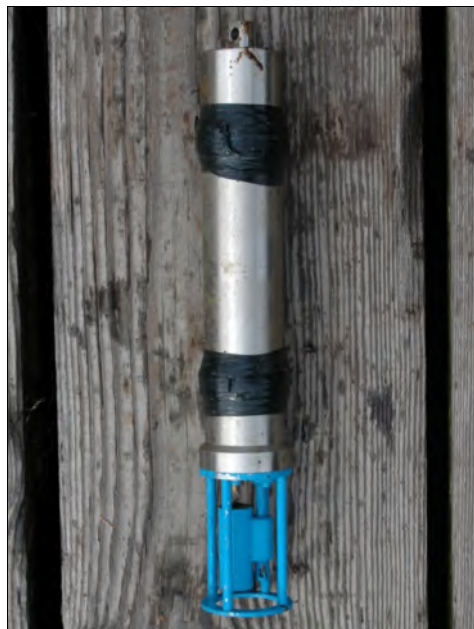
Before and after photos were taken of the instrument to examine the extent and possible impacts of bio-fouling (Fig. 34). The extent of bio-fouling at the AK test site was very small and the lowest of any of the five test sites. No hard fouling was observed.

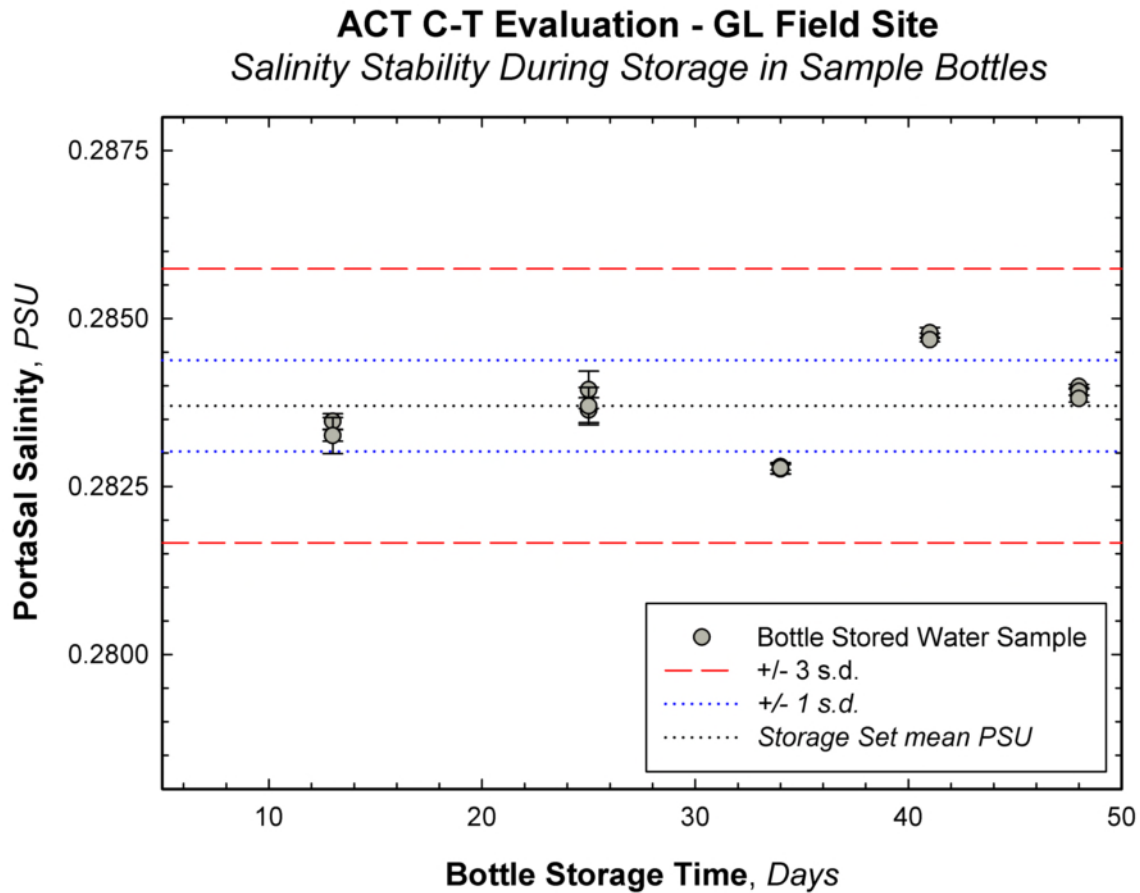
**Figure 40.** Assessment of drift in laboratory salinity measures associated with sample storage in field reference sample bottles. Sample bottles filled from single batch of test site surface water and subsets included in each sample shipment to MLML. Storage time reflects total time (days) since initial water collection.

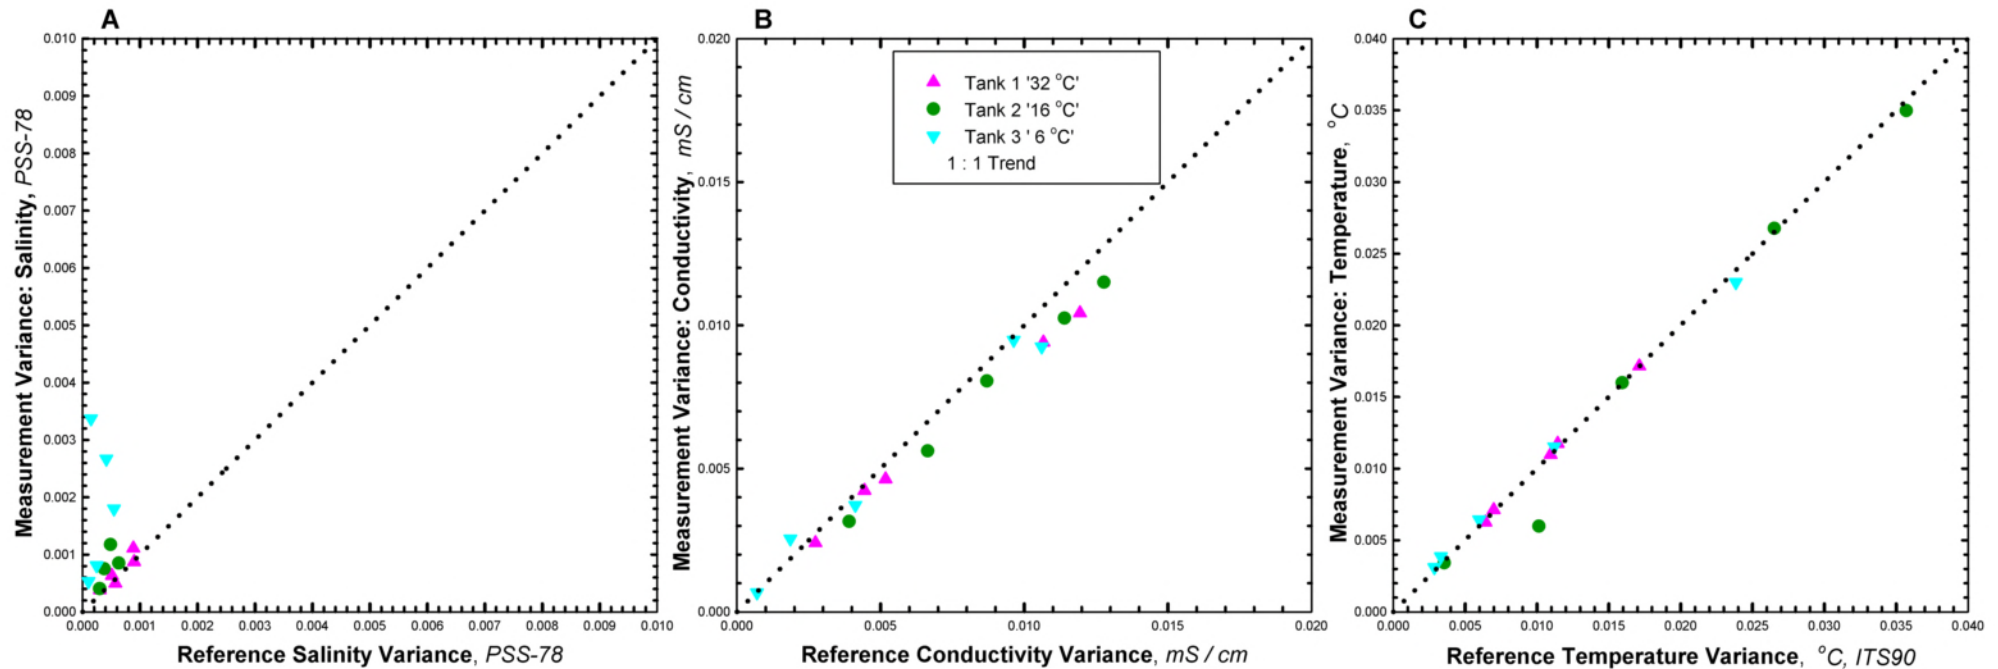
*Alternative Presentation of Laboratory Test Results for Measurement of Instrument Variance  
Relative to Reference Sample Variance*

**Figure 4.** Evaluation of measurement variation of JFE ALEC's model CTW conductivity and temperature sensor package achieved during the laboratory exposure trials plotted in Fig. 3. Instrument measurement variance is presented as the standard deviation from 30 consecutive instrument reads recorded during the 30 min reference sampling for each test exposure and plotted against the corresponding variation in the reference measure. The 1:1 correspondence line (dotted) is provided for comparison, with points below the line indicating lower and above higher-instrument measurement variation than obtained by our reference methods and test conditions. [A] Co-variation of derived salinity estimates; [B] Co-variation of in situ conductivity measurements; [C] Co-variation of instrument temperature measurements.
