PERFORMANCE VERIFICATION STATEMENT for the YSI 6-series sonde with model 6560 Salinity Sensor

TECHNOLOGY TYPE:	Coupled conductivity and temperature sensors with instrument based algorithms for estimation of salinity
APPLICATION:	In situ estimates of salinity for coastal moored and profiled deployments
PARAMETERS EVALUATED:	Response linearity, accuracy, precision and reliability
TYPE OF EVALUATION:	Laboratory and Field Performance Verification
DATE OF EVALUATION:	Testing conducted from May through October 2008
EVALUATION PERSONNEL:	S. Gilbert, K. Gundersen, T. Johengen, T. McKissack, M. McIntyre, A. Pinchuk, H. Purcell, C. Robertson, D. Schar, G.J. Smith, M. Tamburri and D. Wells.

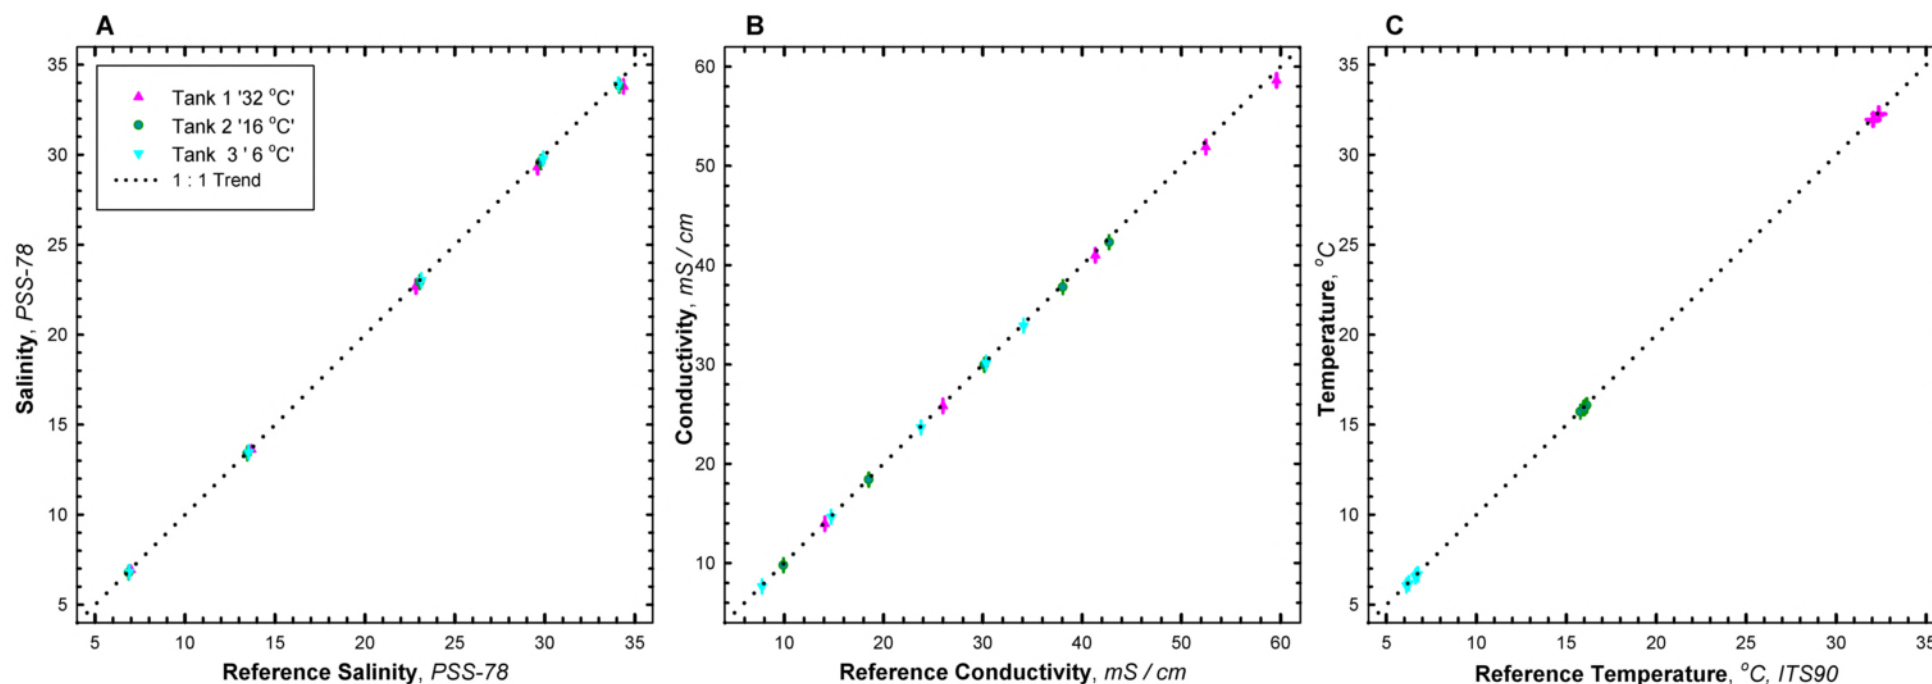
Figure 3. Evaluation of the response linearity for YSI's 6600 Sonde conductivity and temperature sensor package during controlled laboratory exposures to a combination of natural seawater dilutions and temperatures. Consecutive test exposures ranged between 35 to 6 on the practical salinity scale (PSS-78; 60 to 6 mS/cm conductivity) and 33 to 6 °C. [A] Correspondence of instrument derived salinity to Portosal reference measurements; [B] Correspondence of instrument in situ conductivity measurement to conductivity estimate derived from the Portosal salinity and reference temperature measurement by inversion of the seawater equations of state (IAPSO PSS-78); [C] Correspondence of instrument temperature measurement to bath reference temperature recorded by a calibrated RBR 1060 logging thermometer. Data points are represented as mean \pm standard deviation of and 10 reference water samples. Dotted lines represent 1:1 ideal correlation of measures.

Analyzed across all five salinity levels and all three temperatures, the YSI 6600 exhibited a strong linear response to the test solutions with $R^2 > 0.9999$, a standard error = 0.1015 and a slope = 0.991 (Fig. 3). Most of variability was observed in the conductivity measurements which had a regression standard error of 0.125 compared to only 0.003 for the temperature sensor responses. The variance in 30 repeated measurements taken at one minute intervals for each of the laboratory trials is shown in Figure 4. The plots are not a measure of engineering precision as environmental conditions within the test baths did change during the sampling process. The variation in instrument derived measurements is plotted relative to the average standard deviation and 3-times the standard deviation upper specification limit of reference salinity, conductivity, and temperature measurements taken over corresponding time intervals for all lab tests. An alternative version of this figure showing a direct comparison of instrument versus reference sample variance for each individual trial is given in Appendix 1. Instrument offsets in salinity, conductivity and temperature were computed for each test run as the difference in the mean instrument measure from the mean reference measure for that test bath condition (Fig. 5). There was an increase in conductivity measurement error and consequently salinity offset, as the salinity of the test solutions increased. The temperature sensor also should an increased offset as test temperatures increased. The average of the measurement offsets across all 15 lab tests were -0.1678 psu for salinity, -0.2732 mS/cm for conductivity, and -0.0737 °C for temperature.

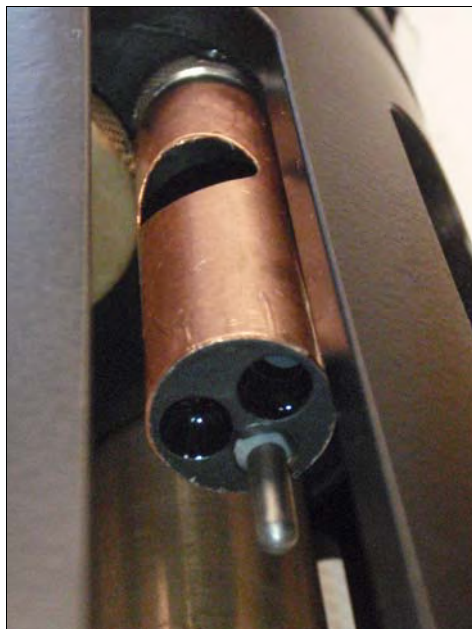
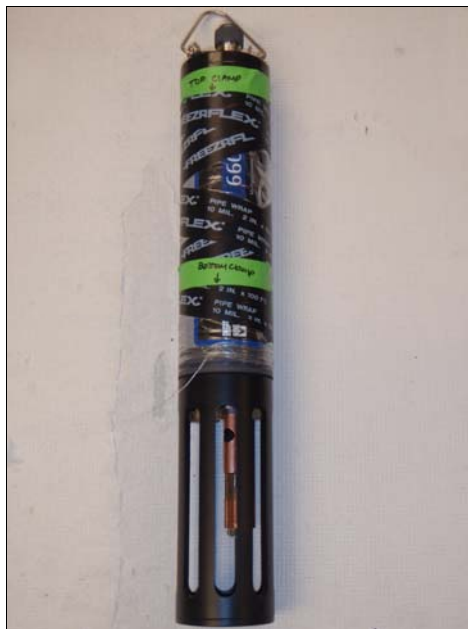
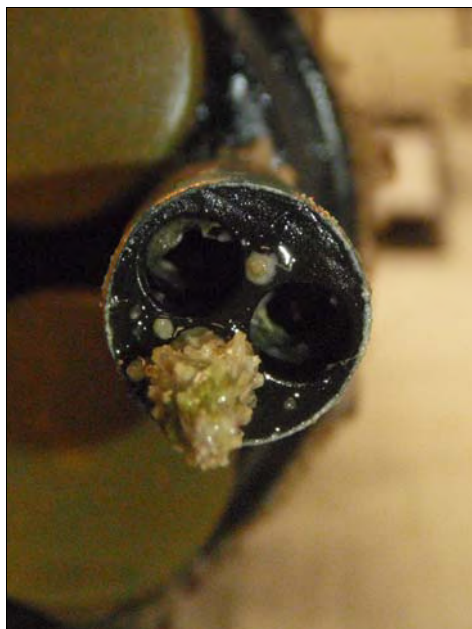
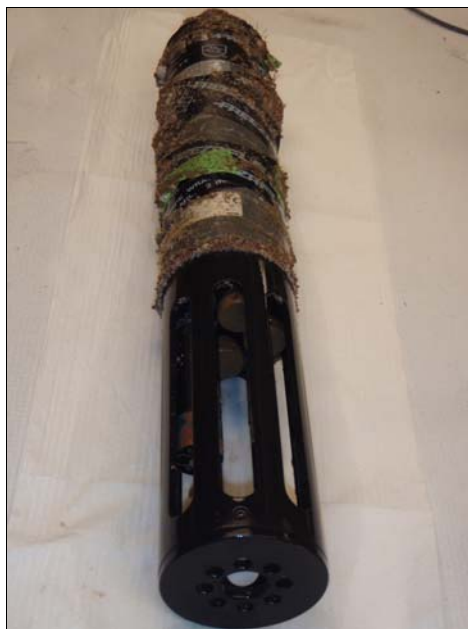
Before and after photos were taken of the instrument to examine the extent and possible impacts of bio-fouling (Fig. 10). A significant amount of hard, encrusting bio-fouling was evident across most of the instrument body by the end of the deployment, including some directly within the conductivity cell despite the application of copper tape on the outside of the sensor.

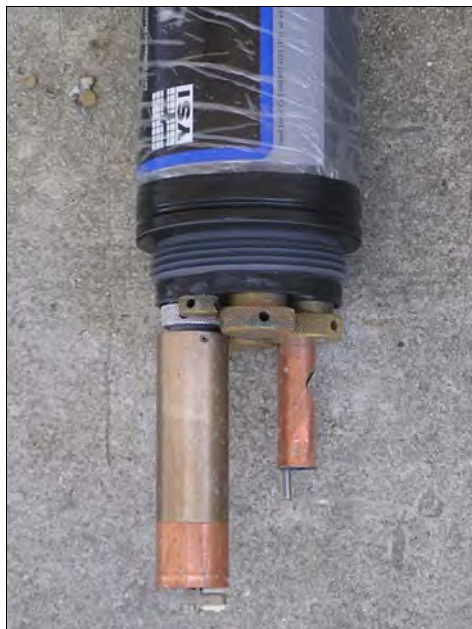
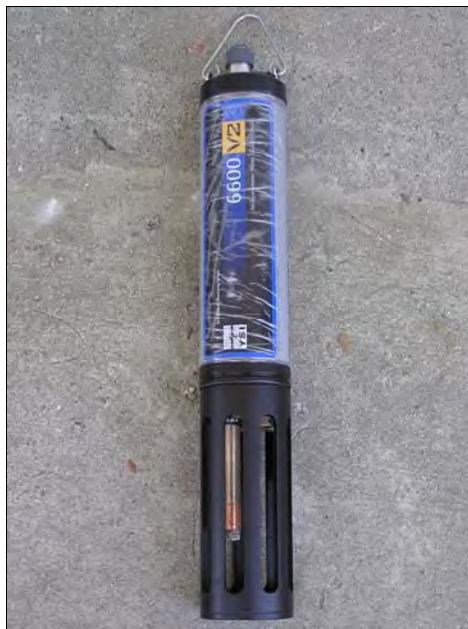
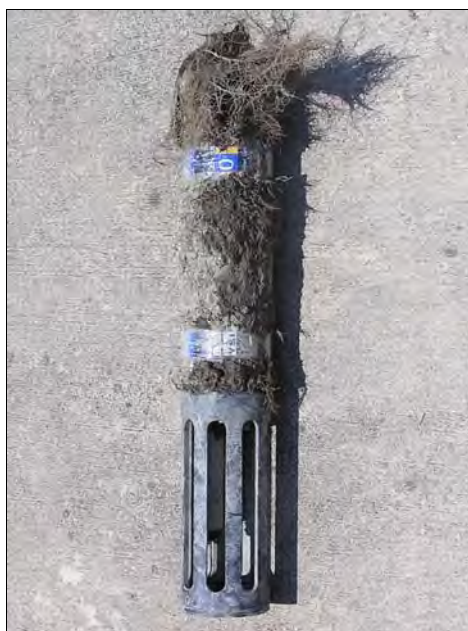
Before and after photos were taken of the instrument to examine the extent and possible impacts of bio-fouling (Fig. 16). A significant amount of soft (plant material) and hard (calcified) bio-fouling was evident across most of the instrument body by the end of the deployment. The copper tape on the sensors reduced the extent of fouling but appeared to get within the opening of the conductivity cell itself.

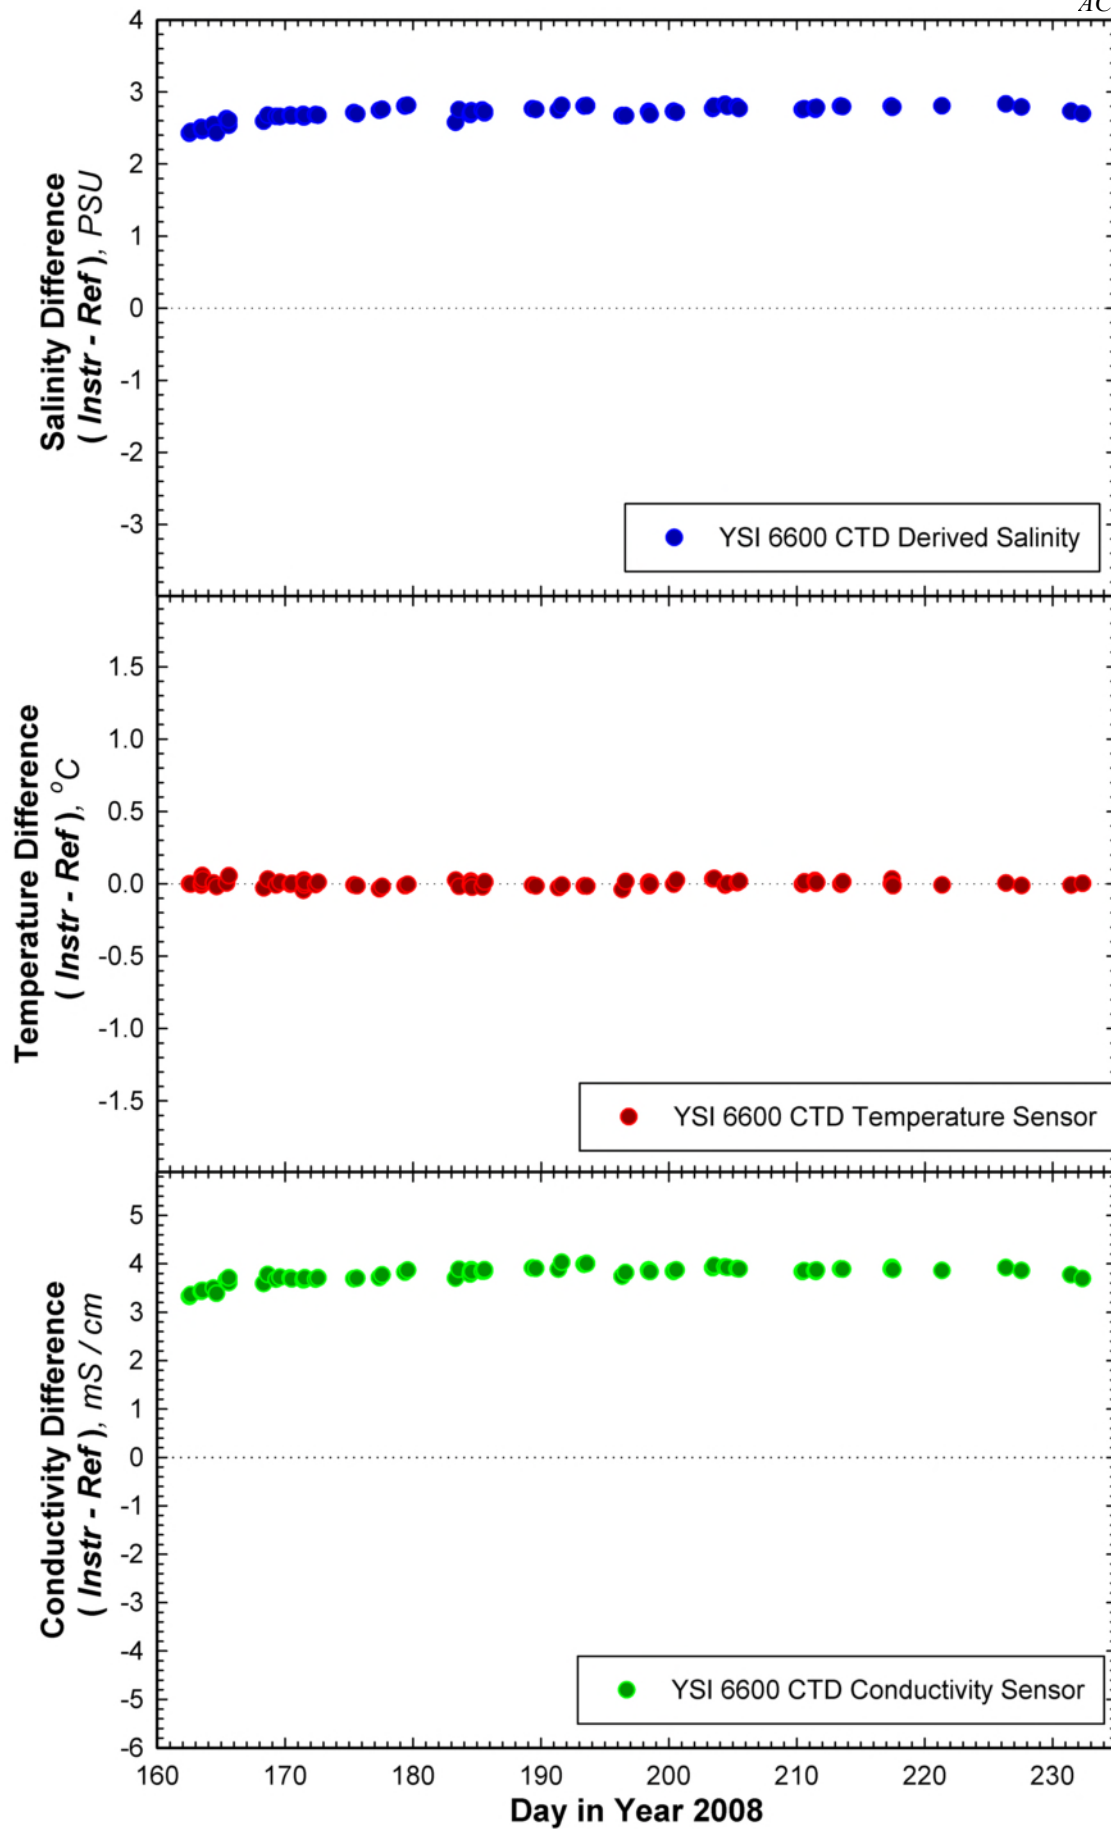
Figure 20. Assessment of relative accuracy of instrument time series measurements during the HI field deployment.

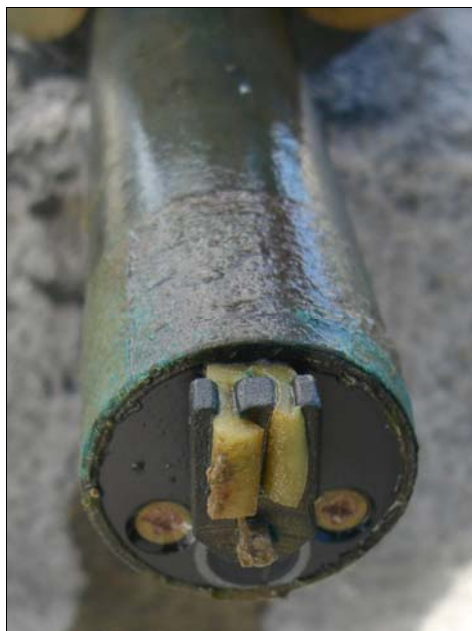
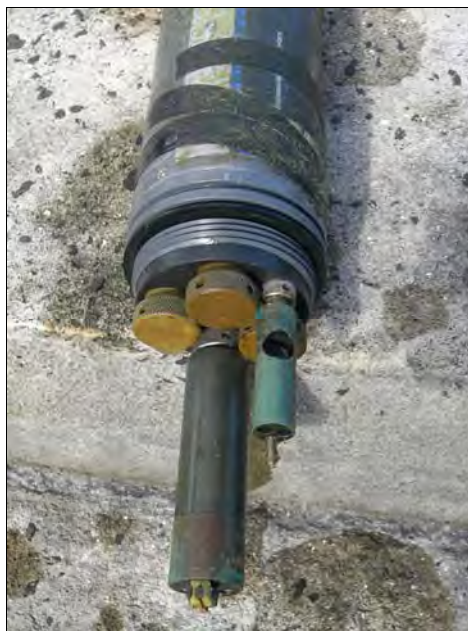
Before and after photos were taken of the instrument to examine the extent and possible impacts of bio-fouling (Fig. 22). The extent of bio-fouling was significantly less at this test site relative to FL or GA despite the longer deployment period and was mostly comprised of plant material and worm cases.

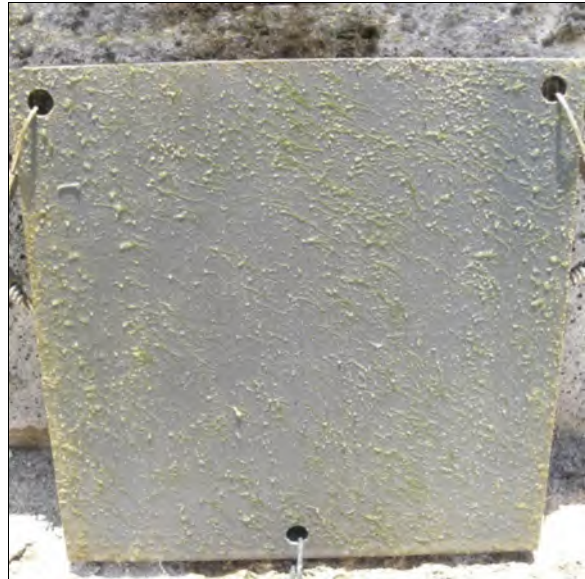
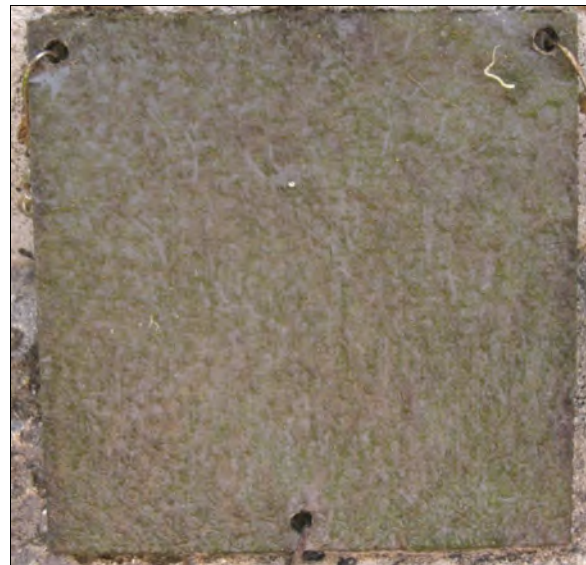
Bio-fouling plates were retrieved and photographed once each week throughout the deployment to help define the rate and extent of biofouling within the test environment. A subset of the plate photographs covering weeks 1, 2, 4, and 8 are shown in Figure 23. The extent of bio-fouling was significantly less at this test site relative to FL or GA despite the longer deployment period and was mostly comprised of plant material and worm cases.

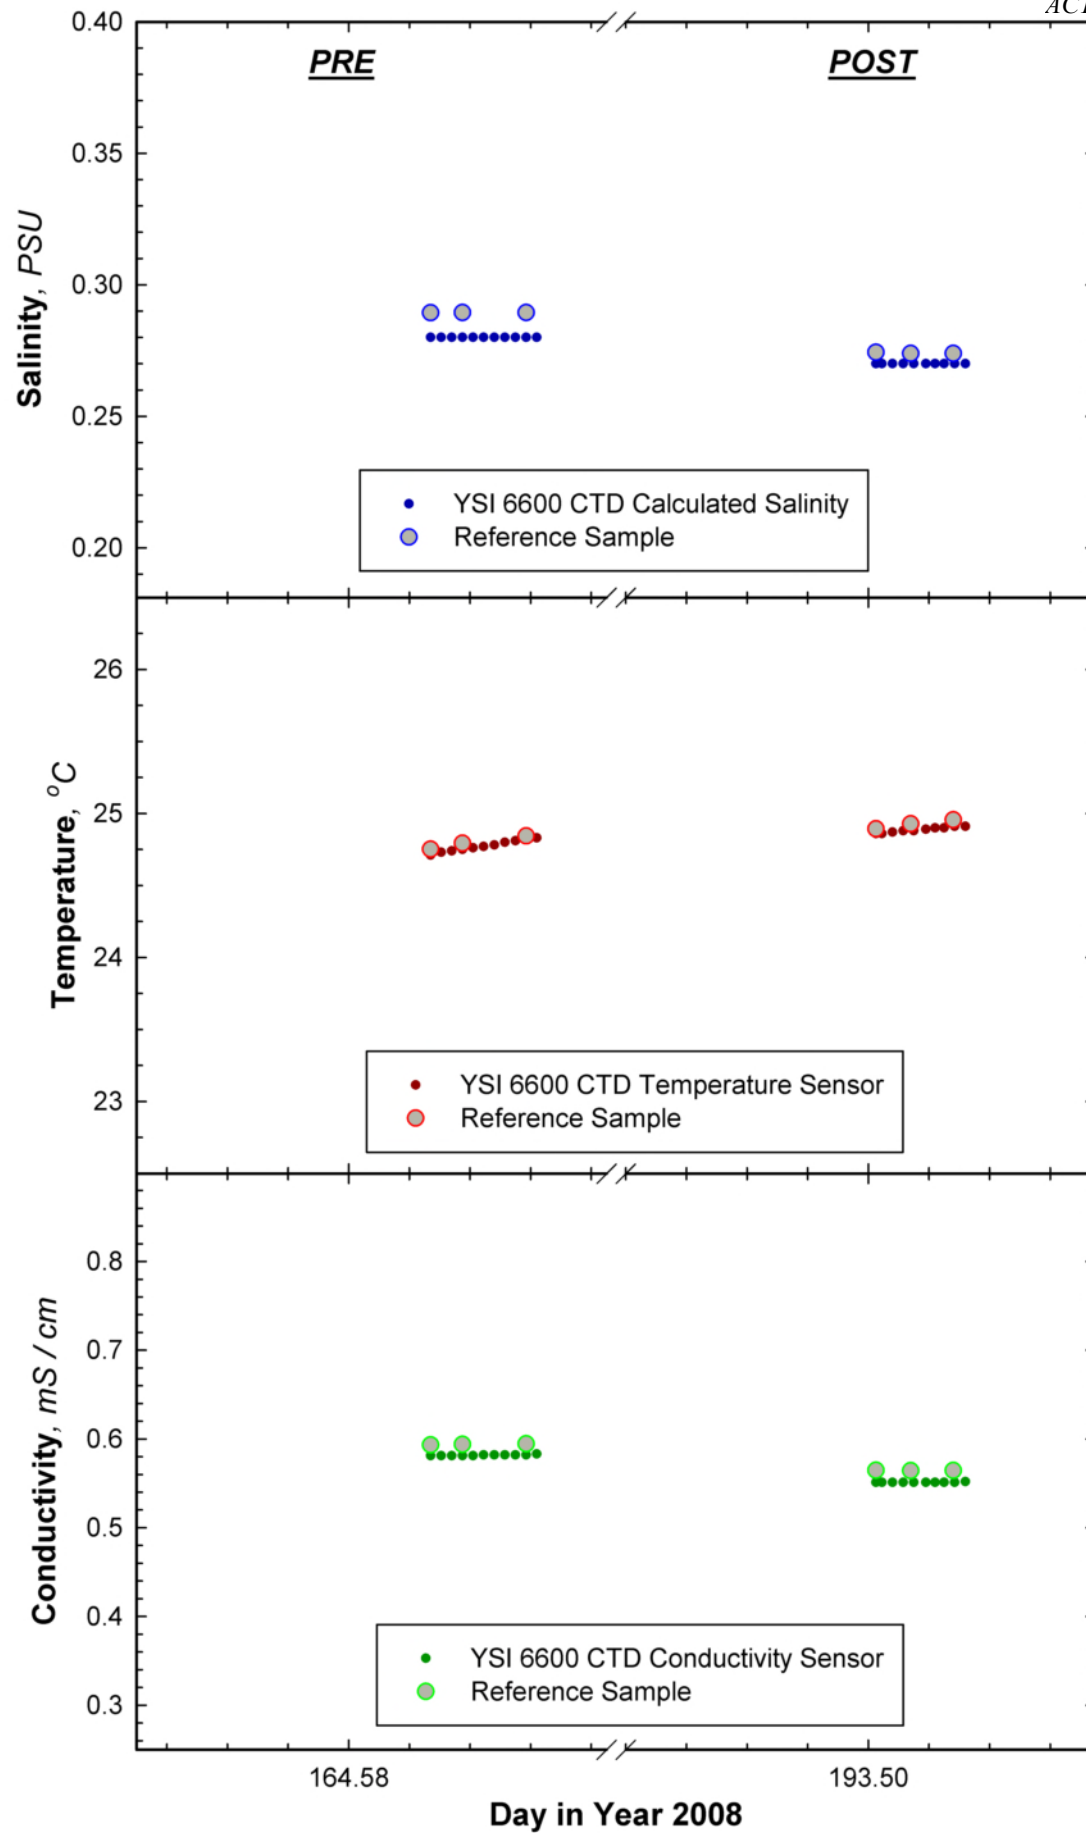
Figure 27. Pre- and Post-deployment reference checks in tanks of river water at GL. Post-deployment tests conducted after cleaning instrument of all fouling material according to manufacturer's recommendations.

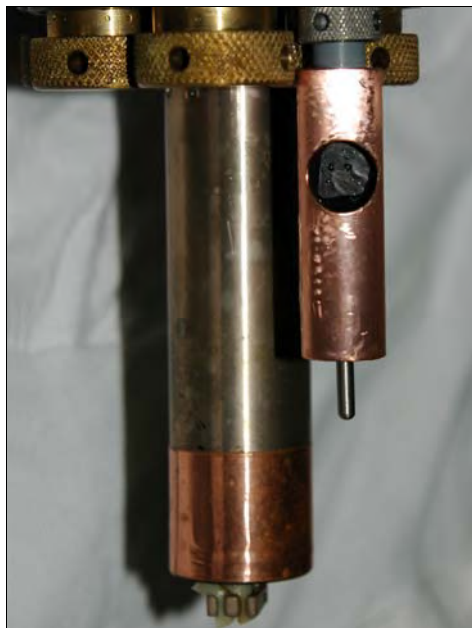
Before and after photos were taken of the instrument to examine the extent and possible impacts of bio-fouling (Fig. 28). The extent of bio-fouling was quite low at the MI test site and consisted of only soft plant material.

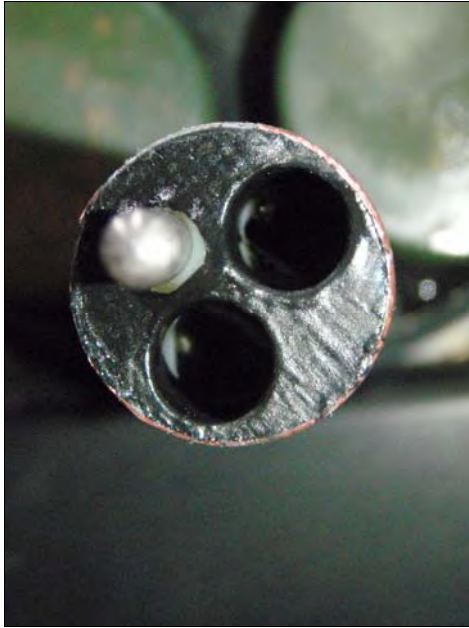
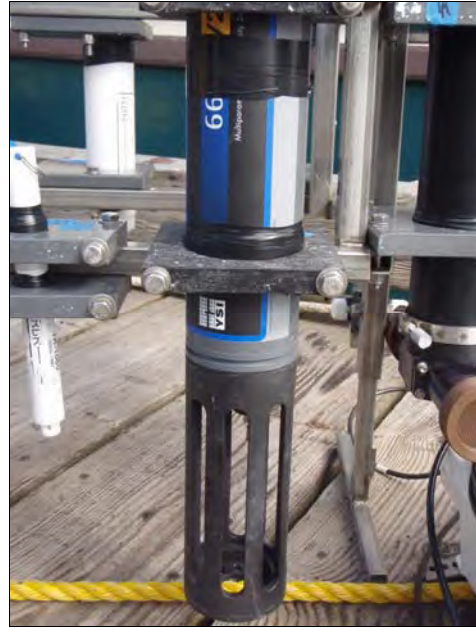
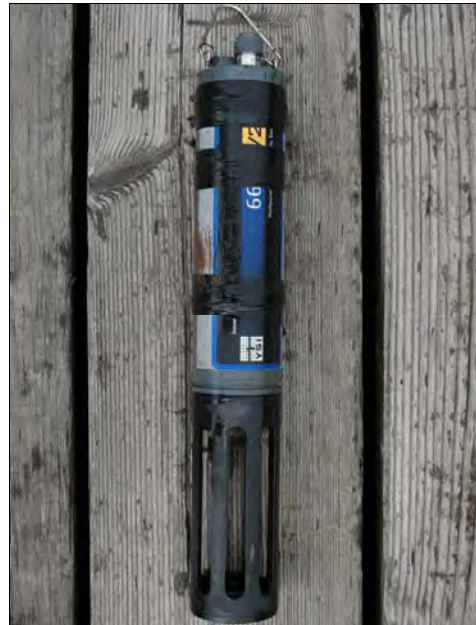
Before and after photos were taken of the instrument to examine the extent and possible impacts of bio-fouling (Fig. 34). The extent of bio-fouling at the AK test site was very small and the lowest of any of the five test sites. No hard fouling was observed.
