## PERFORMANCE VERIFICATION STATEMENT for the Greenspan EC3000 Conductivity Sensor

| <b>TECHNOLOGY TYPE:</b> | Coupled conductivity and temperature sensors with instrument based algorithms for estimation of salinity |
| <b>APPLICATION:</b> | In situ estimates of salinity for coastal moored and profiled deployments |
| <b>TYPE OF EVALUATION:</b> | Laboratory and Field Performance Verification |

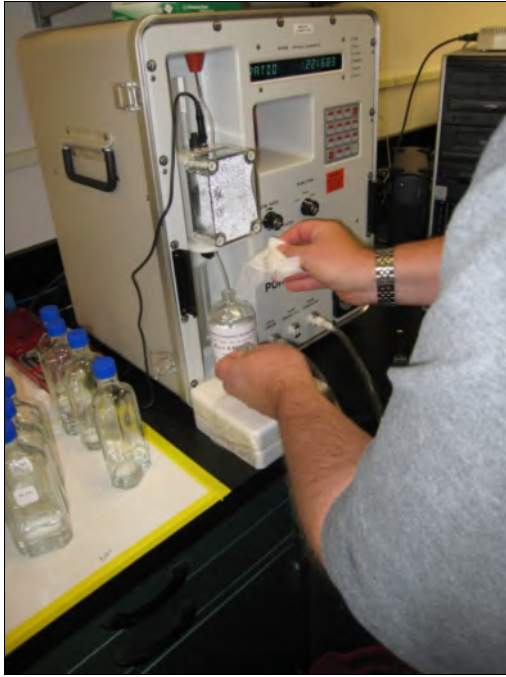
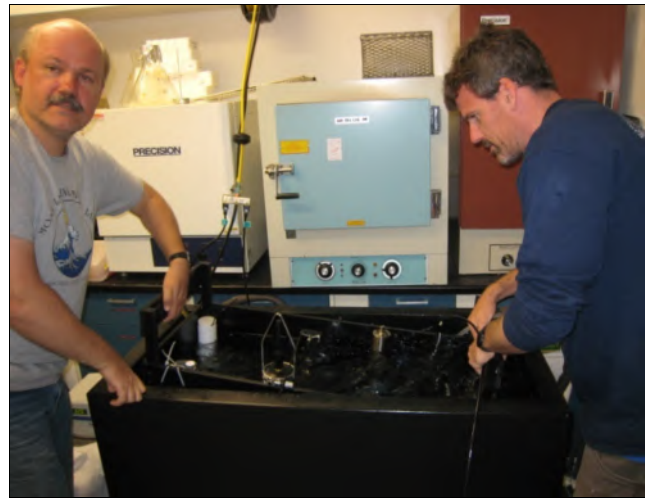
**Figure 1.** Analytical instrumentation (Portasal 8410A) used for laboratory analysis of salinity reference samples and one of the test baths and instrument racks used for the laboratory tests.

minutes prior to the start of reference sampling. The instrument was set to measure in situ conductivity and temperature using its own algorithms to derive a practical salinity estimate from these values at 1-minute intervals. Ten reference water samples were collected at sensor depth into sealed pre-rinsed glass salinity bottles at 3 minute intervals over 30 minutes. Each reference sample set was stored at room temperature and analyzed after 24 hours on the Portasal 8410A (Fig. 1).

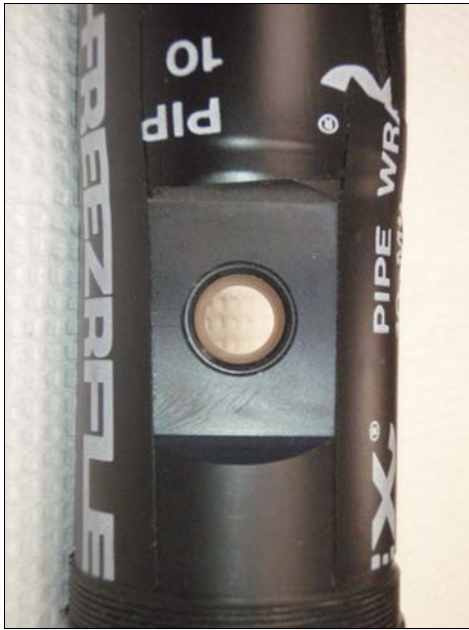
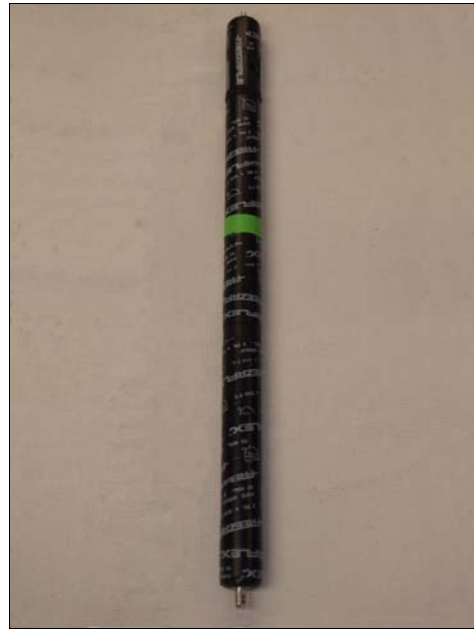
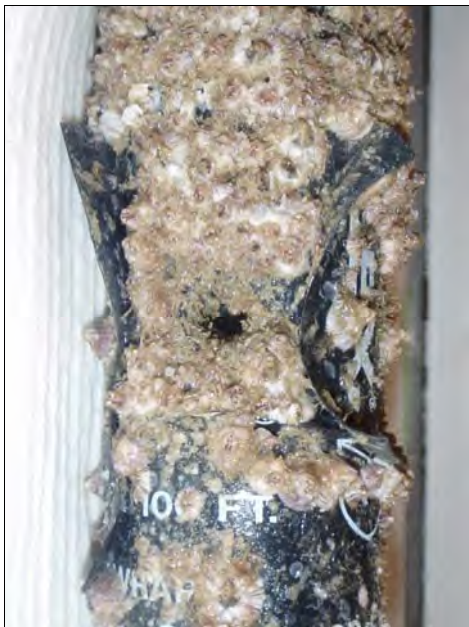
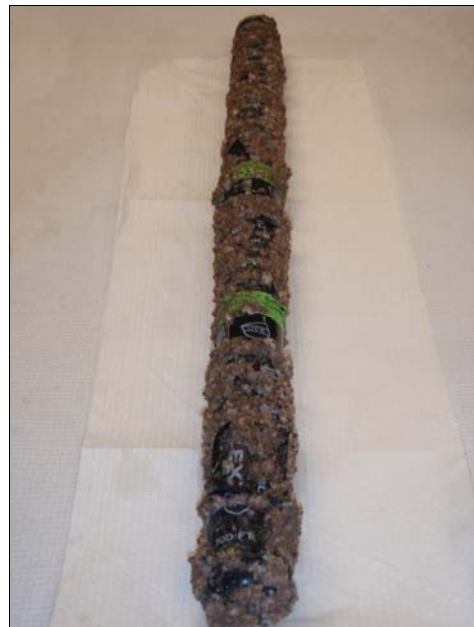
Before and after photos were taken of the instrument to examine the extent and possible impacts of bio-fouling (Fig. 10). A significant amount of hard, encrusting bio-fouling was evident across most of the instrument body by the end of the deployment, including directly within the conductivity cell.

Prior to Deployment (Close-up)

Prior to Deployment (Full View)

After Deployment (Close-up)

After Deployment (Full View)

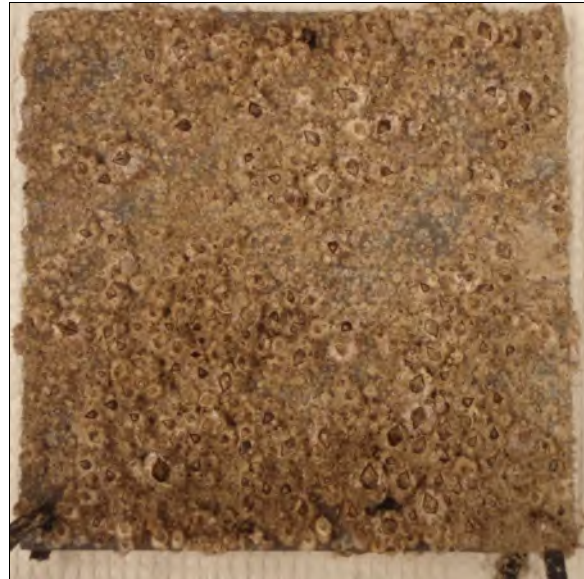
Bio-fouling plates were retrieved and photographed once each week throughout the deployment to help define the rate and extent of biofouling within the test environment (Fig. 11). By the third week of deployment there was an extensive amount of hard, encrusting biofouling at the Florida test site.

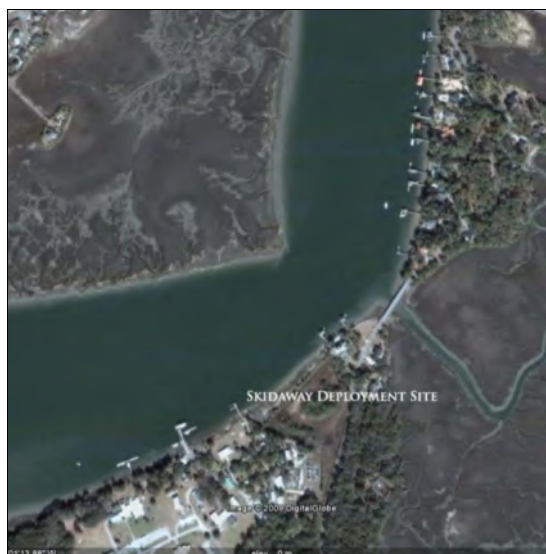
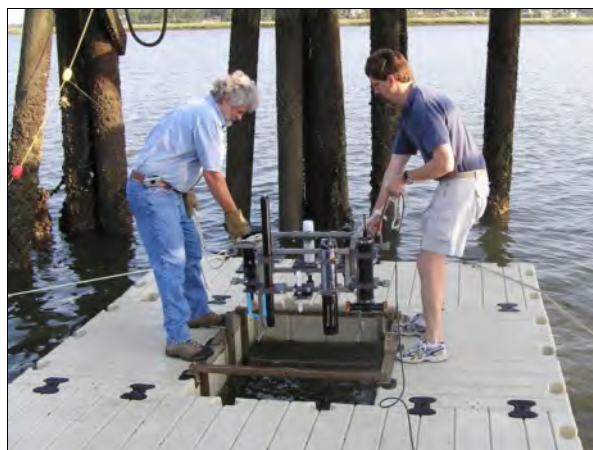
**Figure 12.** Site map and deployment arrangement for the field test conducted at Skidaway Island in Savannah, GA.

SkIO Deployment Site off Skidaway Island

SkIO Easy Dock with Rack in Center

The mooring test in Georgia took place on a floating dock located on Skidaway Island on the Skidaway River (Fig. 12). The water depth of the test site was 2.3 m at minimum. The site exhibited a fairly large fluctuation in salinity, ranging from 26 – 33 PSU, and temperatures ranged from 28 – 31 °C.

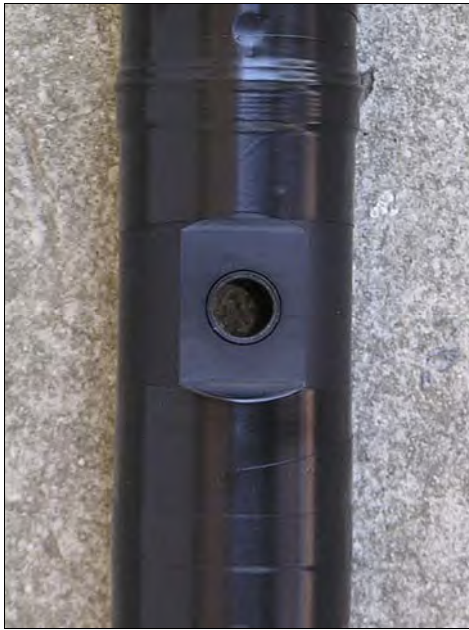
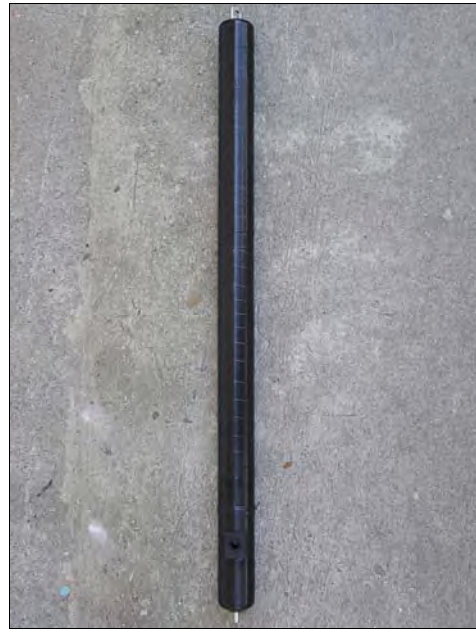
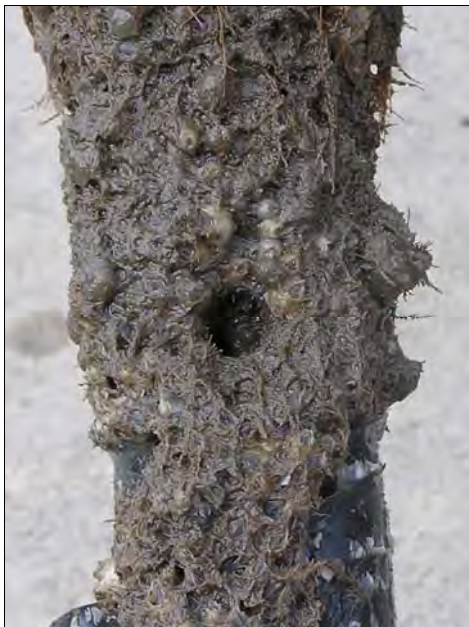
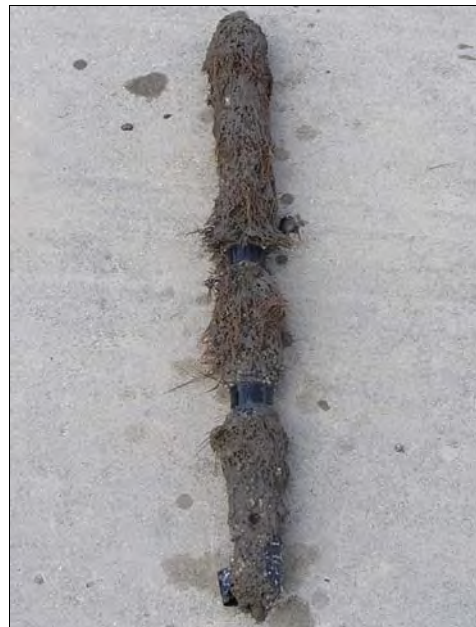
Before and after photos were taken of the instrument to examine the extent and possible impacts of bio-fouling (Fig. 16). A significant amount of soft (plant material) and hard (calcified) bio-fouling was evident across most of the instrument body by the end of the deployment including directly within the conductivity cell.

Prior to Deployment (Close-up)

Prior to Deployment (Full View)

After Deployment (Close-up)

After Deployment (Full View)

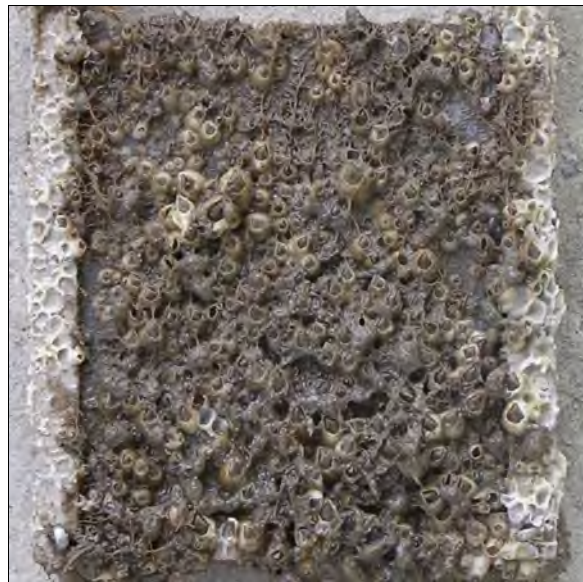
Bio-fouling plates were retrieved and photographed once each week throughout the deployment to help define the rate and extent of biofouling within the test environment (Fig. 17). Significant amounts of soft biofouling were evident by week 2 and progressed into heavy amounts of hard, encrusting biofouling at the Georgia test site.

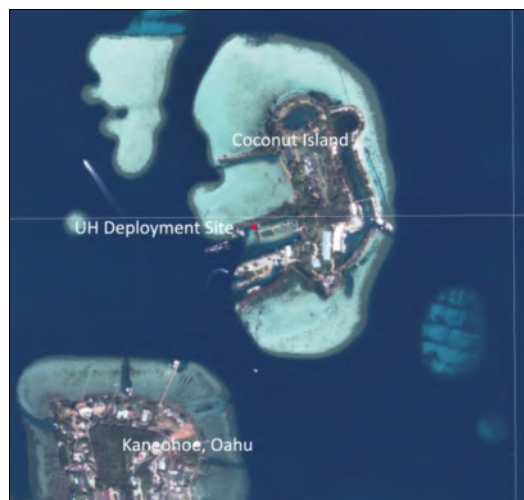
**Figure 18.** Site Photos from Field Deployment off Coconut Island, Kaneohe Bay, HI.

Deployment Site on Coconut Island

The mooring test in Kaneohe Bay took place on the fringing reef flat surrounding Coconut Island. The instruments were placed on a standing rack (Fig. 18) in a water depth of 3 meters with tidal variations typically less than 0.5 m at this site. During the deployment test, salinity values ranged from 33 to 35.5 and water temperatures from 26.1 to 29.6 °C.

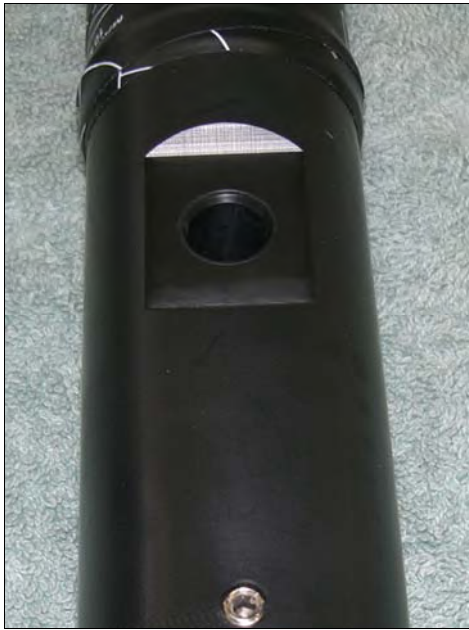
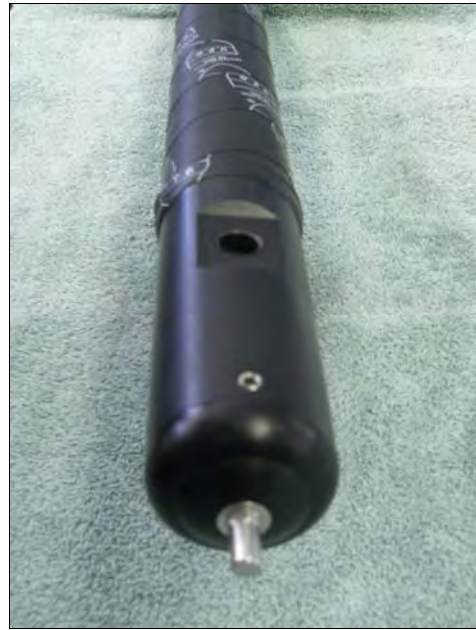
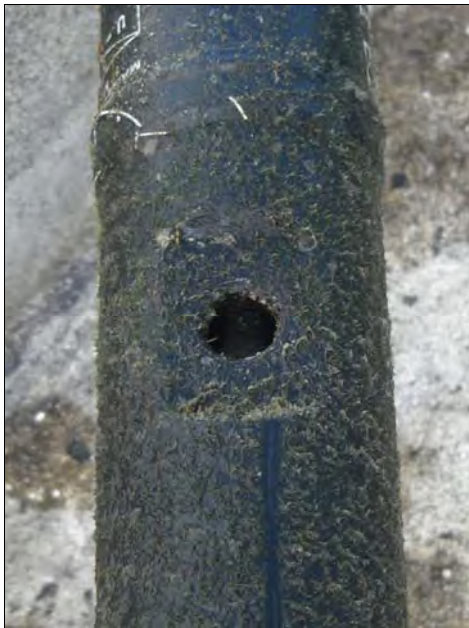
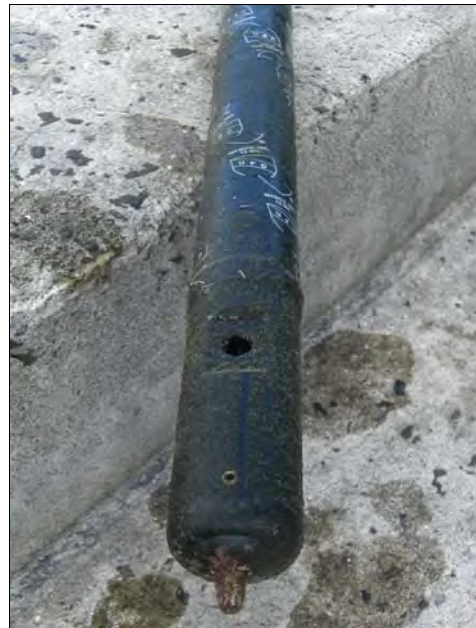
Before and after photos were taken of the instrument to examine the extent and possible impacts of bio-fouling (Fig. 22). The extent of bio-fouling was significantly less at this test site relative to FL or GA despite the longer deployment period and was mostly comprised of plant material and worm cases.

Prior to Deployment (Close-up)

Prior to Deployment (Full View)

After Deployment (Close-up)

After Deployment (Full View)

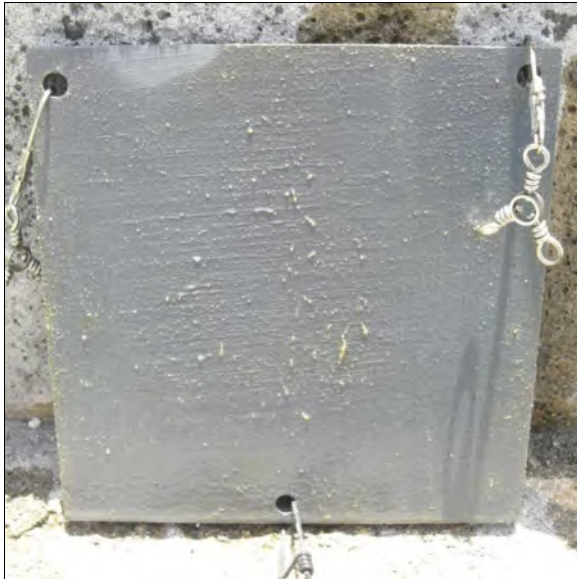
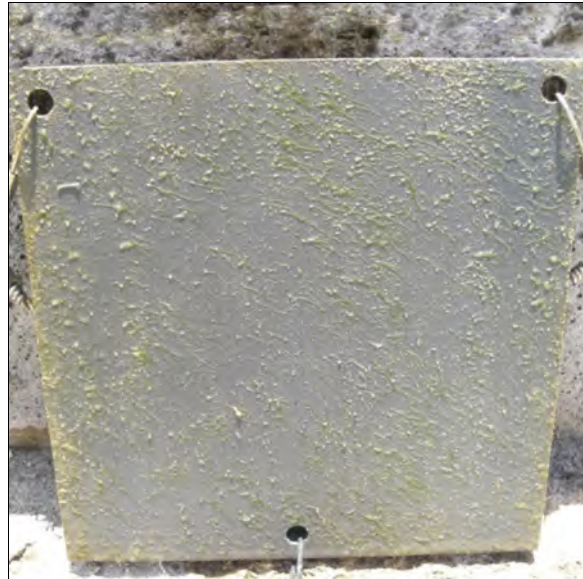
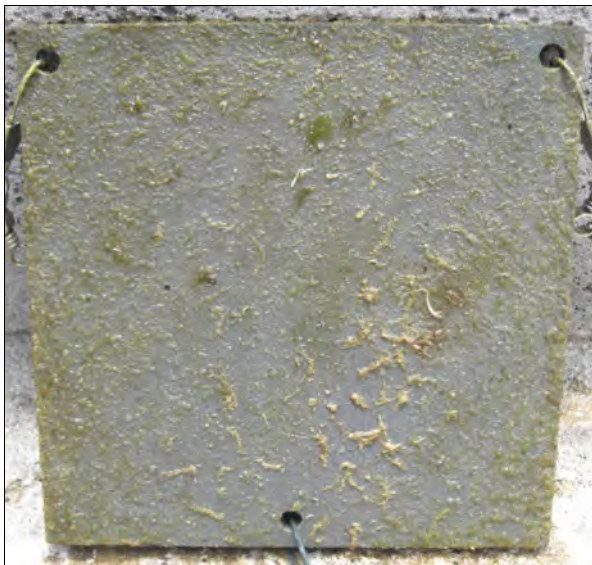
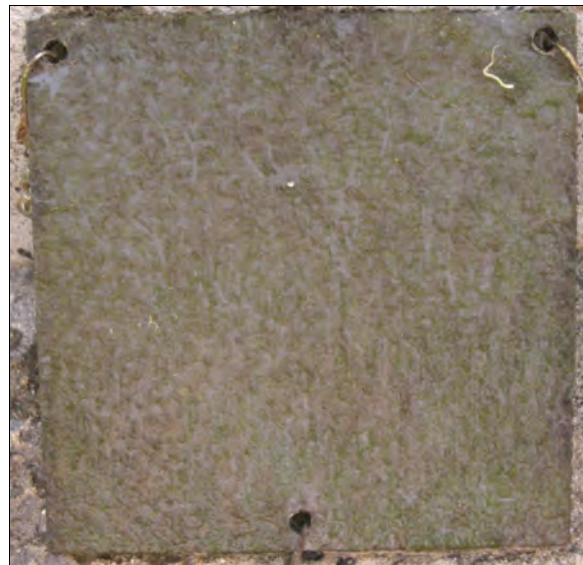
Bio-fouling plates were retrieved and photographed once each week throughout the deployment to help define the rate and extent of biofouling within the test environment. A subset of the plate photographs covering weeks 1, 2, 4, and 8 are shown in Figure 23. The extent of bio-fouling was significantly less at this test site relative to FL or GA despite the longer deployment period and was mostly comprised of plant material and worm cases.

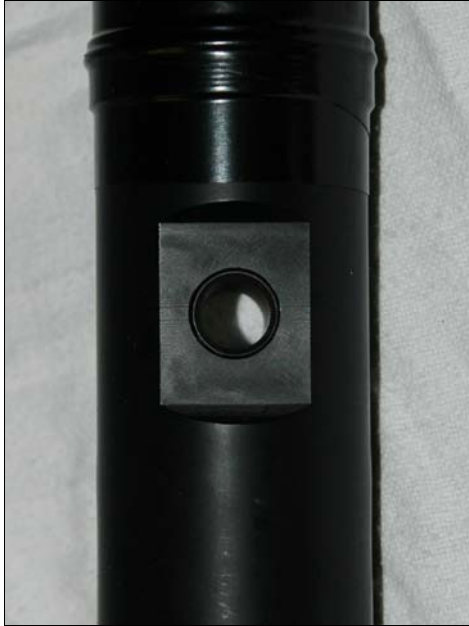
**Figure 28.** Greenspan EC3000 instrument photos from the Clinton River, MI test site before and after deployment

Prior to Deployment (Close-up)

Before and after photos were taken of the instrument to examine the extent and possible impacts of bio-fouling (Fig. 28). The extent of bio-fouling was quite low at the MI test site and consisted of only soft plant material.

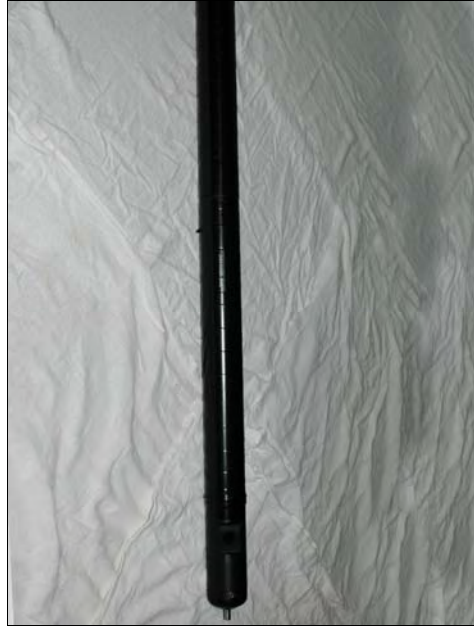
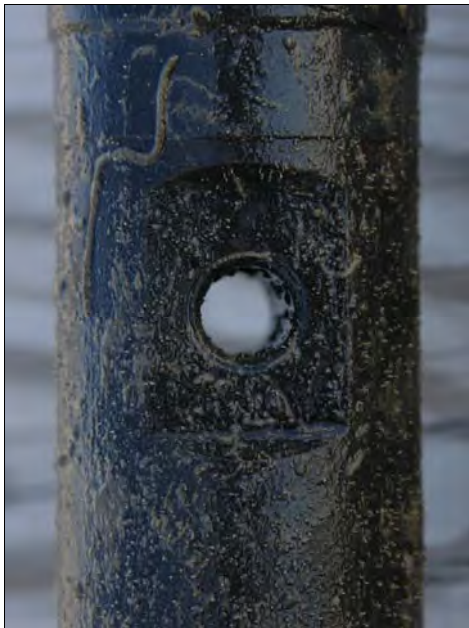
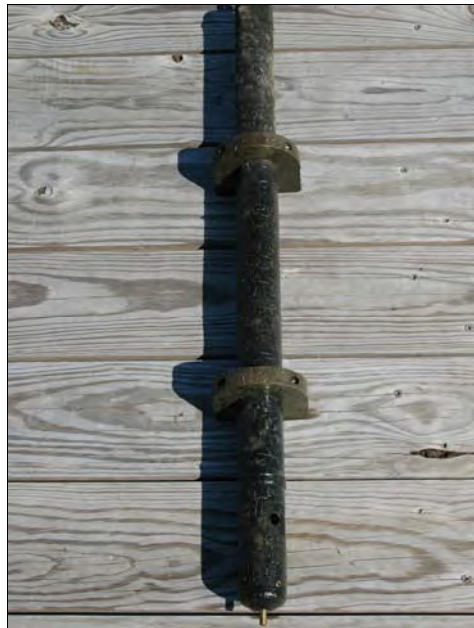
Prior to Deployment (Full View)

After Deployment (Close-up)

After Deployment (Full View)

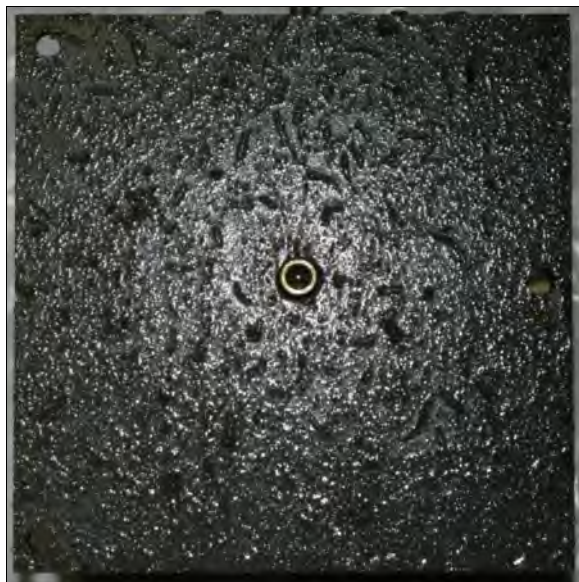
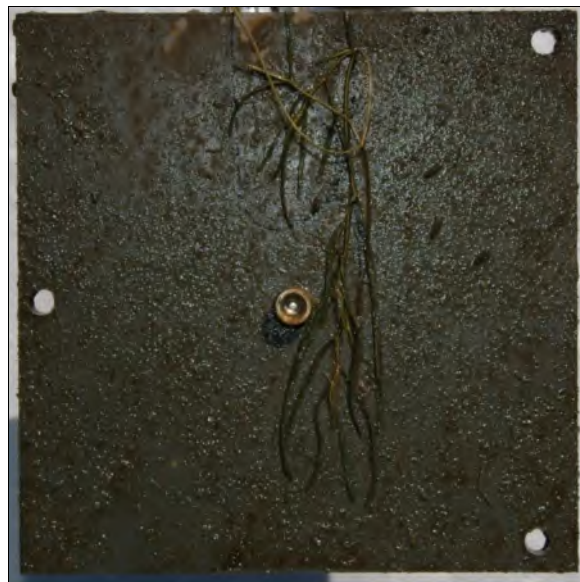
Bio-fouling plates were retrieved and photographed once each week throughout the deployment to help define the rate and extent of biofouling within the test environment (Fig. 29). Biofouling material was mostly comprised of plant material and developed rather quickly but did not appear to accumulate significantly once the original surface was covered.

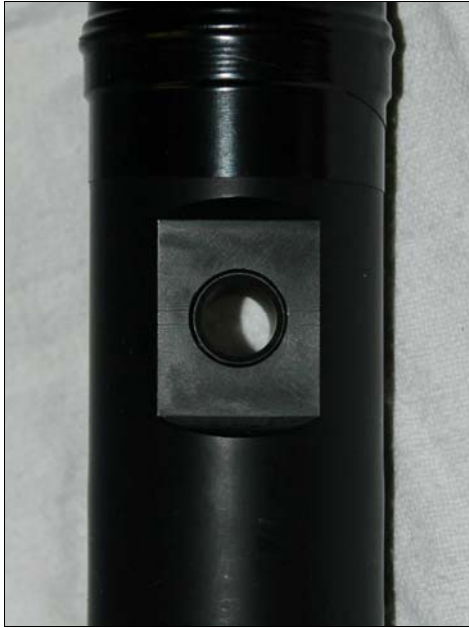
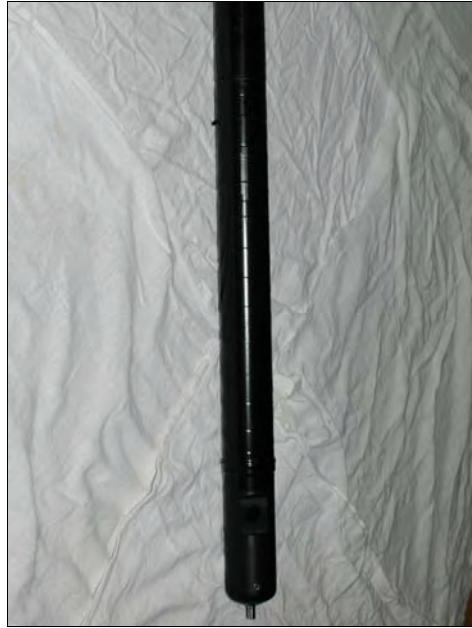
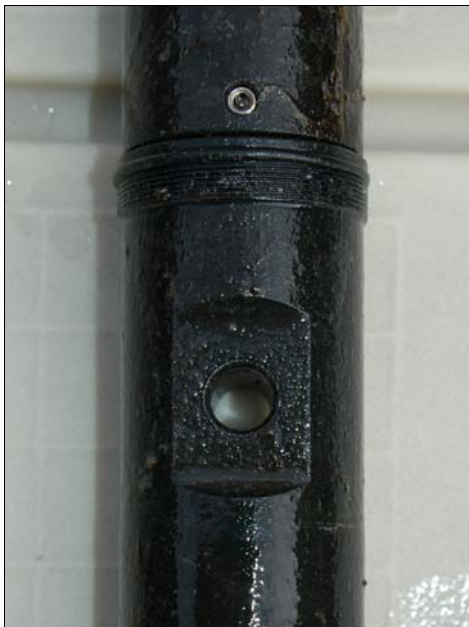
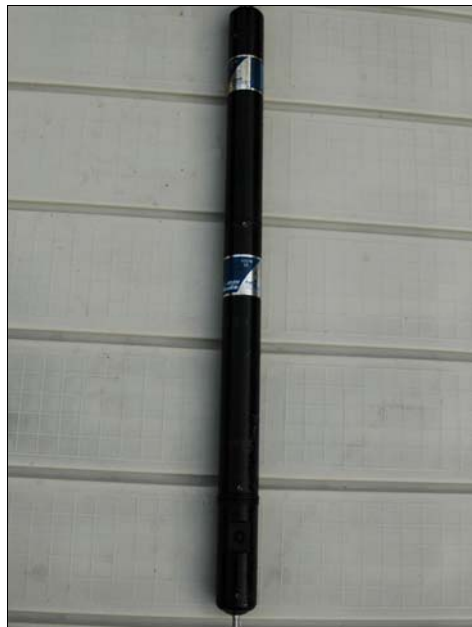
Before and after photos were taken of the instrument to examine the extent and possible impacts of bio-fouling (Fig. 34). The extent of bio-fouling at the AK test site was very small and the lowest of any of the five test sites. No hard fouling was observed.

Prior to Deployment (Close-up)

Prior to Deployment (Full View)

After Deployment (Close-up)

After Deployment (Full View)

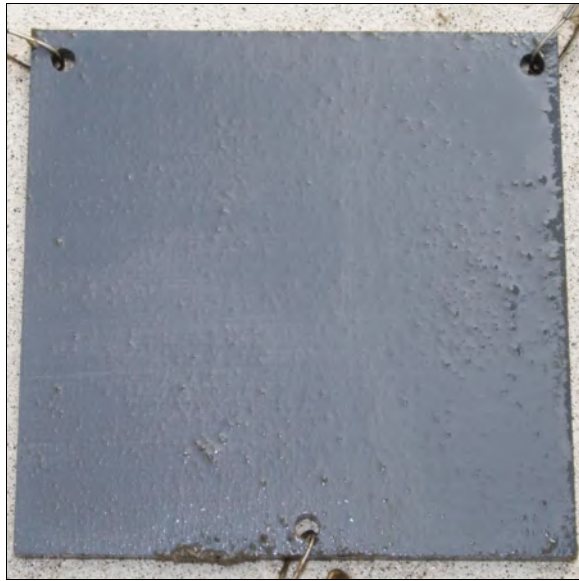
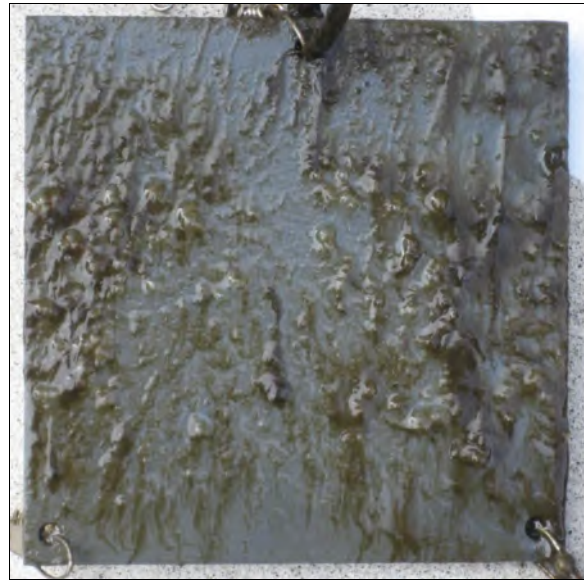
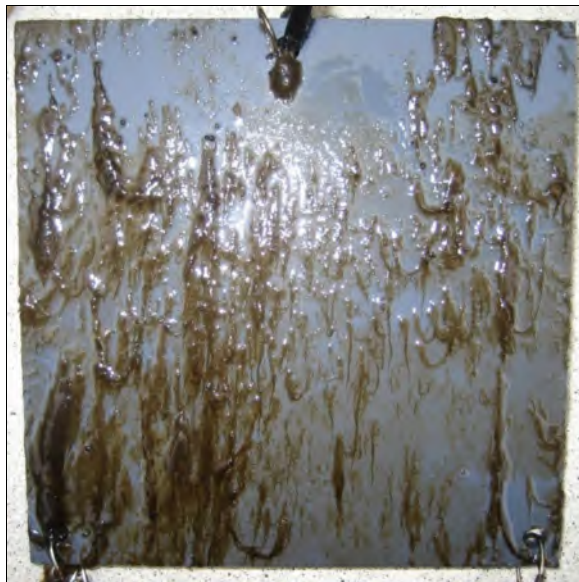
Bio-fouling plates were retrieved and photographed once each week throughout the deployment to help define the rate and extent of biofouling within the test environment (Fig. 35). Biofouling material was mostly comprised of plant material and had a slower but consistent rate of fouling until the surface was completely covered.
